CORNER RECORD

CR-97-17

Brief Legal Description SOUTHEAST & SOUTHWEST CORNER OF PARCEL "A" AS SHOWN ON THE PARCEL MAP
FILED IN BOOK 11 OF PARCEL MAPS, AT PAGE 77, SOUTH 1/2 OF SECTION 34, T.1 S., R.9 E., M.D.B. & M.

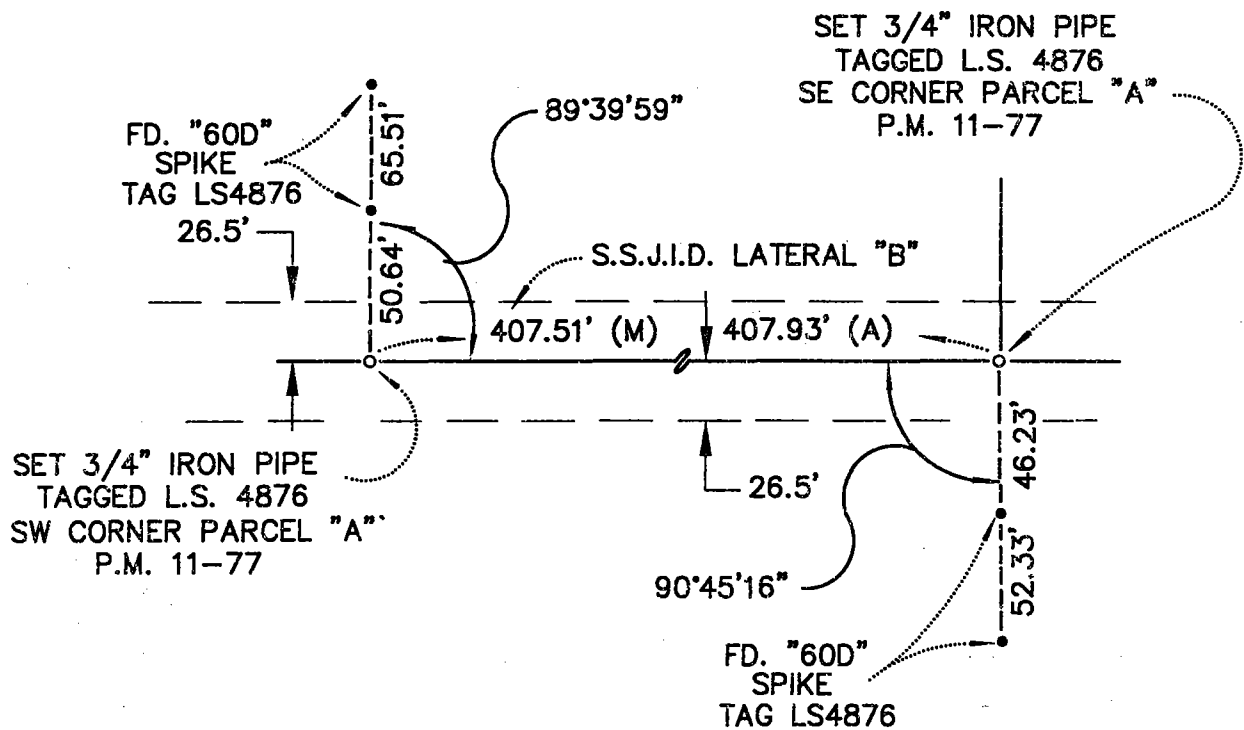
Identification and type of corner found: Evidence used to identify or procedure used to establish or reestablish the corner: 3/4" IRON PIPE NOT TAGGED AT SOUTHEAST CORNER OF PARCEL "A"

AND 3/4" IRON PIPE TAGGED L.S. 3580 AT THE SOUTHWEST CORNER OF PARCEL "A"

DESTROYED DURING CONSTRUCTION OF S.S.J.I.D. IRRIGATION LINE LATERAL "B".

FOUND WITNESS CORNERS AS SHOWN ON CORNER RECORD CR-97-10

A description of the physical condition of the monument as shown and as set or reset: SET 3/4" X 30"
IRON PIPES WITH PLASTIC PLUG STAMPED LS 4876 USING TIES SHOWN ON

CORNER RECORD CR-97-10
