CORNER RECORD

Document Number 05-19

County of SAN JOAQUIN, California

Brief Legal Description INTERIOR QUARTER CORNER OF SECTION 15, T. 2 S., R. 9 E., M.D.B. & M.

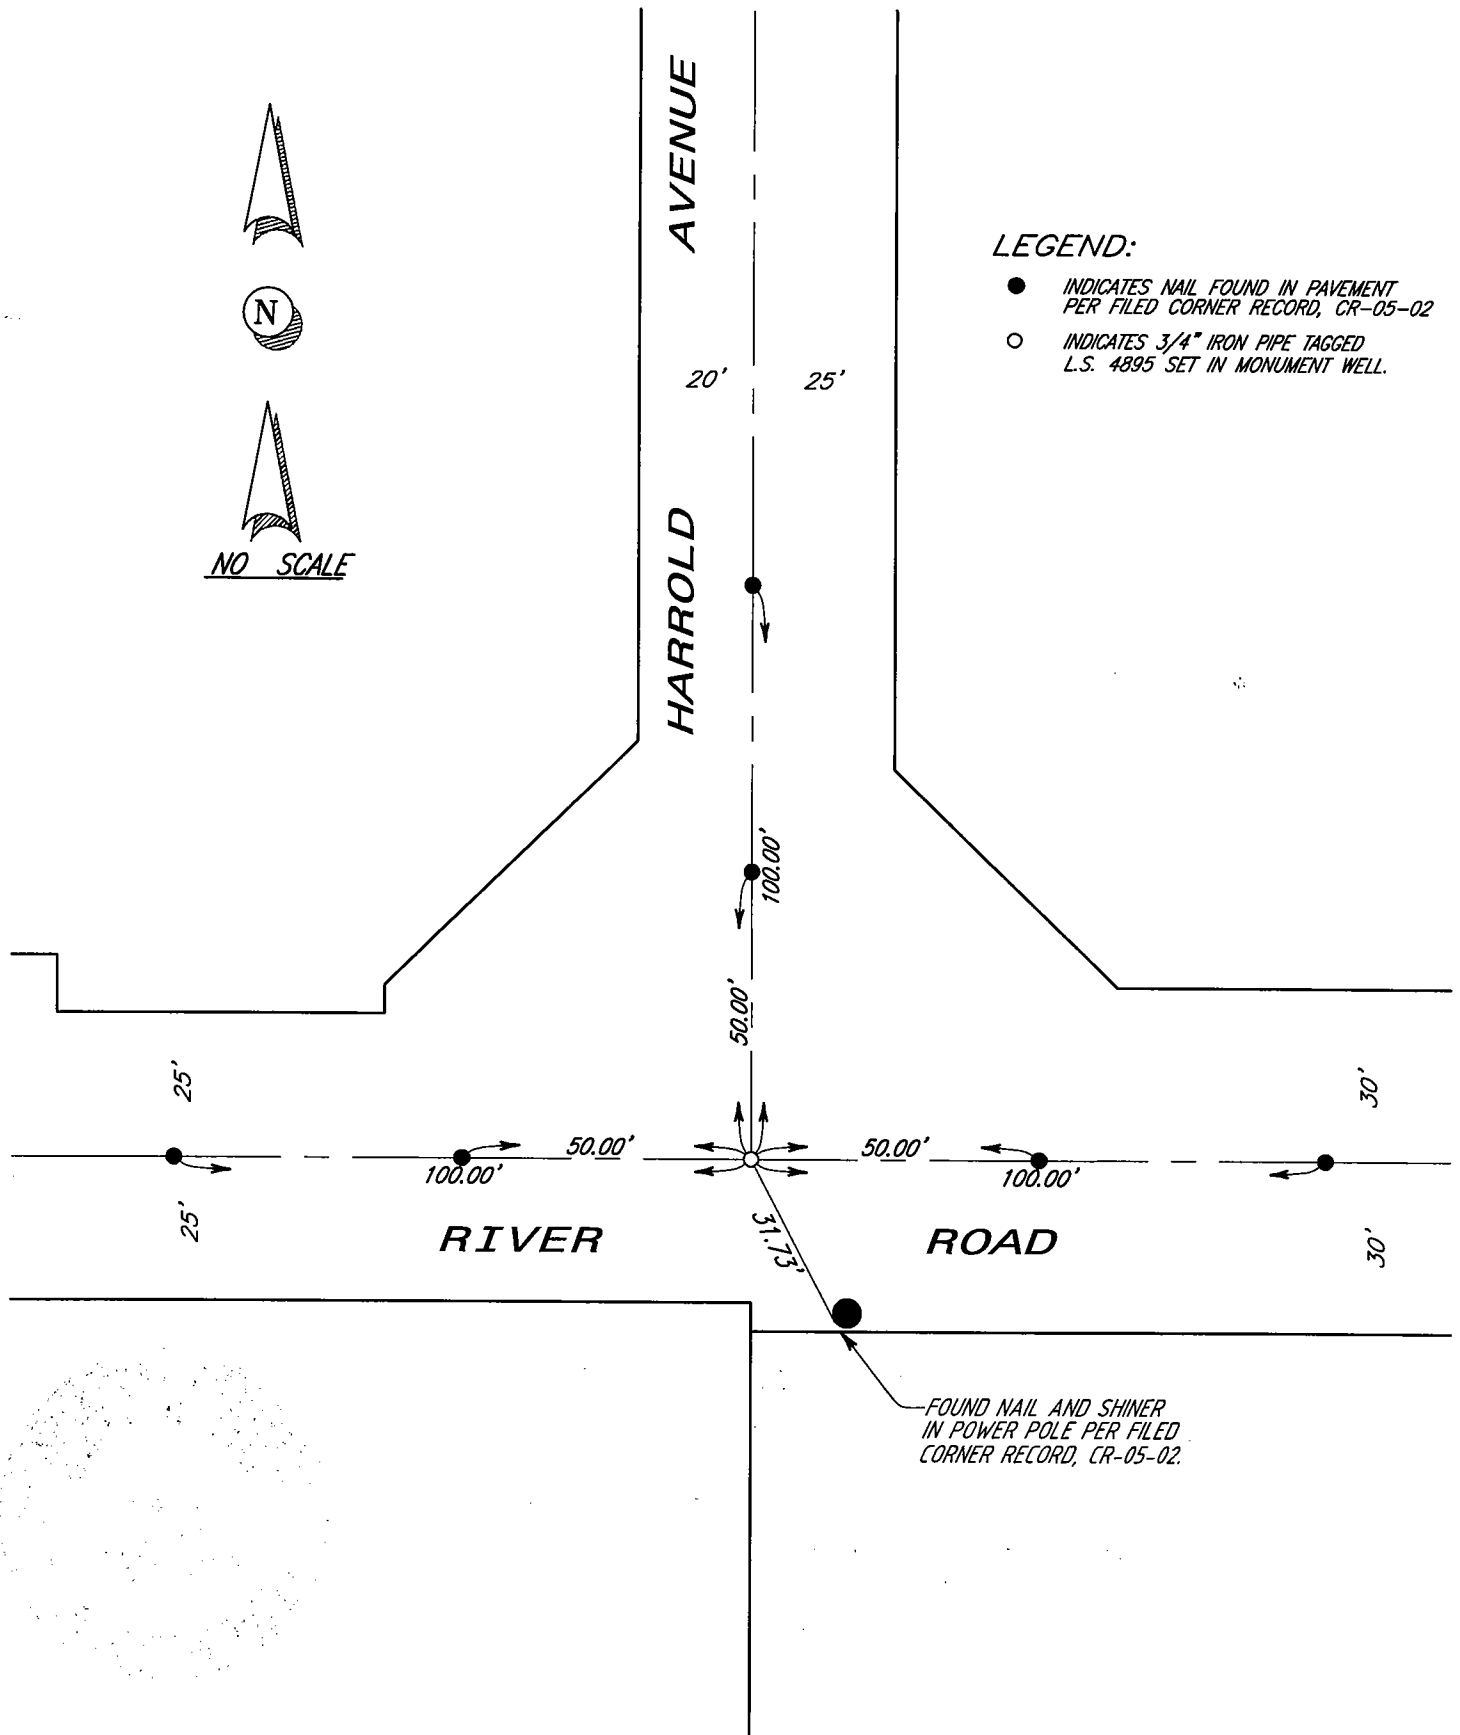
IRON PIN AND WASHER IN MONUMENT WELL PER BOOK 16 OF PARCEL MAPS, PAGE 101, SAN JOAQUIN COUNTY RECORDS, WAS DESTROYED WITH THE CONSTRUCTION OF A TUNNEL FOR A CONVEYOR SYSTEM. CORNER WAS REESTABLISHED USING TIES SHOWN ON FILED CORNER RECORD, CR-05-02. SEE FOLLOWING PAGE FOR LOCATION OF TIES.

SET MONUMENT IS A 3/4" IRON PIPE TAGGED L.S. 4895 SET IN NEW MONUMENT WELL.
