CORNER RECORD

Document Number CR-01-134

County of San Joaquin, California

Brief Legal Description BIRD ROAD 40' ± N/O KENNER RD. AND

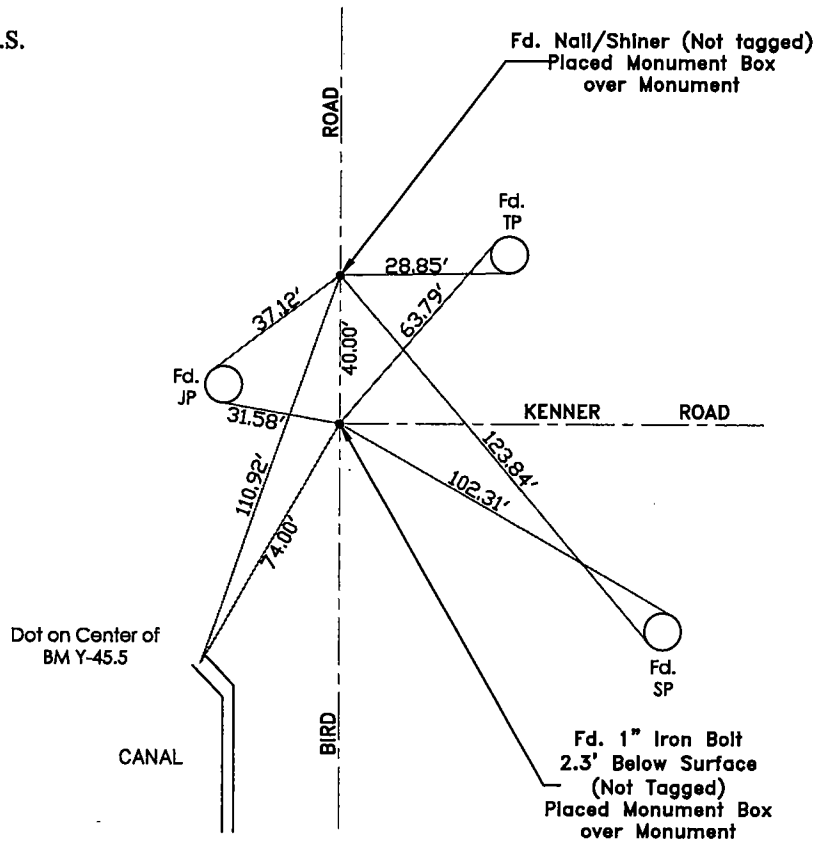
N.T.S.

Identification and type of corner found: Evidence used to identify or procedure used to establish or reestablish the corner:  
FOUND NAIL/SHINER AND FOUND 1" IRON BOLT 2.3' BELOW SURFACE. CONFIRMED LOCATION PER SWING TIES ON  
CR-00-227. SEE SKETCH ON BACKSIDE.

A description of the physical condition of the monument as found and as set or reset:  
FOUND MONUMENTS IN GOOD CONDITION. SEE SKETCH ON BACKSIDE.
