CORNER RECORD

City of Stockton
 Brief Legal Description Section 11 of C.M. Weber Grant

Document Number 06-2
 County of San Joaquin, California

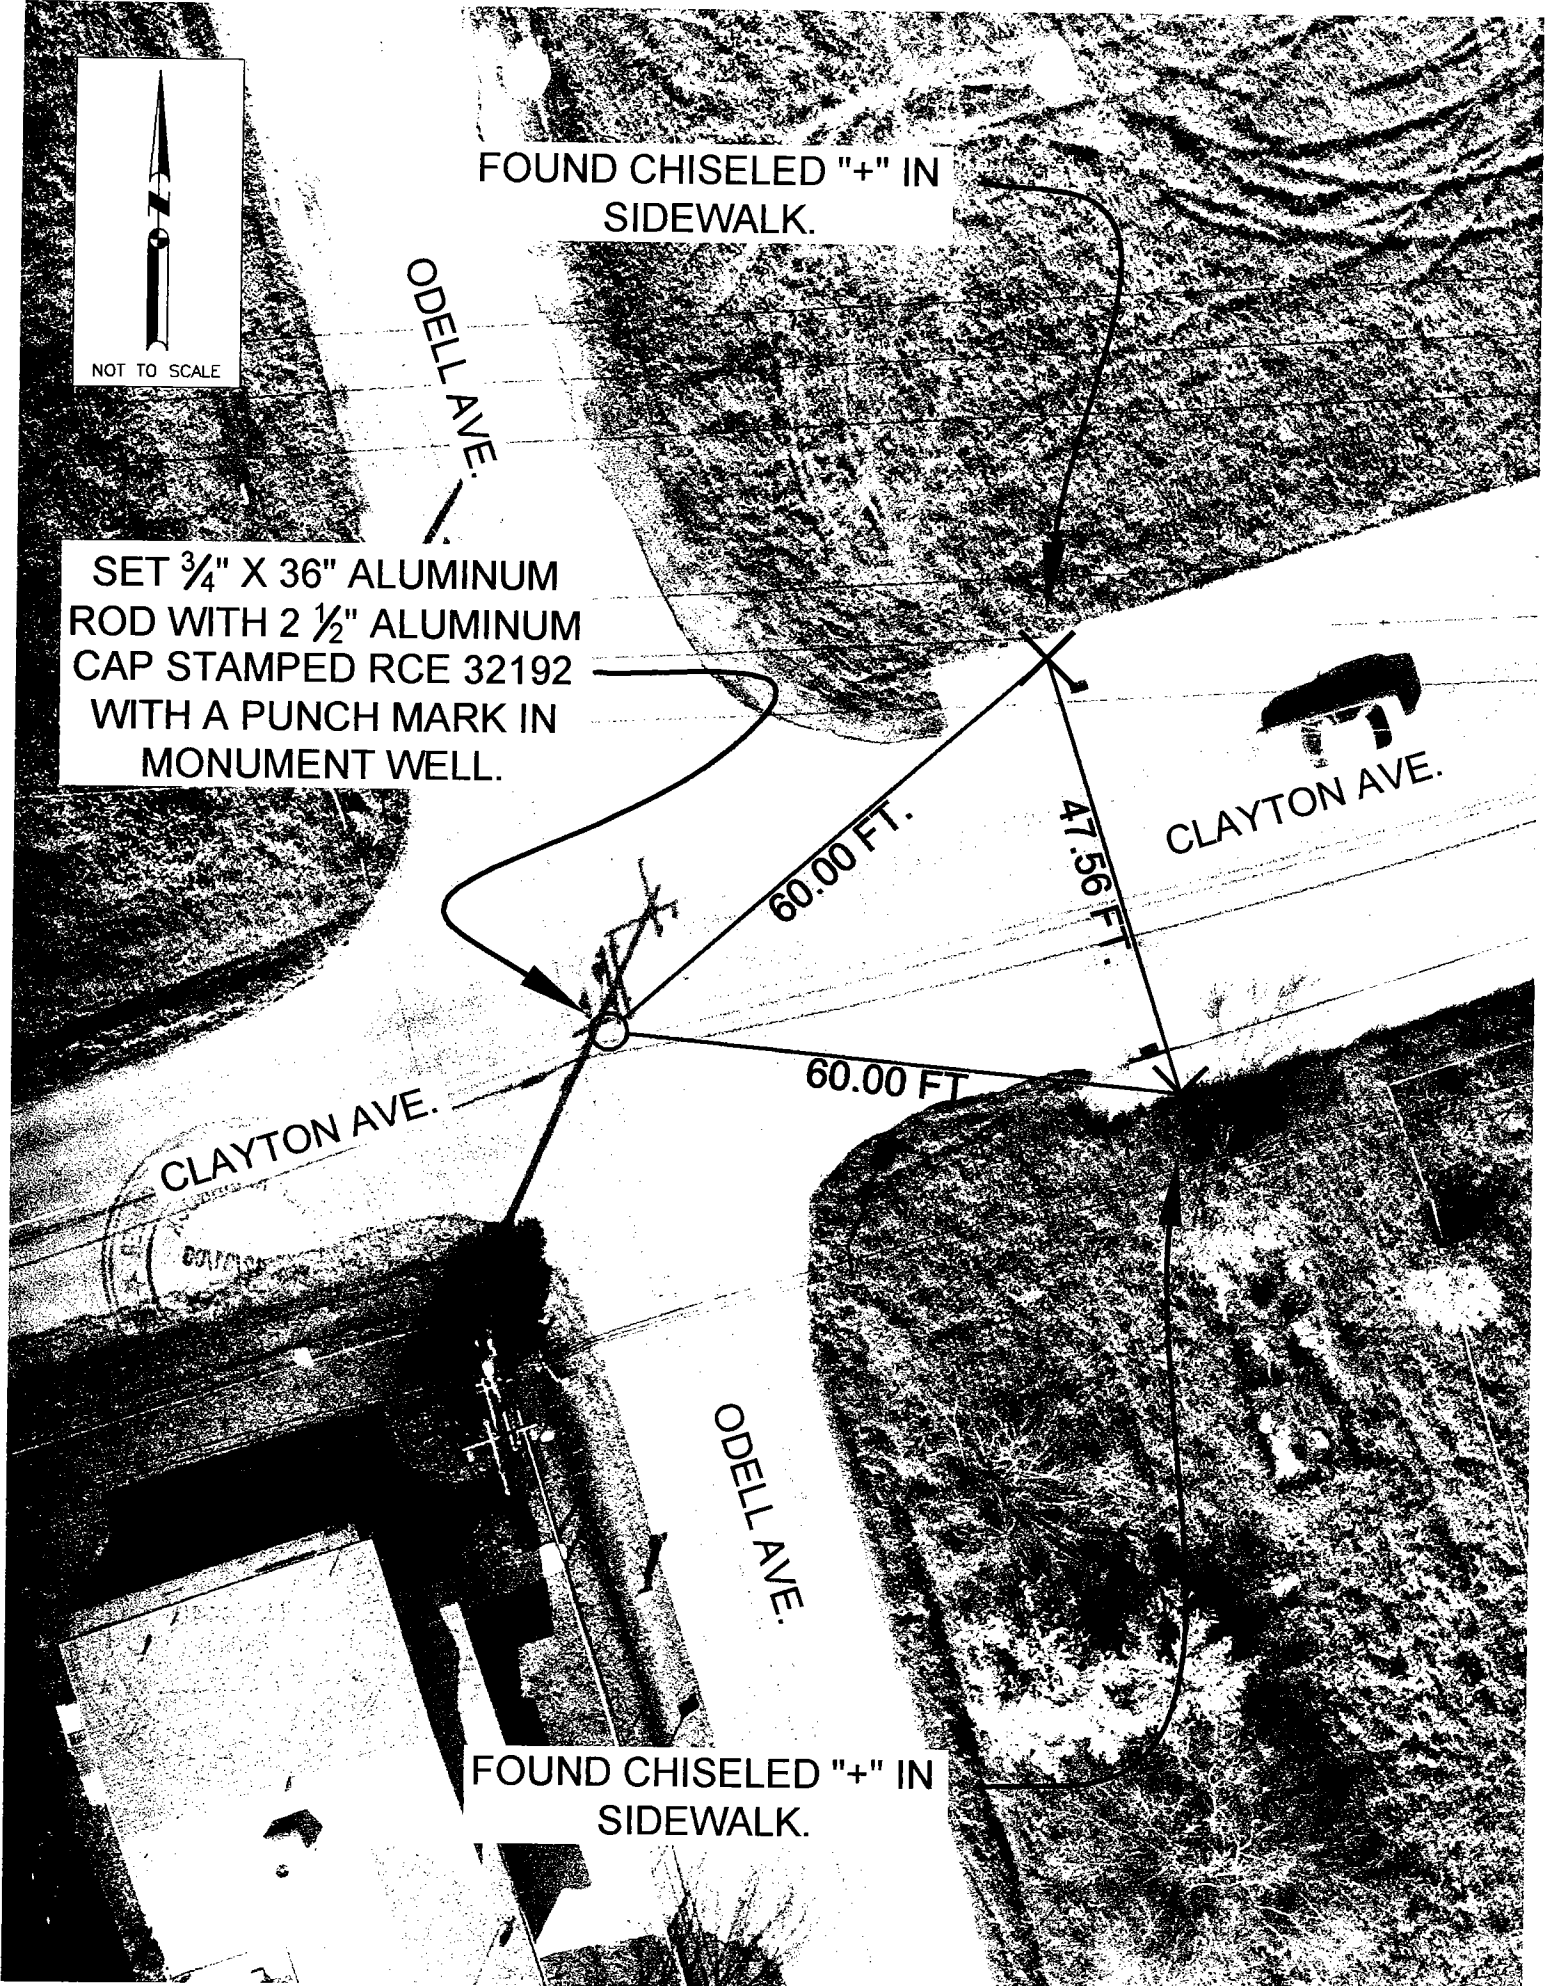
(D.D. SHEET NO. 34)

FOUND CHISELED "+" IN
SIDEWALK.

SET $\frac{3}{4}$ " X 36" ALUMINUM
ROD WITH 2 $\frac{1}{2}$ " ALUMINUM
CAP STAMPED RCE 32192
WITH A PUNCH MARK IN
MONUMENT WELL.

Identification and type of corner found: Evidence used to identify or procedure used to establish or reestablish the corner:
Monument was established using swing ties from pre-construction corner record, CR-05-25.

A description of the physical condition of the monument as found and as set or reset:
Set 3/4" x 36" aluminum rod with 2 1/2" aluminum cap stamped RCE 32192 with a punch mark in monument well.
