CORNER RECORD

Document Number CR-91-012

Brief Legal Description CITY MONUMENT IN INTERSECTION OF 'D' ST & MARKET ST.

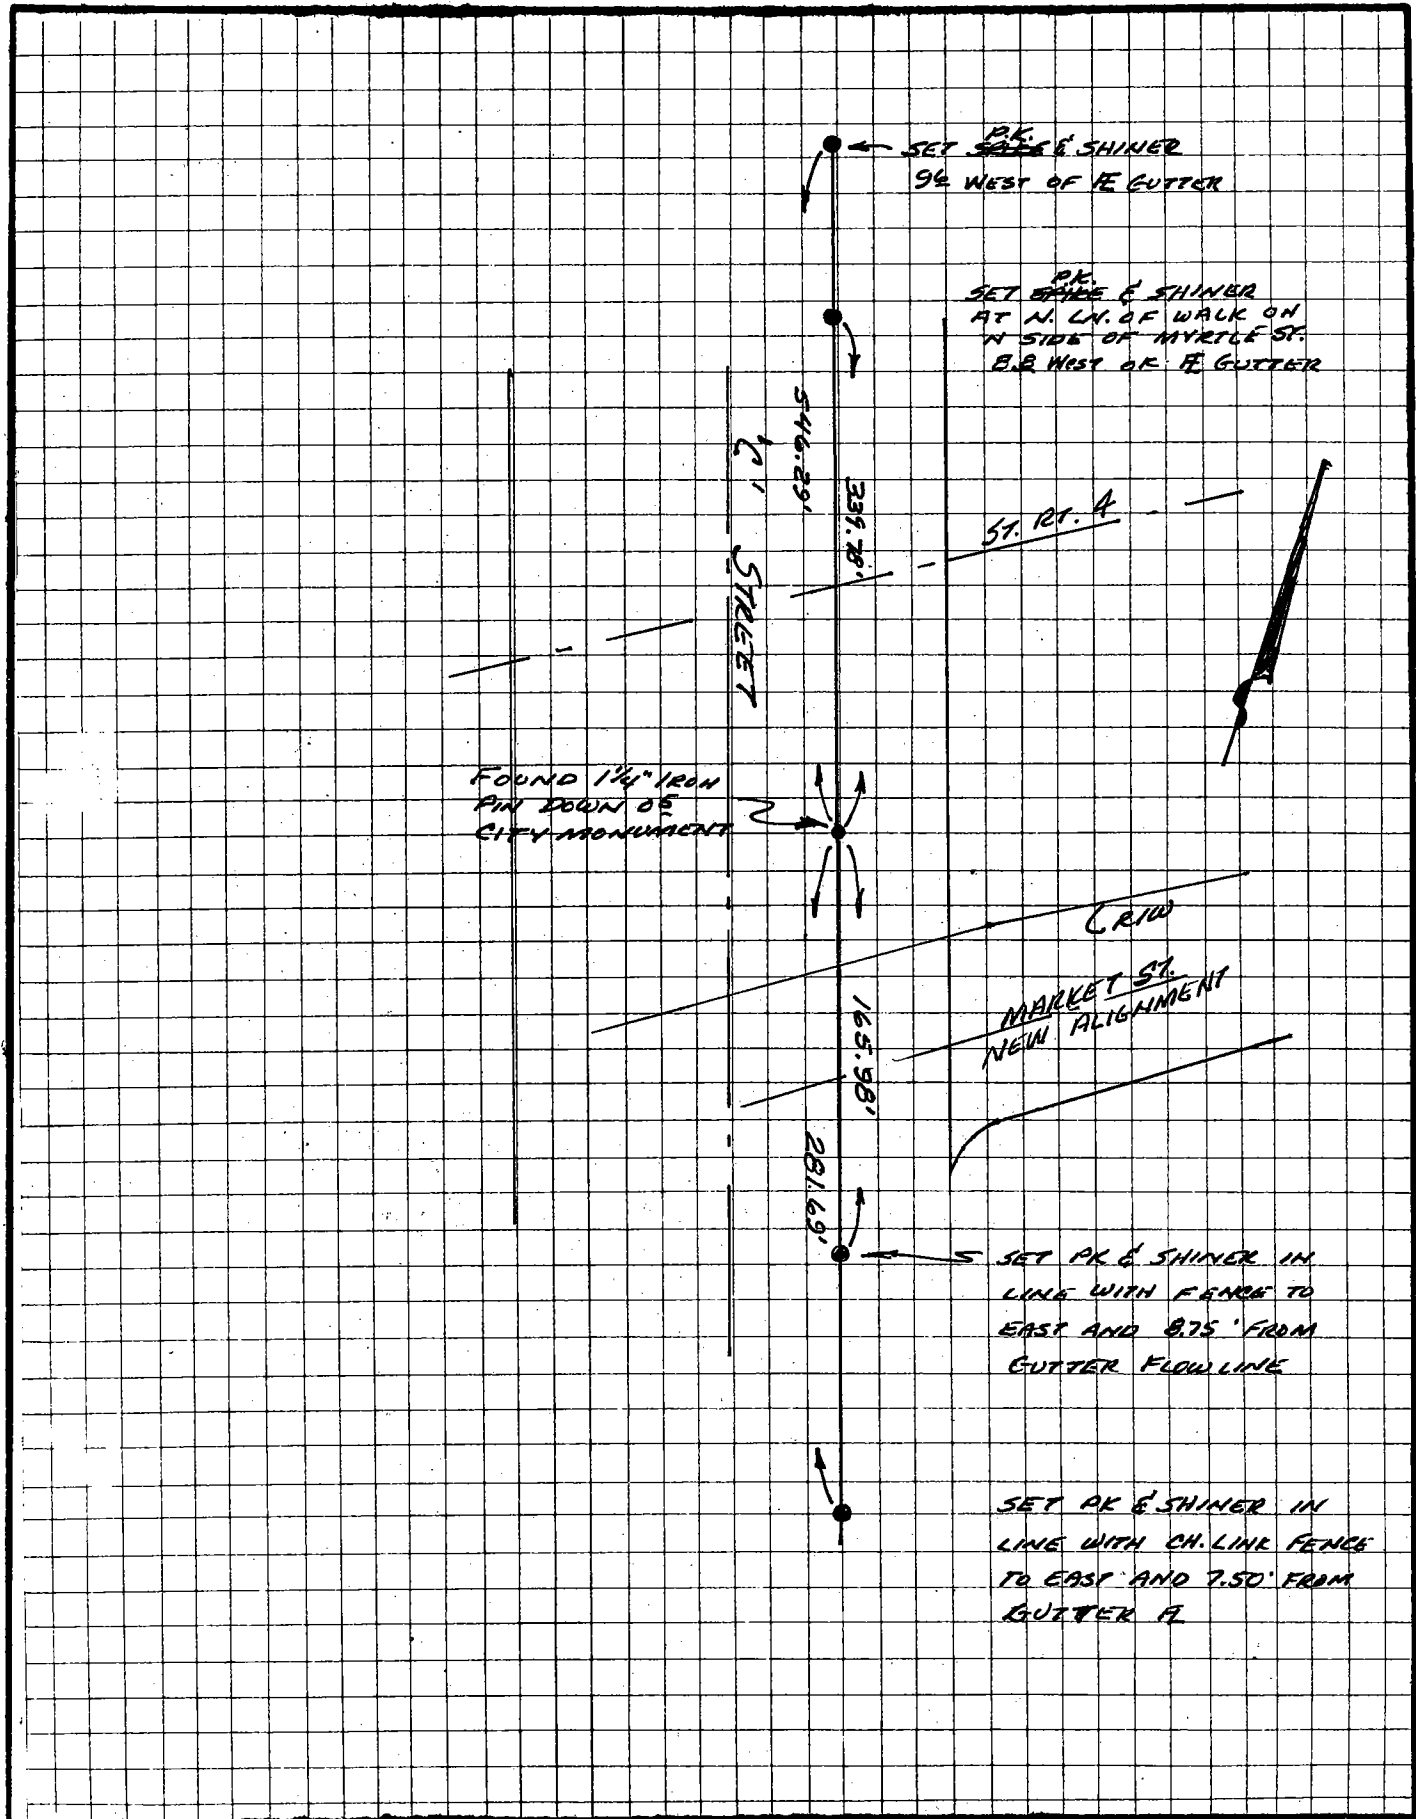
Identification and type of corner found: Evidence used to identify or procedure used to establish or reestablish the corner: 1 1/4" IRON PIN IN INTERSECTION OF 'D' & MARKET STS., 10' ± EAST OF CENTERLINE OF 'D' STREET. — CITY MONUMENT

A description of the physical condition of the monument as found and as set or reset: MONUMENT IN GOOD CONDITION — WILL BE DESTROYED BY CONSTRUCTION.

PK. & SHINER
 SET ~~SAFER~~ 94 WEST OF FE GUTTER

PK. & SHINER
 SET ~~SAFER~~ AT N. LI. OF WALK ON N SIDE OF MYRTLE ST. 8.2 WEST OF FE GUTTER

FOUND 1 1/2" IRON PIN DOWN OF CITY MONUMENT

CRWD
 MARKET ST.
 NEW ALIGNMENT

SET PK. & SHINER IN LINE WITH FENCE TO EAST AND 8.75' FROM GUTTER FLOW LINE

SET PK. & SHINER IN LINE WITH CH. LINE FENCE TO EAST AND 7.50' FROM GUTTER A
