CORNER RECORD

Document number 02-1
County of San Joaquin, California

Brief Legal Description BIRD ROAD 80' ± N/O HWY 132

NW CORNER OF SECTION 31, T.3S., R.6E.

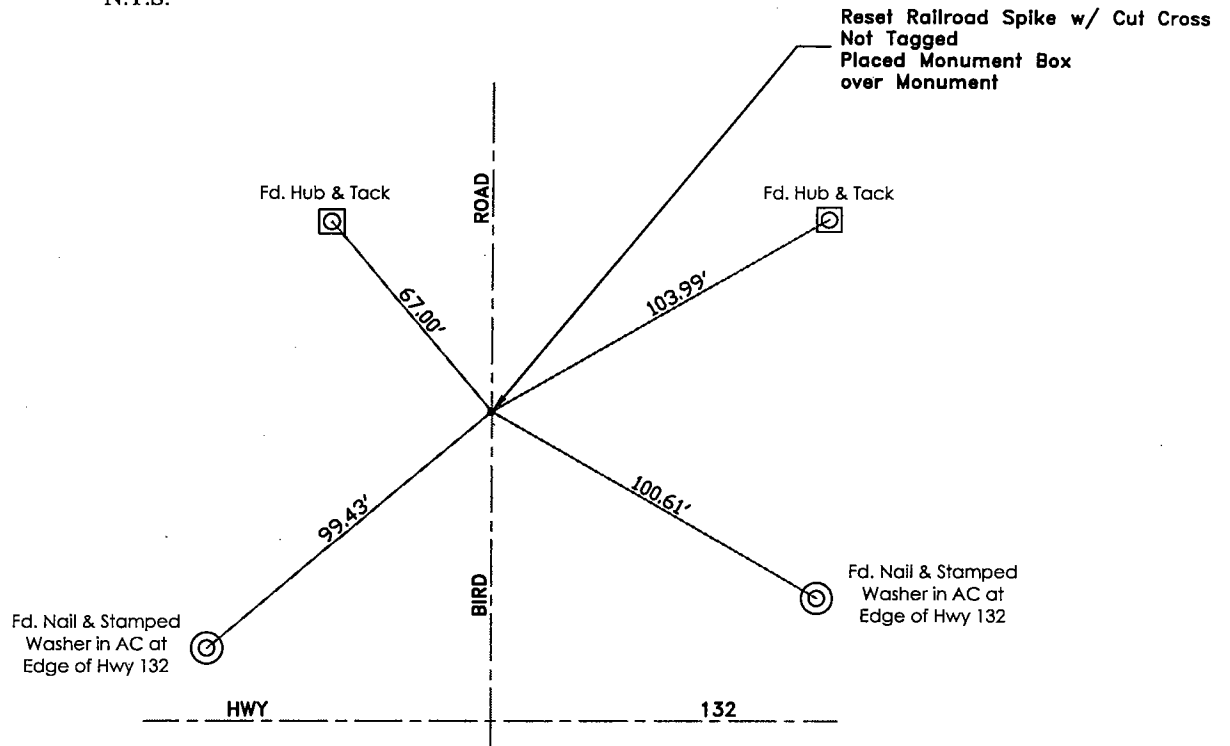
Identification and type of corner found: Evidence used to identify or procedure used to establish or reestablish the corner:
FOUND RAILROAD SPIKE W/ CUT CROSS DISTURBED. RESET MONUMENT. CONFIRMED LOCATION PER SWING TIES ON
CR-00-230. SEE SKETCH ON BACKSIDE.

A description of the physical condition of the monument as found and as set or reset:
RESET MONUMENT. SEE SKETCH ON BACKSIDE.
