CORNER RECORD

Document Number CR-13-63

City of Stockton

Brief Legal Description Witness corner of the SE corner of Lot 12 of Block 7 East of Center.

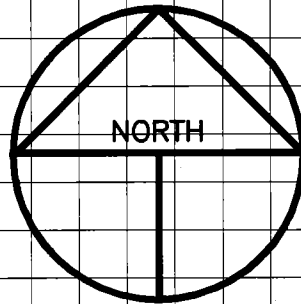
SCALE: 1" = 6'
2012-221 CR9

15.59'(M)

SET 1-1/4"
MAGNETIC NAIL

FD. SAW-CUT
CROSS

14.15'(M)

Set two 1-1/4" Magnetic Nail ties as shown on sheet 2.
