CORNER RECORD

Document Number CR-13-64
City of Stockton County of San Joaquin, California

Brief Legal Description Witness corner of the SW corner of Lot 2 of Block 8 East of Center.

PRE-CONSTRUCTION CORNER RECORD

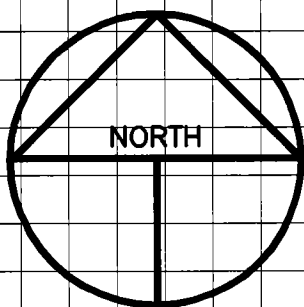
SCALE: 1" = 6'
2012-221 CR10

SET 1-1/4"
MAGNETIC NAIL

16.42'(M)
FD. SAW-CUT
CROSS

14.67'(M)

NO ATTEMPT WAS MADE TO VERIFY THE
POSITION OF THE MONUMENT

Set two 1-1/4" Magnetic Nail ties as shown on sheet 2.
