CORNER RECORD

Document Number CR-13-67
City of Stockton County of San Joaquin, California

Brief Legal Description Witness corner of the NW corner of Lot 1 of Block 8 East of Center.

PRE-CONSTRUCTION CORNER RECORD

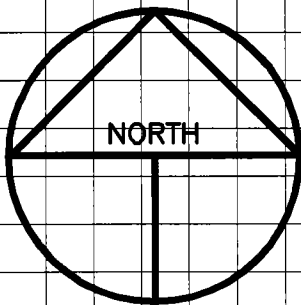
SCALE: 1" = 6'
2012-221 CR13

SET 1-1/4"
MAGNETIC NAIL

16.83'(M)

14.41'(M)

FD. LARGE ETCHED
CROSS

EAST OF CENTER
LOT 1
BLOCK 8

NO ATTEMPT WAS MADE TO VERIFY THE
POSITION OF THE MONUMENT

Set two 1-1/4" Magnetic Nail ties as shown on sheet 2.
