**CORNER RECORD**

Document Number CR-13-220

T3N, R7E, MDM

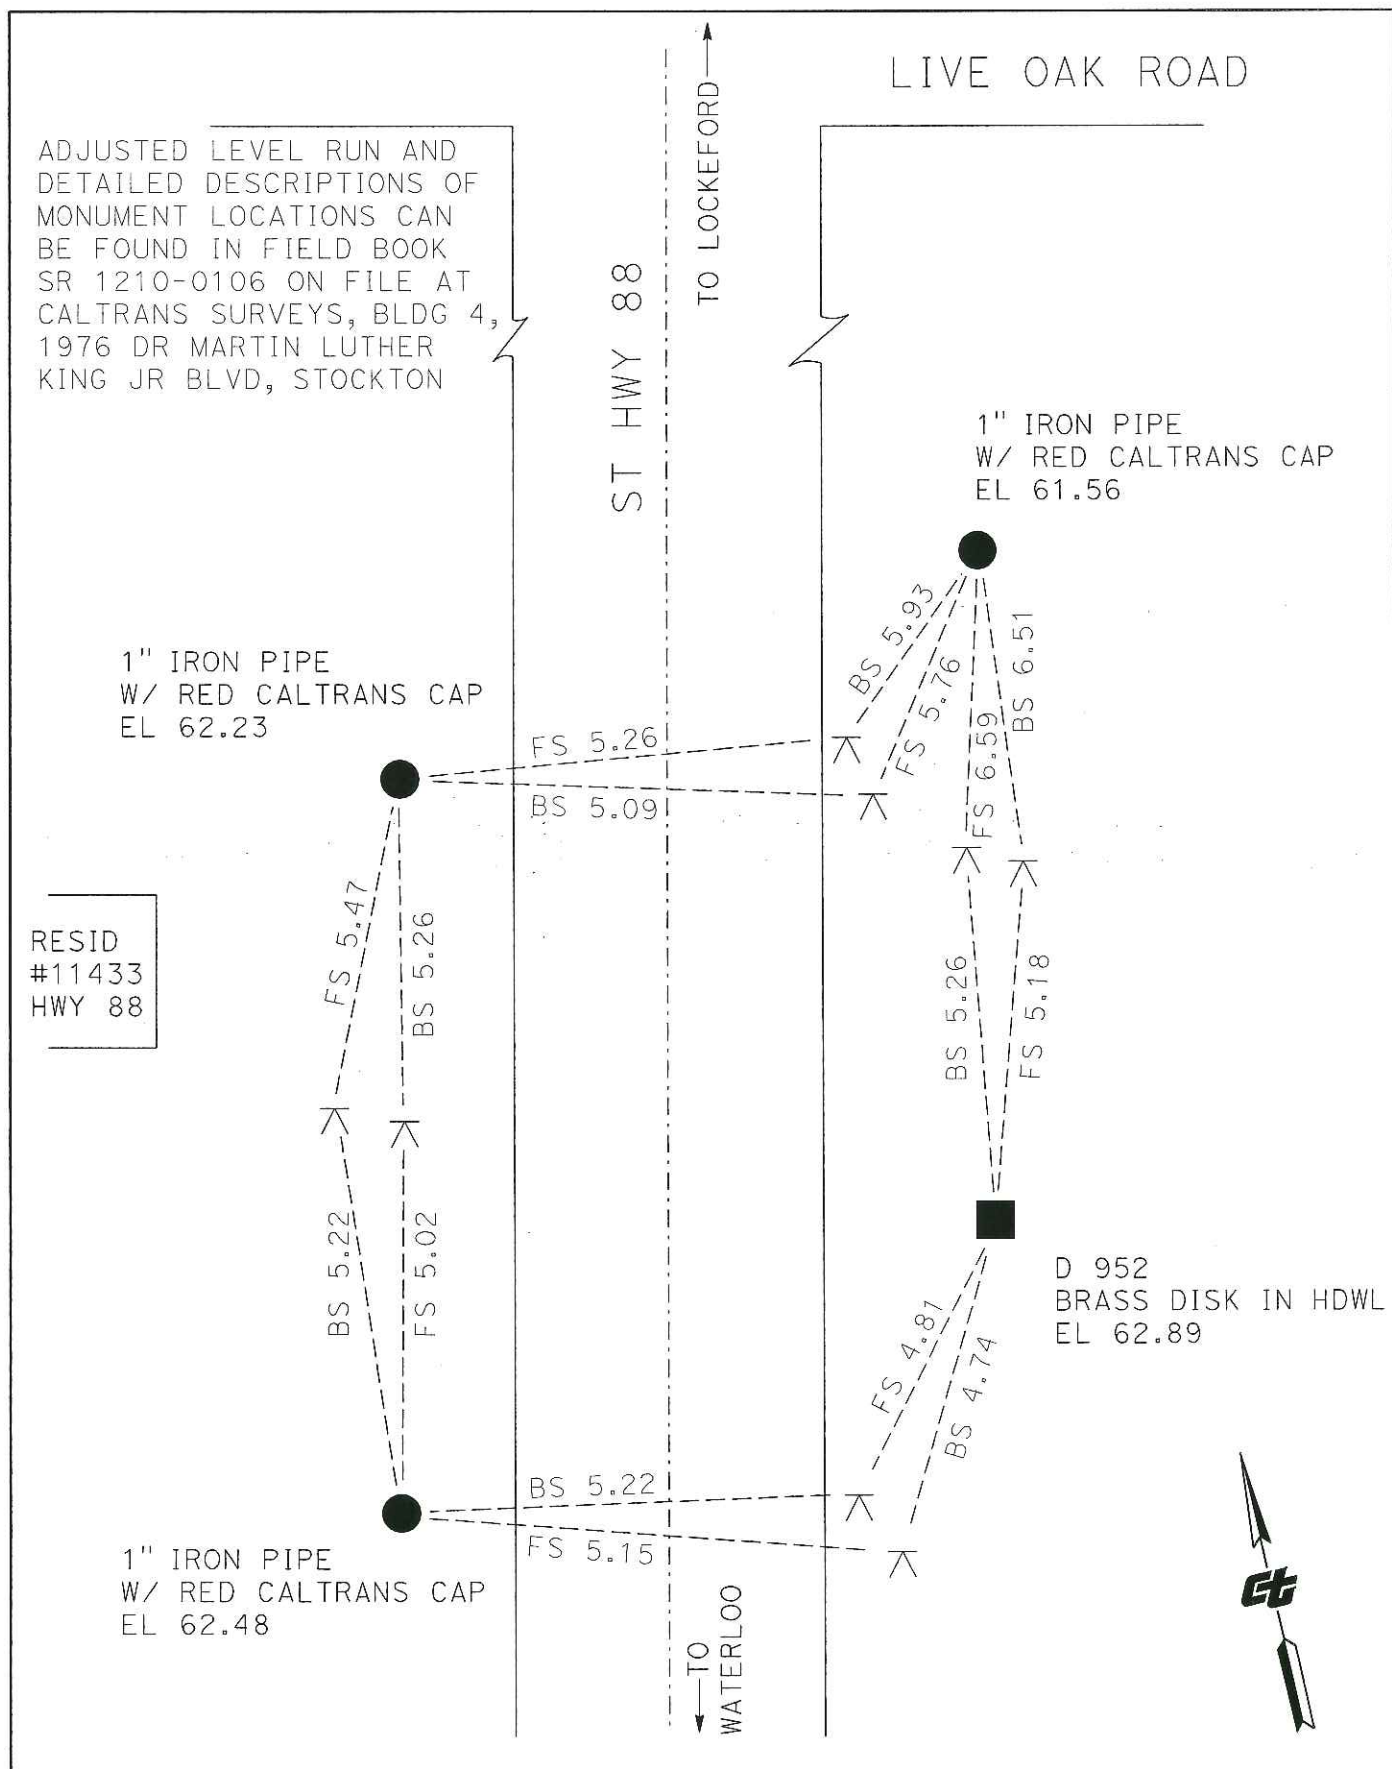
Found brass disk in concrete headwall, along the east side of State Highway 88, 0.1 mile south of Live Oak Road.

Corners set: 1" iron pipe with red plastic Caltrans cap.
