CORNER RECORD

Document Number CR-15-236

City of Stockton

Brief Legal Description Being the Southeasterly corner of Lot 92 per M. & P. 20-31, S.J.C.R.

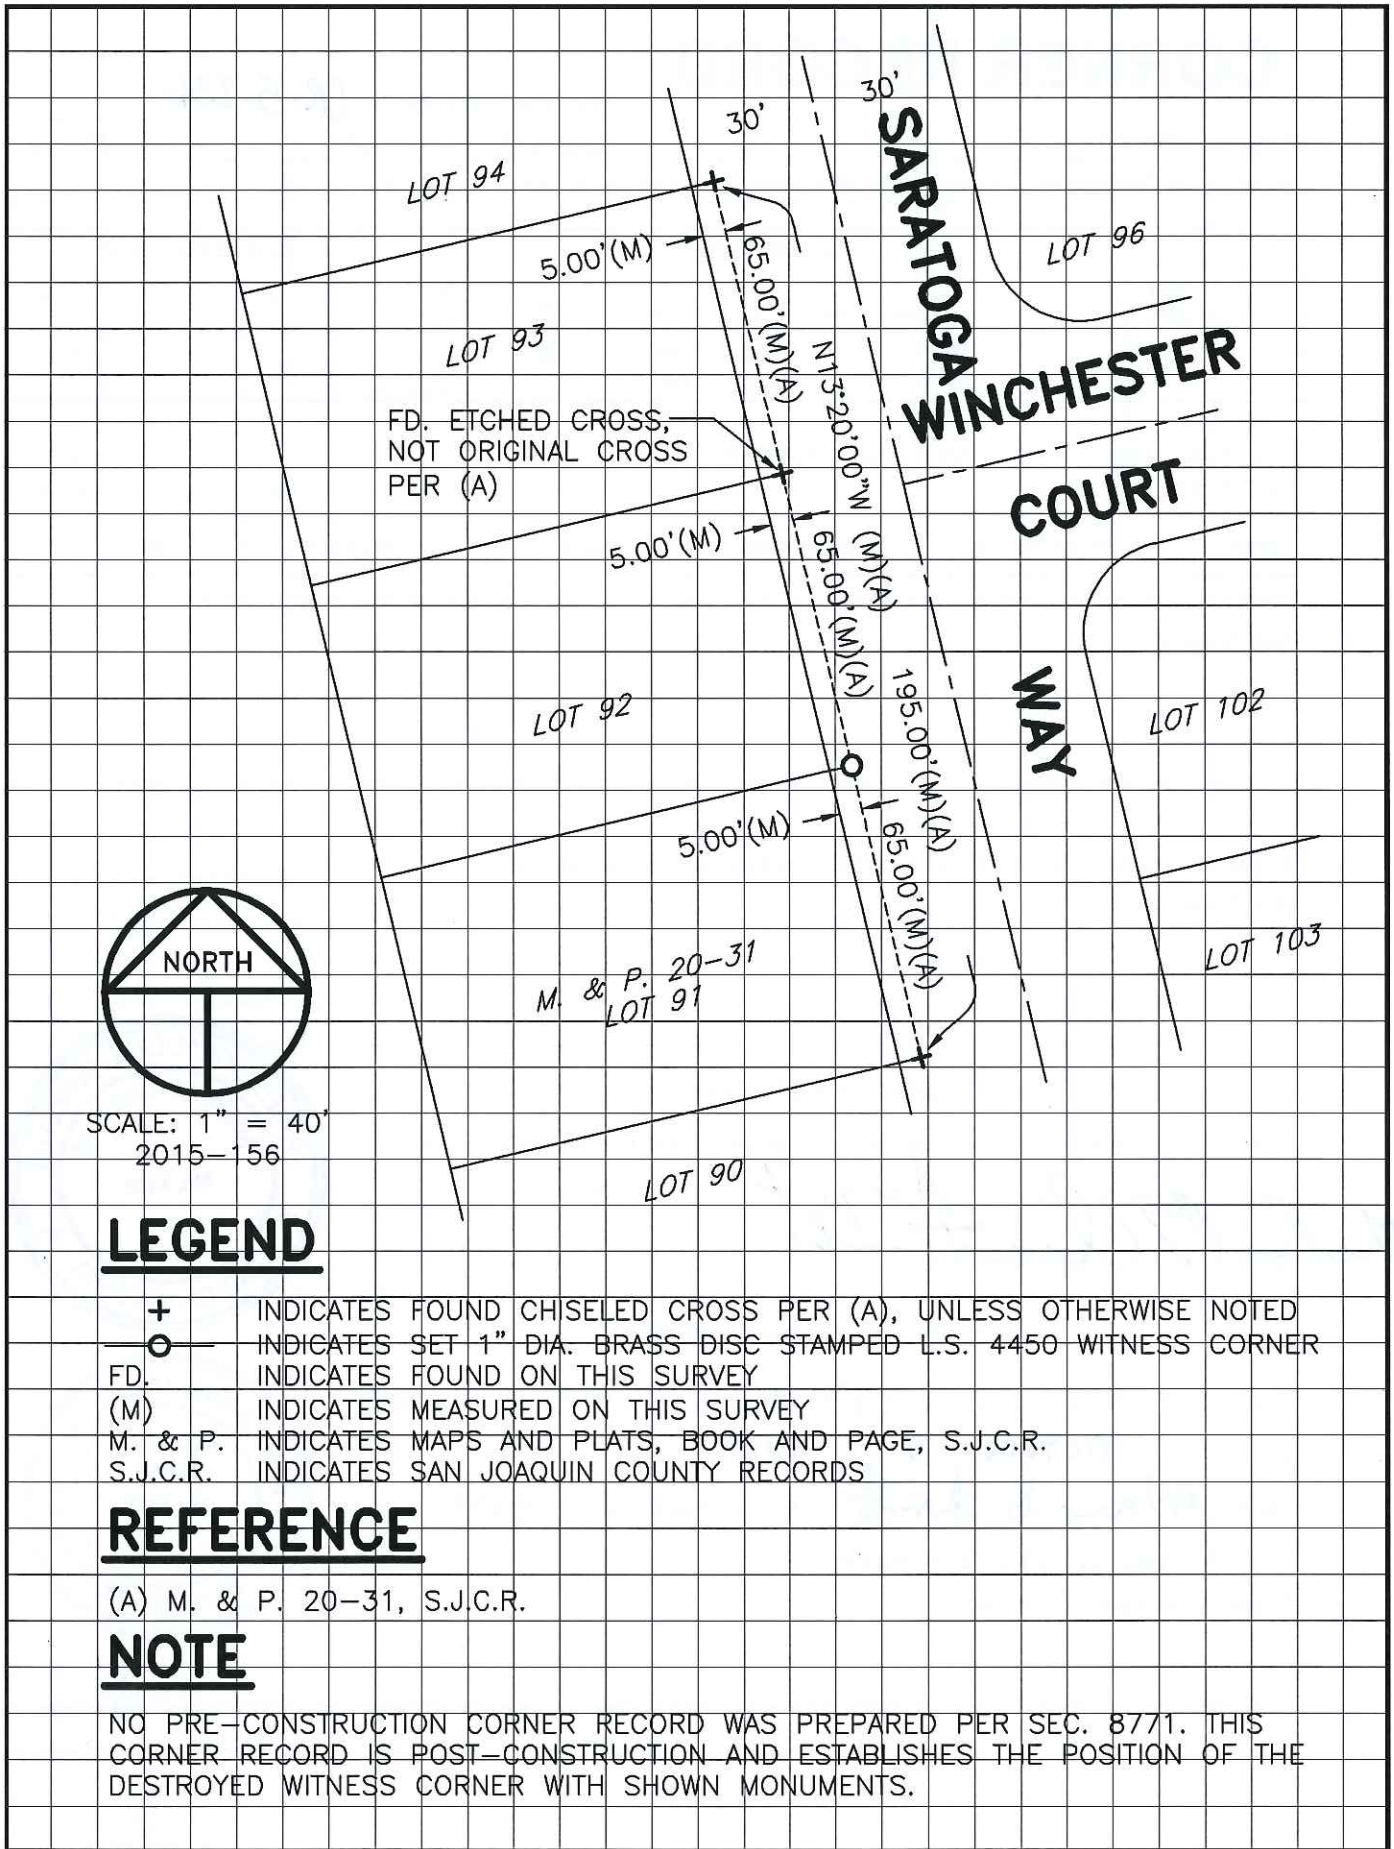
SCALE: 1" = 40'
2015-156

NO PRE-CONSTRUCTION CORNER RECORD WAS PREPARED PER SEC. 8771. THIS CORNER RECORD IS POST-CONSTRUCTION AND ESTABLISHES THE POSITION OF THE DESTROYED WITNESS CORNER WITH SHOWN MONUMENTS.
