CORNER RECORD

Document Number CR-15-286

Brief Legal Description CENTER 1/4 CORNER OF SECTION 3 OF T3N, RTE

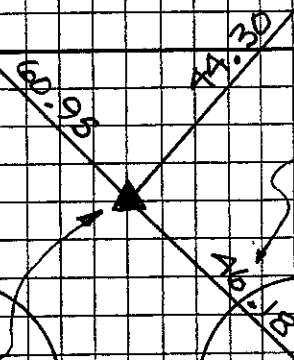
A description of the physical condition of the monument as found and as set or reset: FOUND 3/4" DIA. IRON ROD W/1 3/4" WASHER, SIMILAR TO STANDARD SAN JOAQUIN CO. MONUMENT, IN NEW MONUMENT WELL. MONUMENT WAS LOOSE AND APPEARS TO HAVE BEEN DISTURBED. RESET NEW 1" ID IRON PIPE W/YELLOW PLASTIC PLUG STAMPED "CALIF DOT" DOWN 0.45' INSIDE OF NEW MONUMENT WELL USING 3 FOUND REFERENCE POINTS FROM PREVIOUS CORNER RECORD.

FOUND PK NAIL WITH
BRASS WASHER STAMPED
"CALTRANS" IN
TELEPHONE POLE
PER CR-06-11.

* NOTE: PREVIOUS CORNER
RECORD SHOWS 45.13'
OBVIOUS ERROR IN
PREVIOUS MEASUREMENT

SET 1" I.D. IRON
PIPE W/ YELLOW
PLASTIC PLUG
STAMPED "CALIF DOT"
DOWN 0.45' BELOW
AC SURFACE IN
MONUMENT WELL

FOUND PK NAIL WITH
BRASS WASHER STAMPED
"CALTRANS" IN
JOINT-USE POLE
PER CR-06-11.
