CORNER RECORD

Document Number CR-15-289

Brief Legal Description SW CORNER OF SECTION 2 OF T2N, R7E

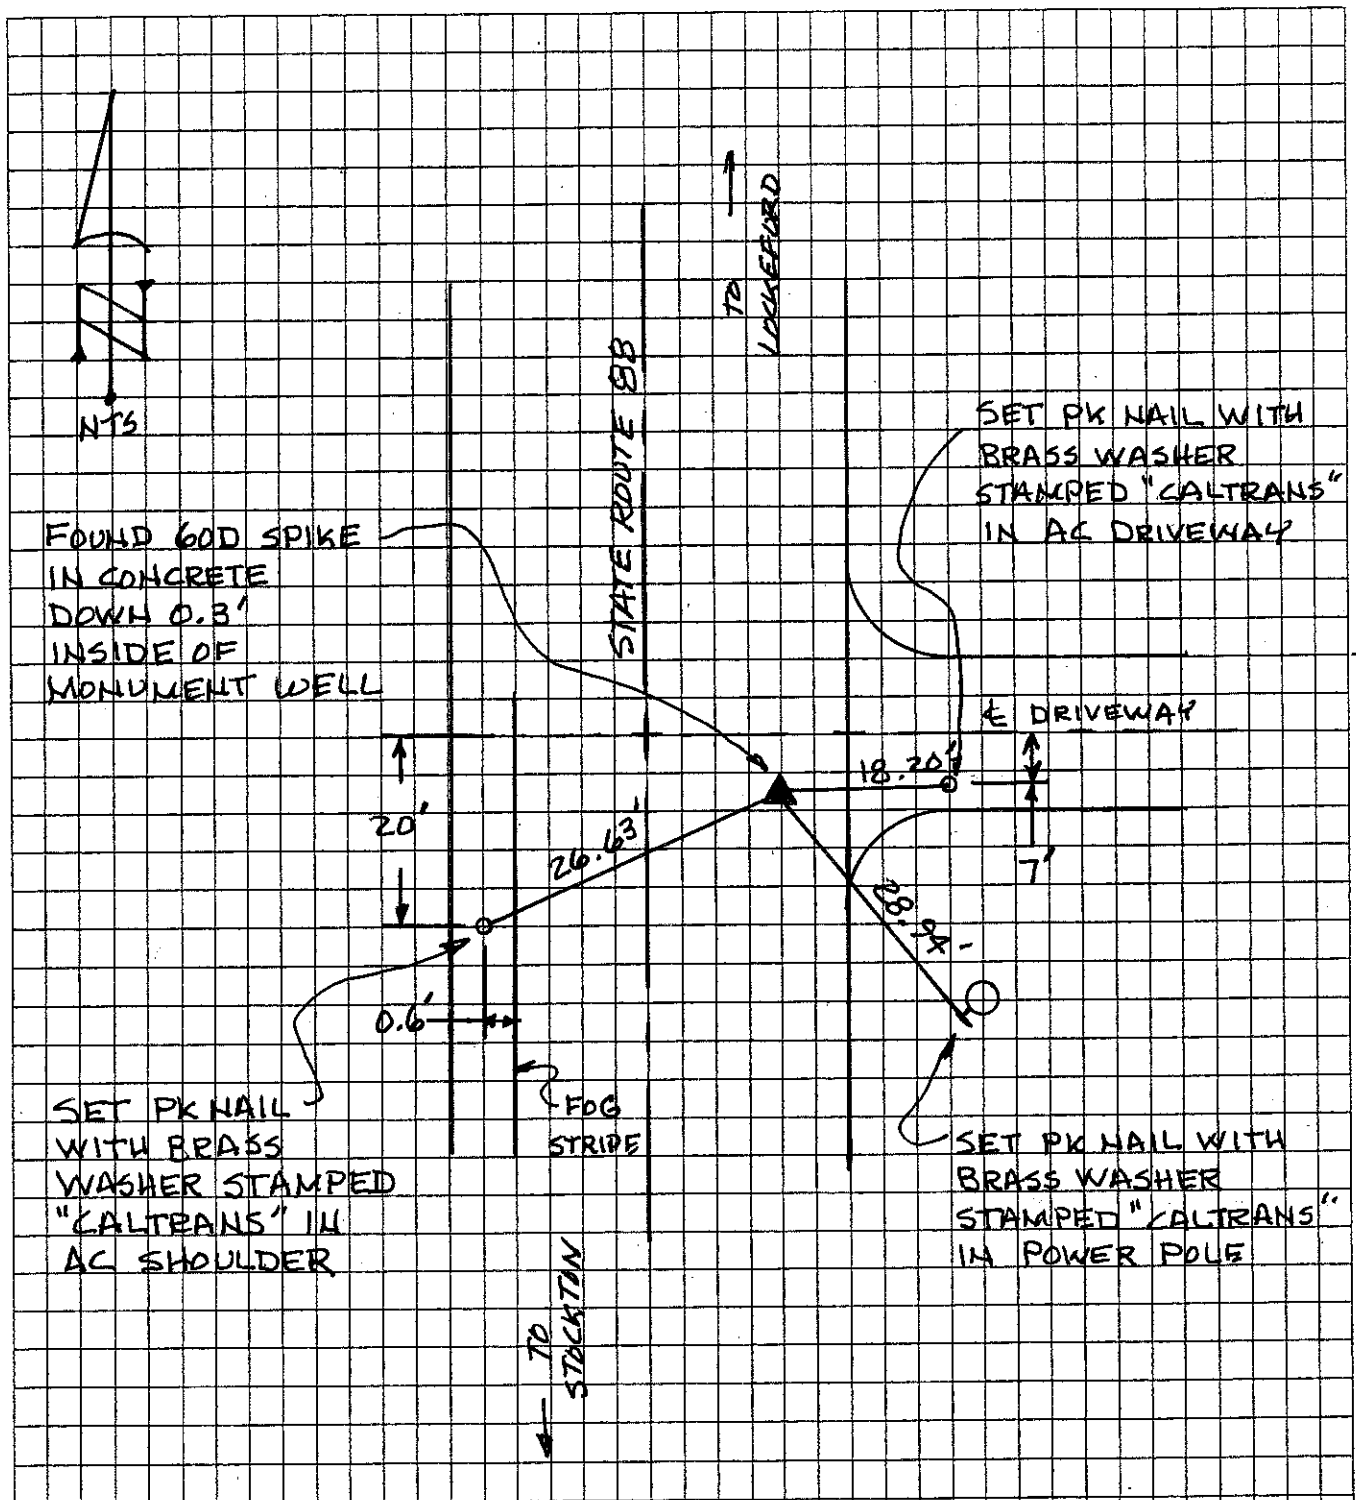
FOUND SOUTHWEST SECTION CORNER OF SECTION 2 OF T2N, R7E AS PER RECORD OF SURVEY VOLUME 34, PAGE 196.

A description of the physical condition of the monument as found and as set or reset: FOUND 60D SPIKE IN CONCRETE, DOWN 0.3' INSIDE OF A MONUMENT WELL. NO ATTEMPT WAS MADE TO FIND A POSSIBLE MONUMENT BELOW THE SPIKE. SET 3 REFERENCE POINTS, MEASURED DISTANCES FROM MONUMENT TO REFERENCE POINTS.
