# CORNER RECORD

Agency Index CR-19-135  
Document Number \_\_\_\_\_

City of Stockton County of San Joaquin, California  
Brief Legal Description Northeasterly corner of Lot 219, per M. & P. 18-29, S.J.C.R.

Sec. 19, T.2N., R.6E.,  
M.D.B. & M.

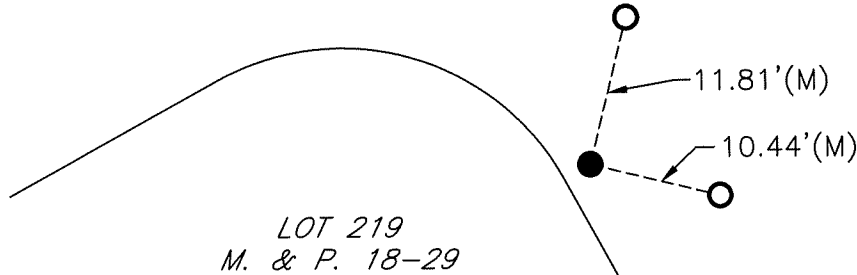
SCALE: 1" = 15'  
2019-186

- INDICATES FOUND CHISELED CROSS, NO REFERENCE, CHISELED CROSS IS VERY LARGE AND CRUDE, EXISTING SIDEWALK IS VERY ERODED
- INDICATES SET MAG NAIL
- M. & P. INDICATES MAPS AND PLATS, VOLUME AND PAGE, S.J.C.R.
- S.J.C.R. INDICATES SAN JOAQUIN COUNTY RECORDS
- (M) INDICATES MEASURED ON THIS SURVEY
