CORNER RECORD

Agency Index CR-22-034
Document Number _____

City of Stockton County of San Joaquin, California
Brief Legal Description Found monument as noted, referenced and left as found.

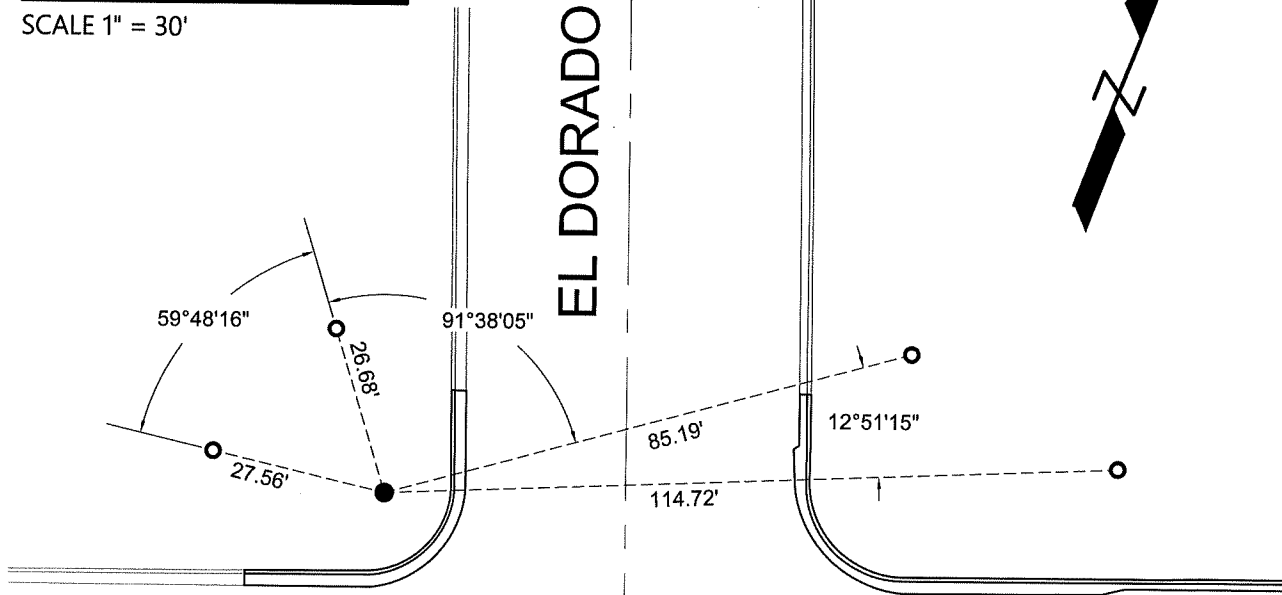
Found a cut cross in the concrete sidewalk of the northwest return at the intersection of Miner Ave and El Dorado St. Set four (4) reference points, as noted on the reverse, outside of the construction limits.

EL DORADO ST

MINER AVE
