# CORNER RECORD

Agency Index CR-22-036  
Document Number \_\_\_\_\_

City of Stockton County of San Joaquin, California  
Brief Legal Description Found monument as noted, referenced and left as found.

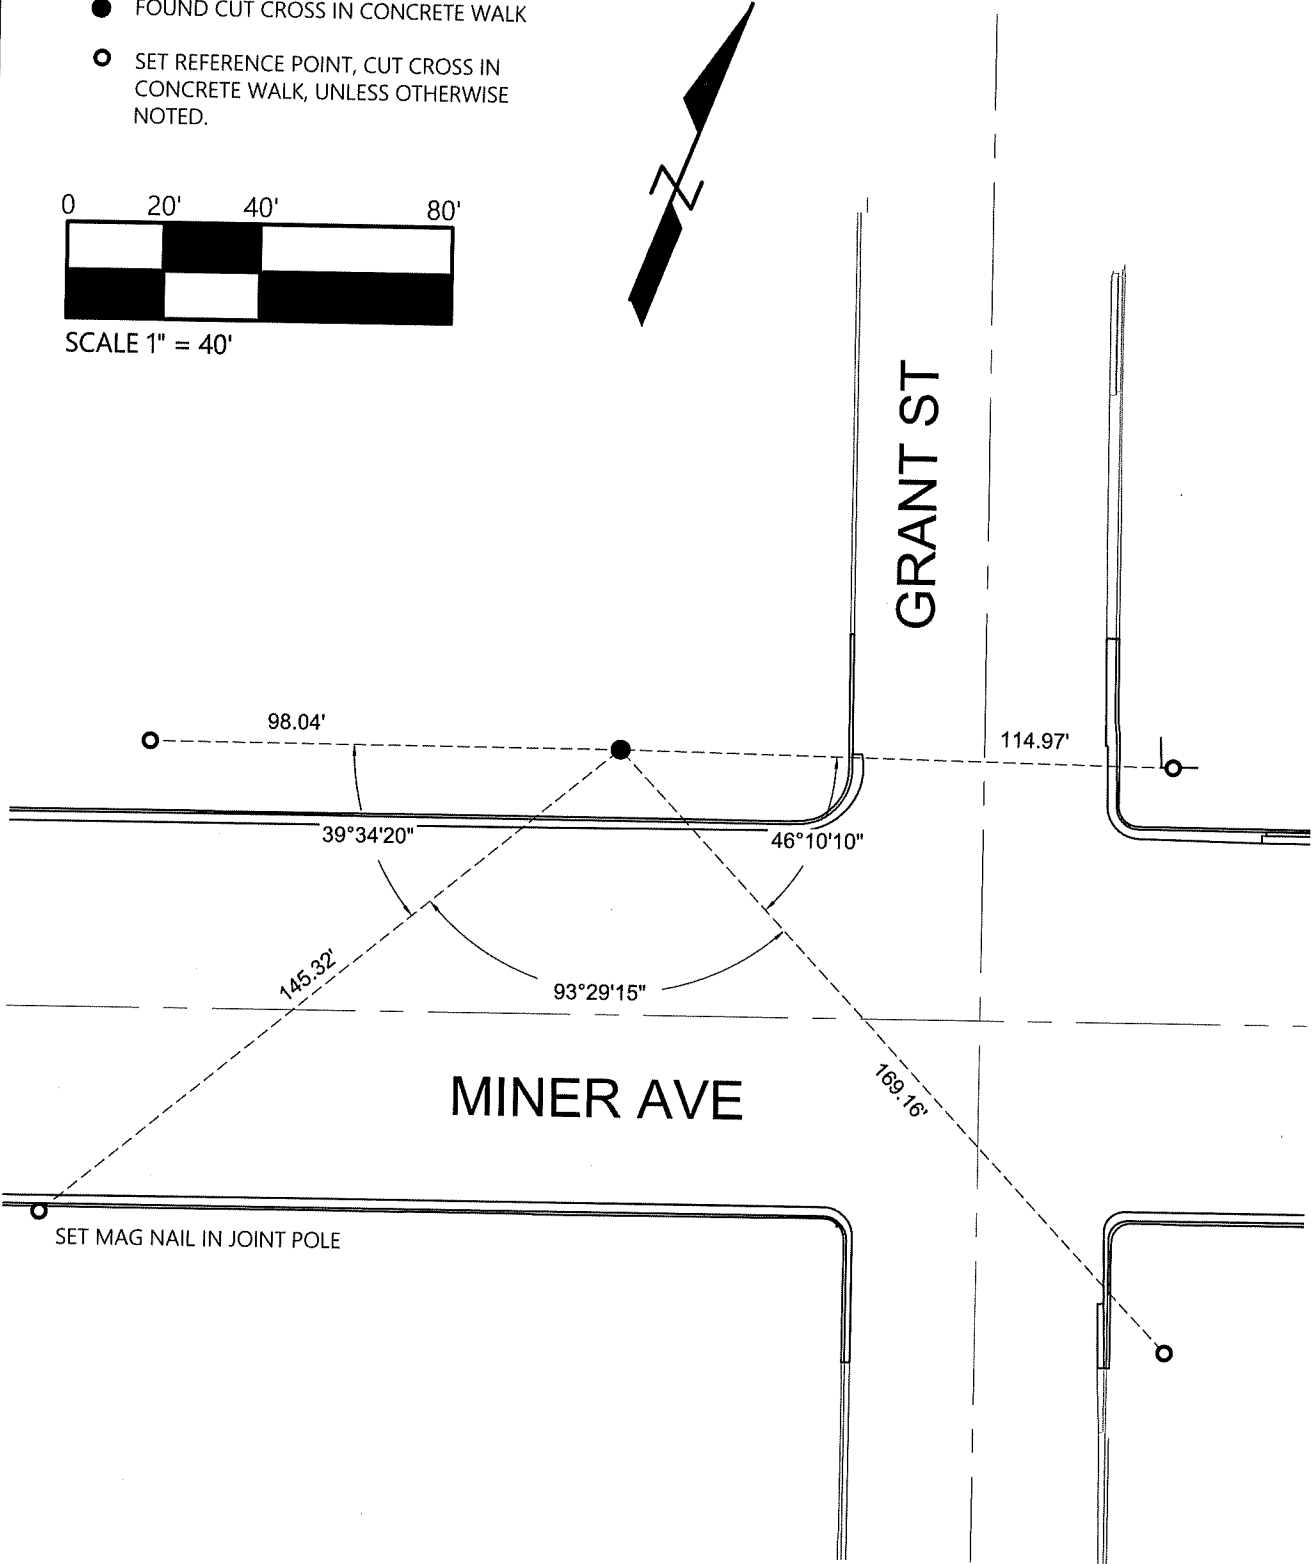
Found a cut cross in the concrete sidewalk near the northwest return at the intersection of Miner Ave and Grant St. Set four (4) reference points, as noted on the reverse, outside of the construction limits.

- FOUND CUT CROSS IN CONCRETE WALK
- SET REFERENCE POINT, CUT CROSS IN CONCRETE WALK, UNLESS OTHERWISE NOTED.

SCALE 1" = 40'
