# CORNER RECORD

Agency Index CR-22-039  
Document Number \_\_\_\_\_

City of Stockton County of San Joaquin, California  
Brief Legal Description Found monument as noted, referenced and left as found.

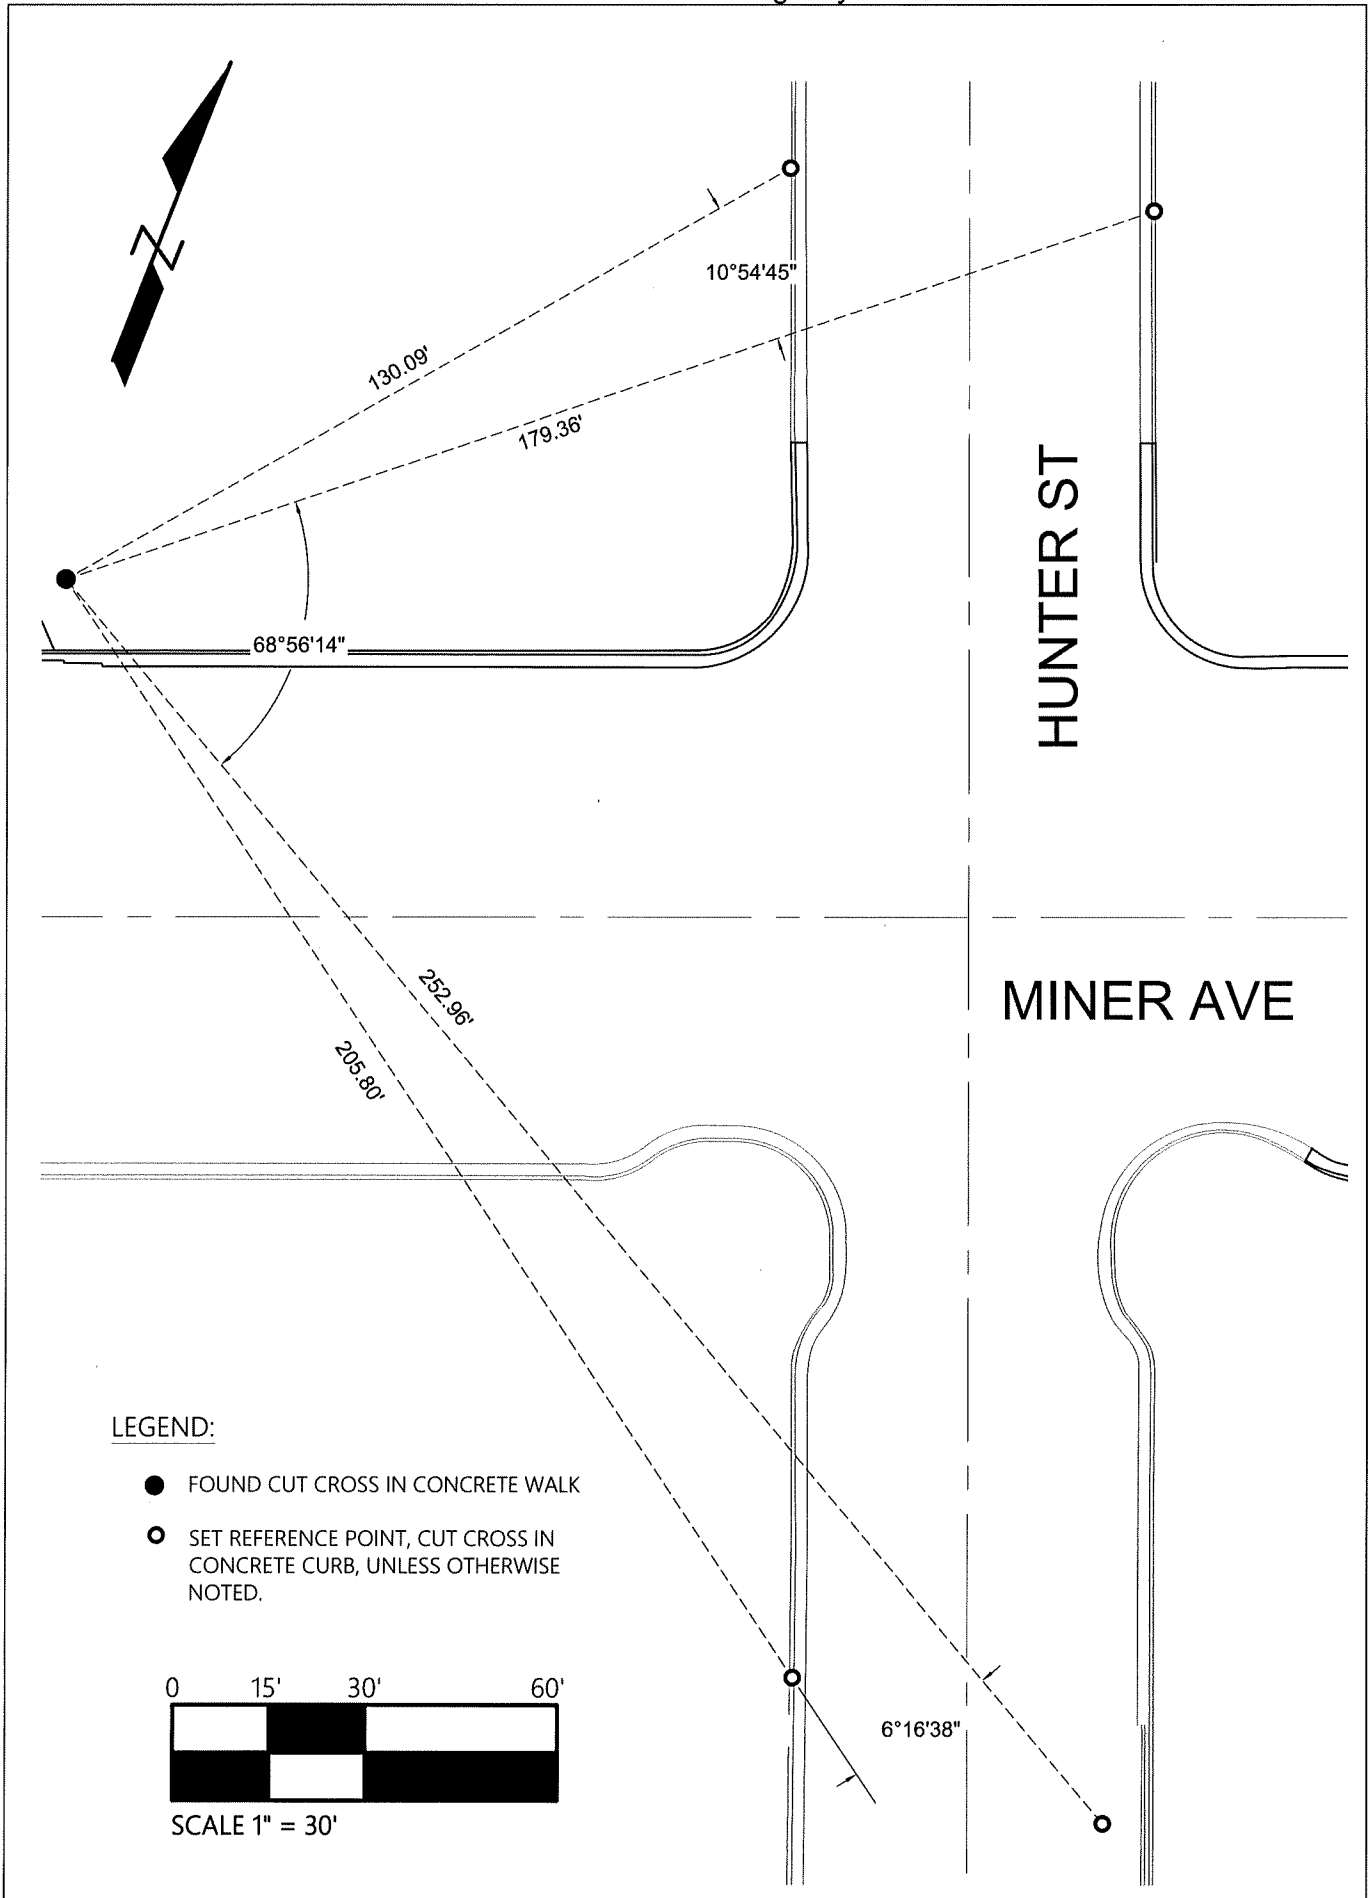
See sheet #2 for description(s):

Found a cut cross in the northerly concrete sidewalk of Miner Ave, approximately 150' west of Hunter St. Set four (4) reference points, as noted on the reverse, outside of the construction limits.
