CORNER RECORD

Agency Index CR-22-043
Document Number _____

City of Stockton County of San Joaquin, California
Brief Legal Description Found monument as noted, referenced and left as found.

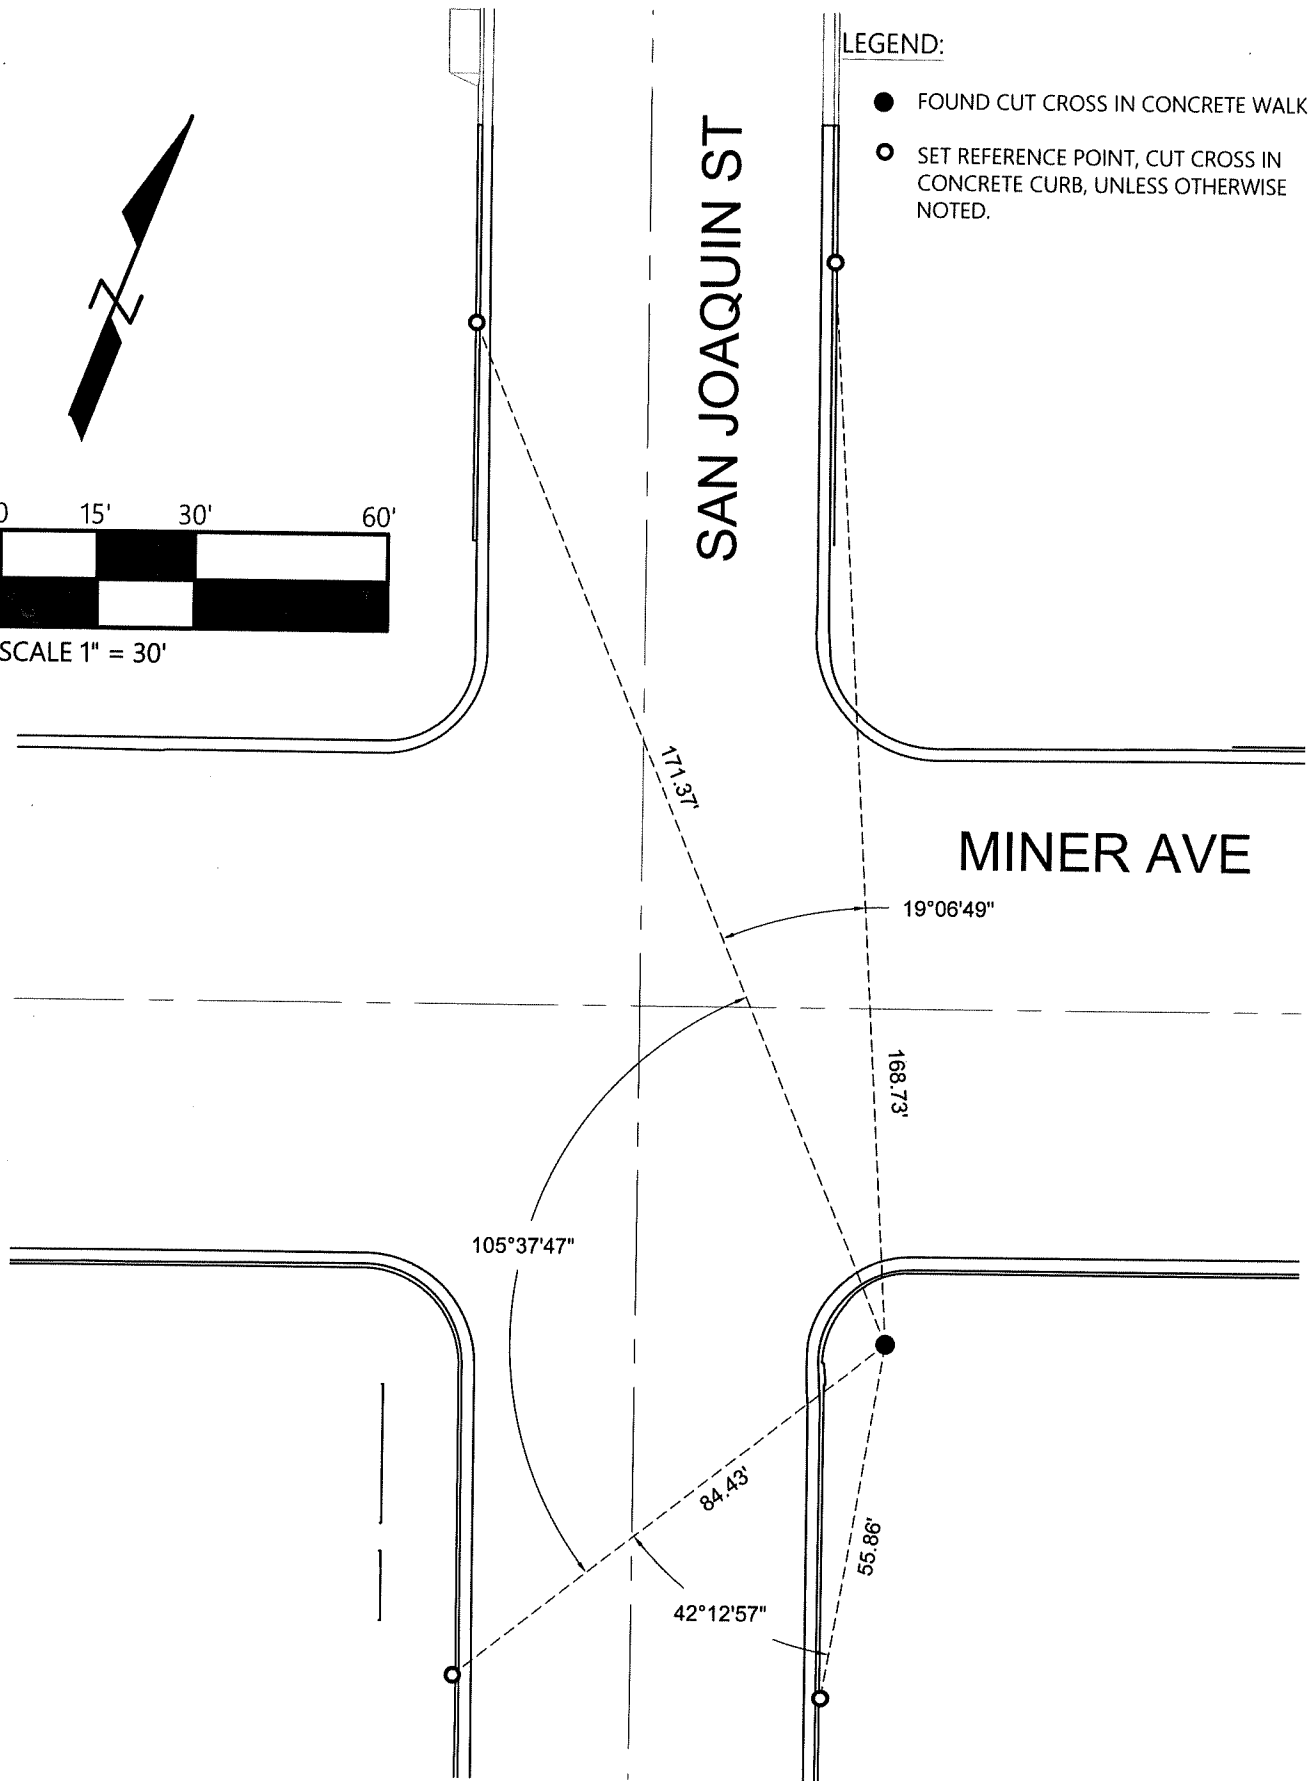
Narrative of corner identified and monument as found, set, reset, replaced, or removed:
 See sheet #2 for description(s):
 Found a cut cross in the concrete sidewalk near the southeast curb return of Miner Ave and San Joaquin St. Set four (4) reference points, as noted on the reverse, outside of the construction limits.

- FOUND CUT CROSS IN CONCRETE WALK
- SET REFERENCE POINT, CUT CROSS IN CONCRETE CURB, UNLESS OTHERWISE NOTED.
