CORNER RECORD

Agency Index CR-22-129
Document Number _____

Brief Legal Description CUT "X" MONUMENT AT NW CORNER MINER AVE AND GRANT ST.

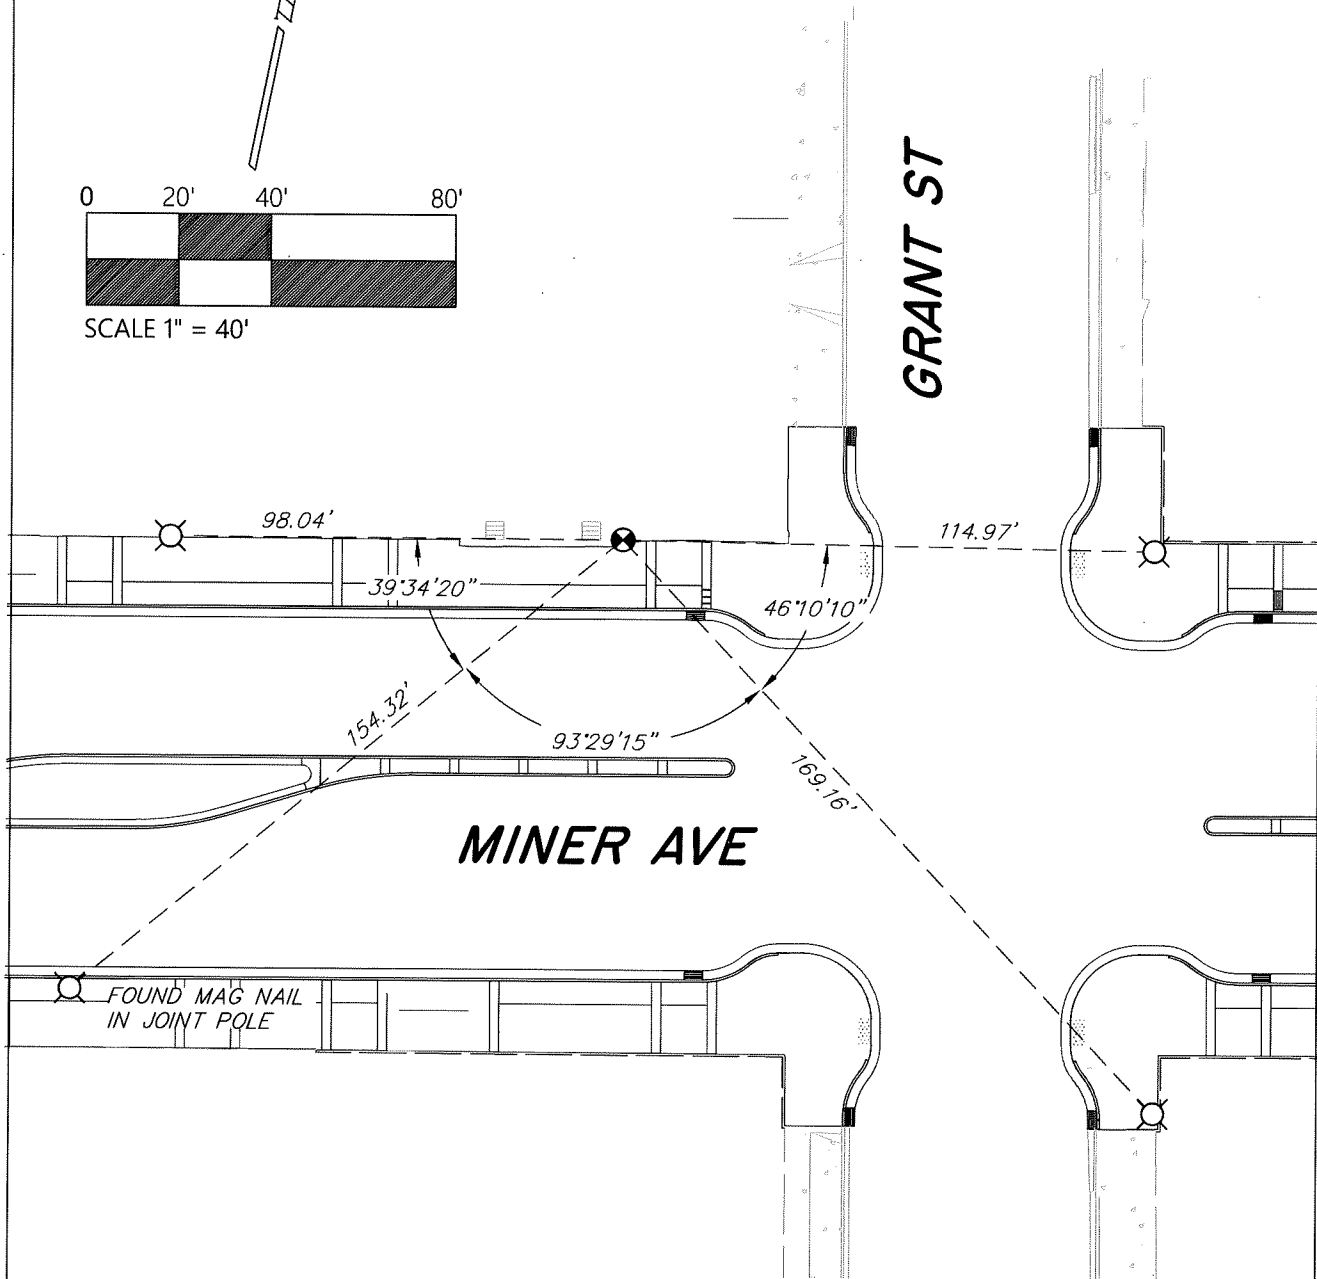
See sheet #2 for description(s):

SET A CUT CROSS ON THE DRAIN COLLAR OF THE NORTHWEST CURB RETURN AT THE INTERSECTION OF MINER AVE AND GRANT ST. OLD MONUMENT WAS REMOVED DURING CONSTRUCTION AND WAS RESET AT ITS ESTABLISHED LOCATION AFTER CONSTRUCTION USING THE FOUND FOUR (4) REFERENCE POINTS PER CR22-036 AS NOTED ON THE REVERSE.
