CORNER RECORD

Agency Index CR-24-096

City of STOCKTON County of SAN JOAQUIN, California

Brief Legal Description WITHIN E 6TH ST AND S CALIFORNIA ST INTERSECTION

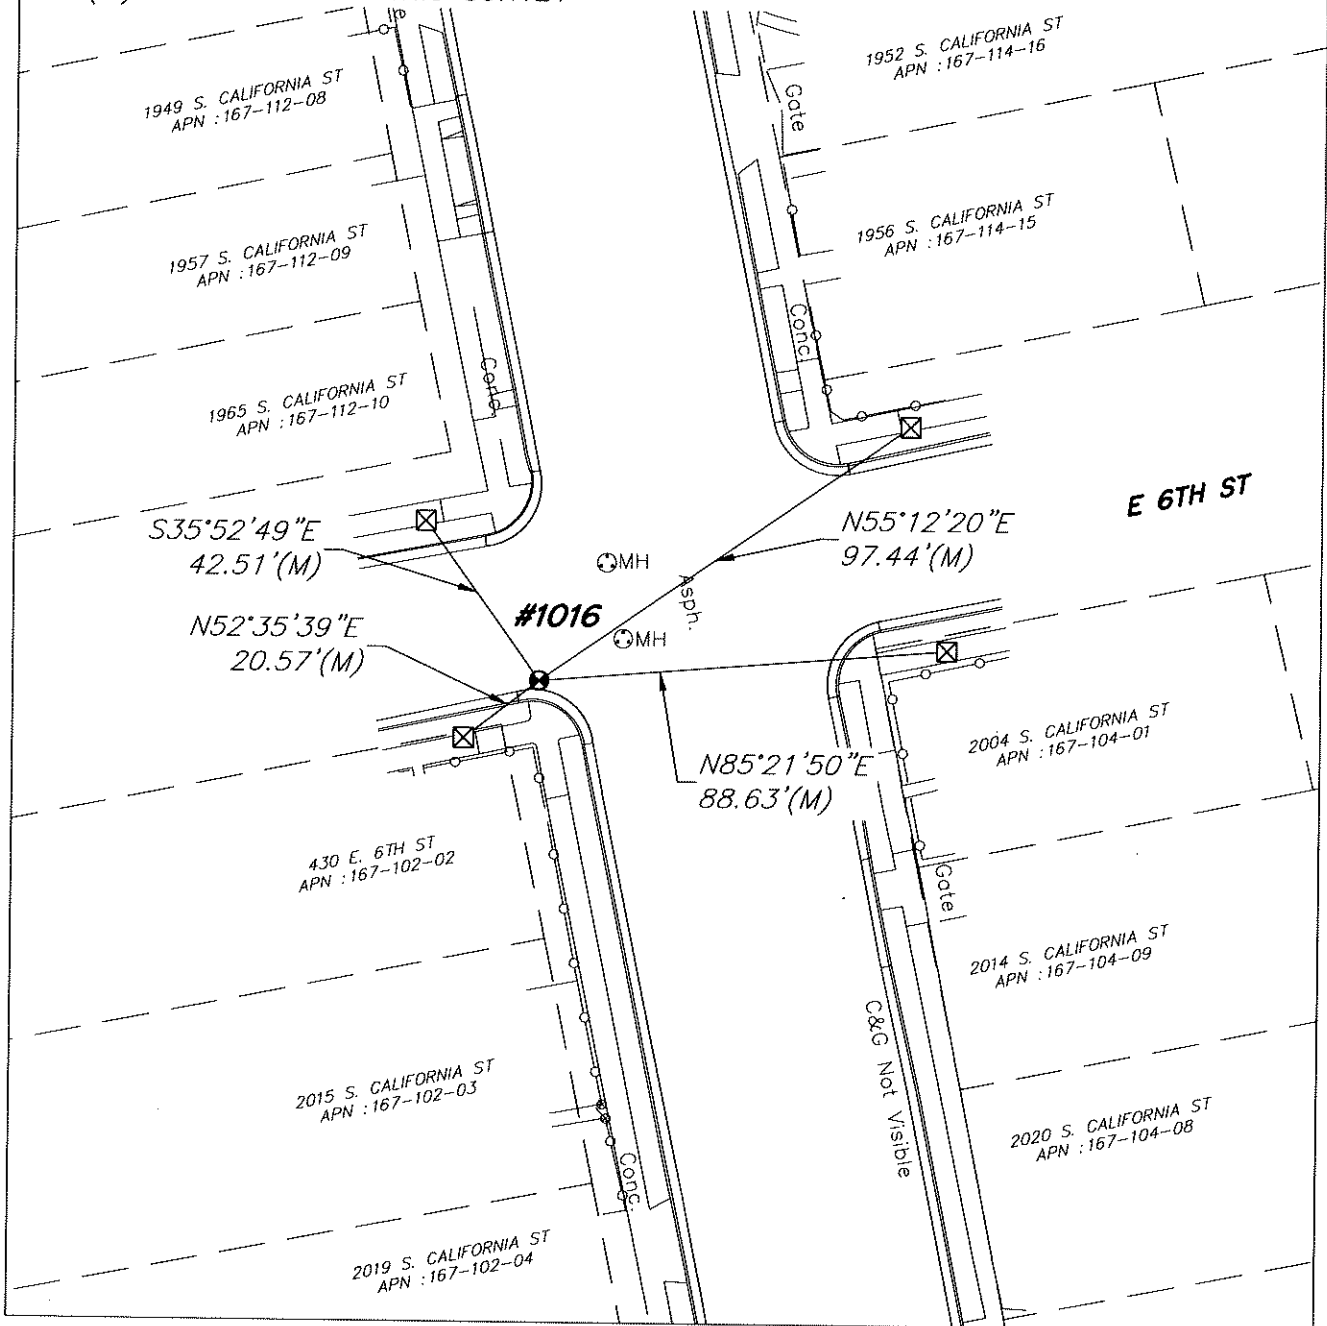
FOUND MAG NAIL IN AC PAVEMENT WITHIN THE INTERSECTION OF EAST 6TH STREET AND SOUTH CALIFORNIA STREET. SET FOUR CUT "X" AS STRADDLERS FOR FOUND MONUMENT SHOWN ON SHEET 2. NO PREVIOUS 8771b CORNER RECORD ON FILE. CONTRACT MON #1016.
