CORNER RECORD

Document Number CR-97-34

Brief Legal Description Intersection of R.O.W. ℄'s of Valpico Rd. and Fairoaks Rd.

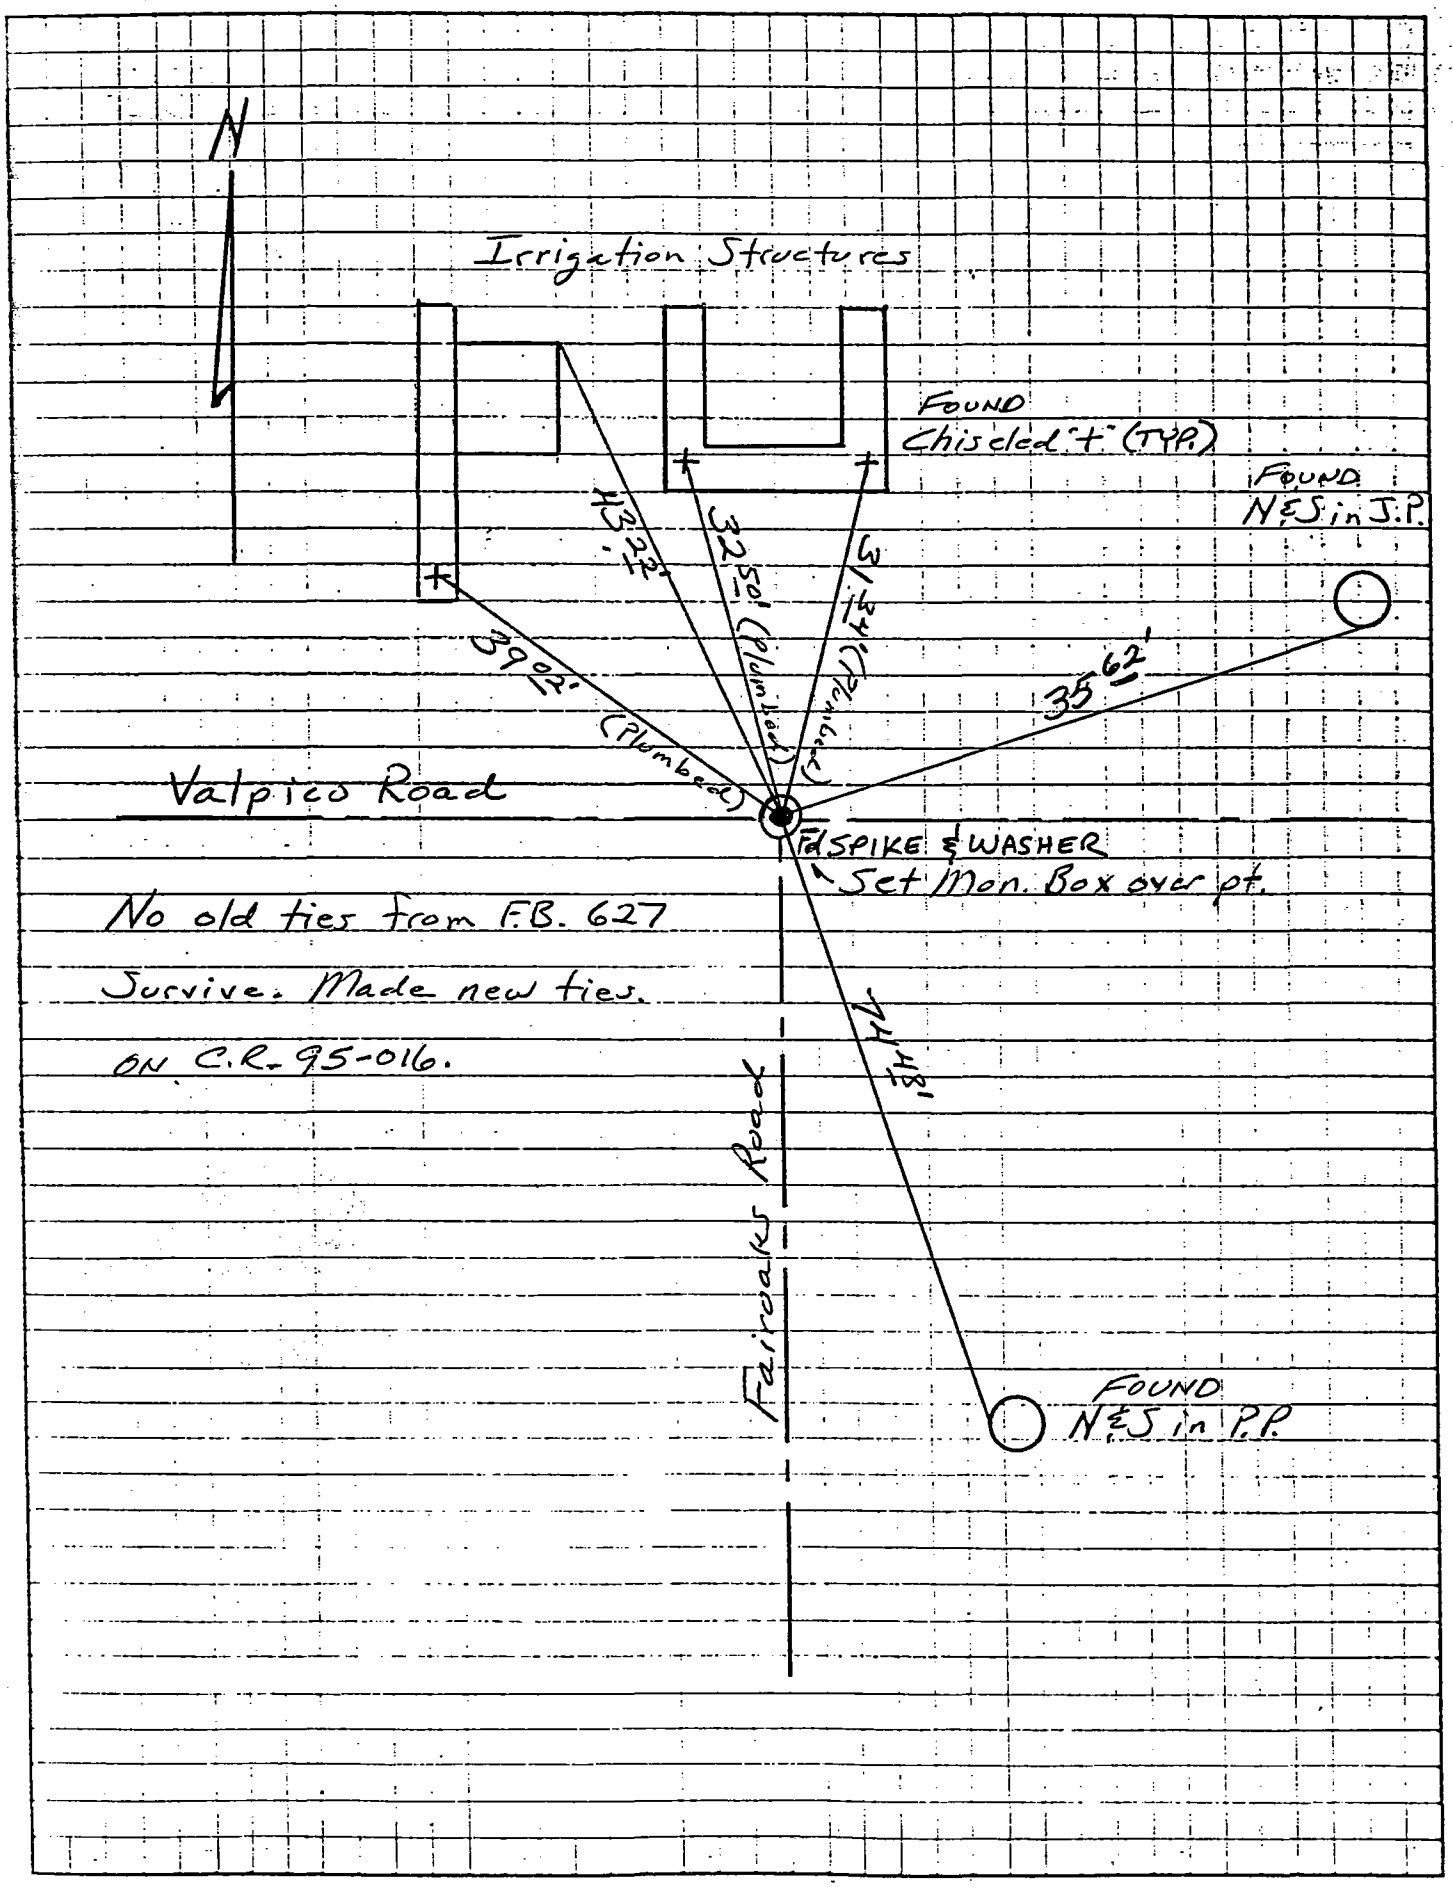
A description of the physical condition of the monument as found and as set or reset: Spike and washer @ surface. Set monument box over point.

N
Irrigation Structures
FOUND
Chiseled "+" (TYP.)
FOUND
N&S in J.P.
43.22'
32.50' (Plumbed)
34.17' (Plumbed)
39.02' (Plumbed)
35.62'
Valpico Road
Fd SPIKE & WASHER
Set Mon. Box over pt.
No old ties from F.B. 627
Survive. Made new ties.
ON C.R. 95-016.
Fairoaks Road
74.48'
FOUND
N&S in P.P.
