CORNER RECORD

Document Number CR-14-97
County of San Joaquin, California

Brief Legal Description MAIN STREET @ HINKLEY AVENUE
(WITHIN SECTION 56, C.M. WEBER GRANT)

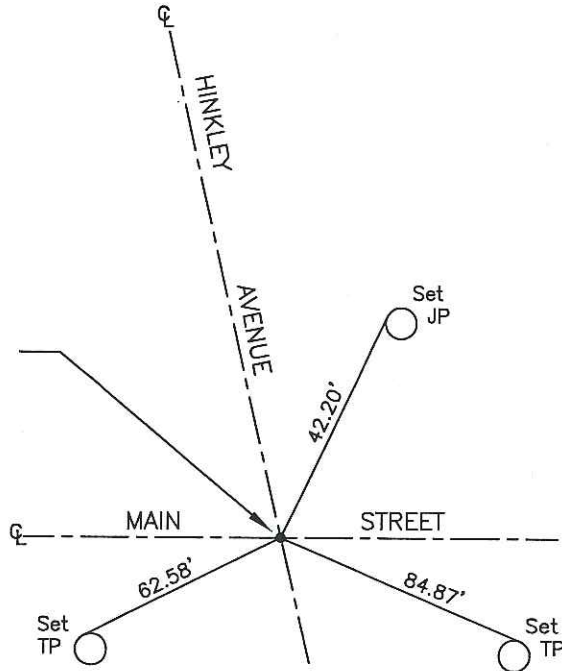
Identification and type of corner found: Evidence used to identify or procedure used to establish or reestablish the corner:
SEE SKETCH ON BACKSIDE.

A description of the physical condition of the monument as found and as set or reset:
SEE SKETCH ON BACKSIDE.

Fd. Pin & Washer
(Old Conc. Post & Pin
per RS 37-157)
