CORNER RECORD

Document Number 01-114

City of MANTECA County of SAN JOAQUIN, California

Brief Legal Description CENTER OF SECTION 9, T.2S., R.7E., M.D.B.&M.

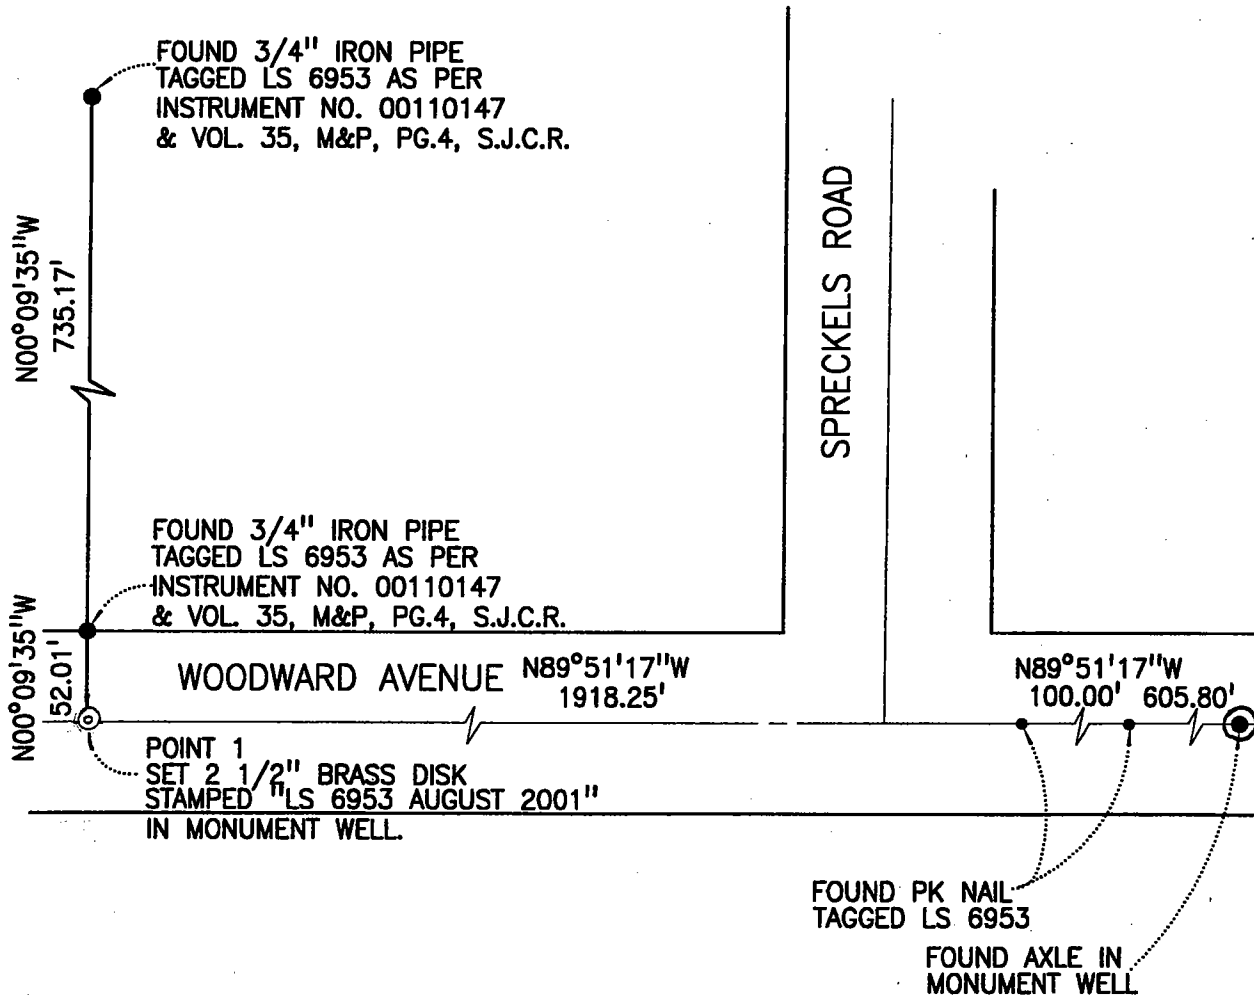
Identification and type of corner found: Evidence used to identify or procedure used to establish or reestablished the corner:
POINT 1: BRASS DISK STAMPED R.E. 9338 IN MONUMENT BOX MARKING THE CENTER OF SECTION 9 AT THE CENTERLINE OF WOODWARD AVENUE AS SHOWN FOR RECORD IN BOOK 35 OF MAPS AND PLATS AT PAGE 4, SAN JOAQUIN COUNTY RECORDS WAS DESTROYED DUE TO PAVEMENT RECONSTRUCTION AND REESTABLISHED USING THE SWING TIES SET PRIOR TO THE MONUMENT BEING DESTROYED AS SHOWN ON PREVIOUS CORNER RECORD 01-29.

A description of the physical condition of the monument as found and as set or reset:
SET 2 1/2" BRASS DISK STAMPED "LS 6953 AUGUST 2001" IN MONUMENT WELL.

NOTE: FOUND MONUMENTS ARE NOT
VERIFIED AS BEING THE CENTERLINE
OF THE STREET RIGHTS-OF-WAYS.
