# CORNER RECORD

Document Number 02-6  
County of San Joaquin, California

Brief Legal Description N. 99 FRONTAGE ROAD (EAST OF HWY. 99) 1300' ± N/O CORA POST RD.

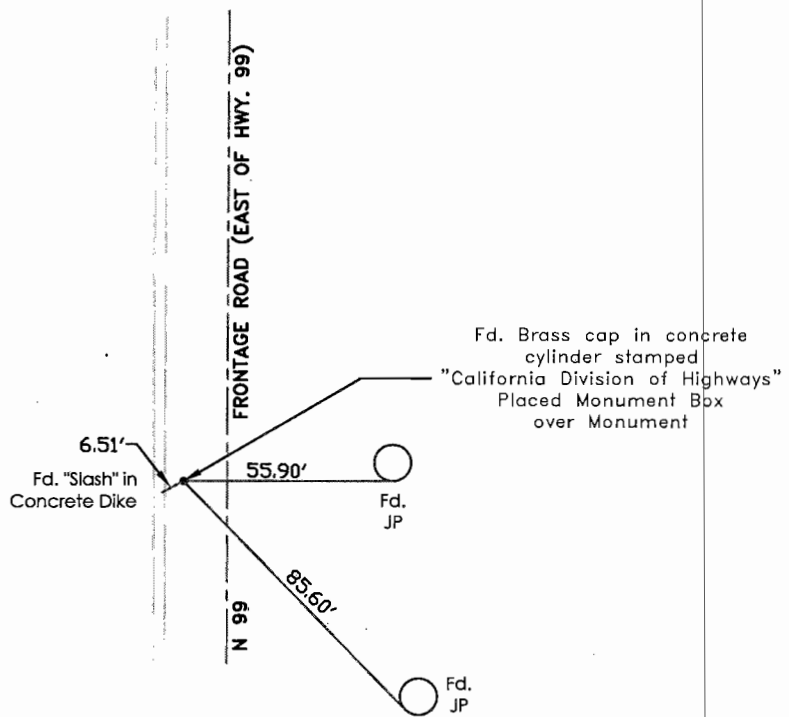
Identification and type of corner found: Evidence used to identify or procedure used to establish or reestablish the corner:  
FOUND BRASS CAP IN CONCRETE CYLINDER STAMPED "CALIFORNIA DIVISION OF HIGHWAYS". CONFIRMED LOCATION PER SWING TIES ON CR-01-126. SEE SKETCH ON BACKSIDE.

A description of the physical condition of the monument as found and as set or reset:  
FOUND MONUMENT IN GOOD CONDITION. SEE SKETCH ON BACKSIDE.
