CORNER RECORD

Document Number 02-8
County of San Joaquin, California

Brief Legal Description N. 99 FRONTAGE ROAD (EAST OF HWY. 99) 900' ± S/O LIVE OAK RD.

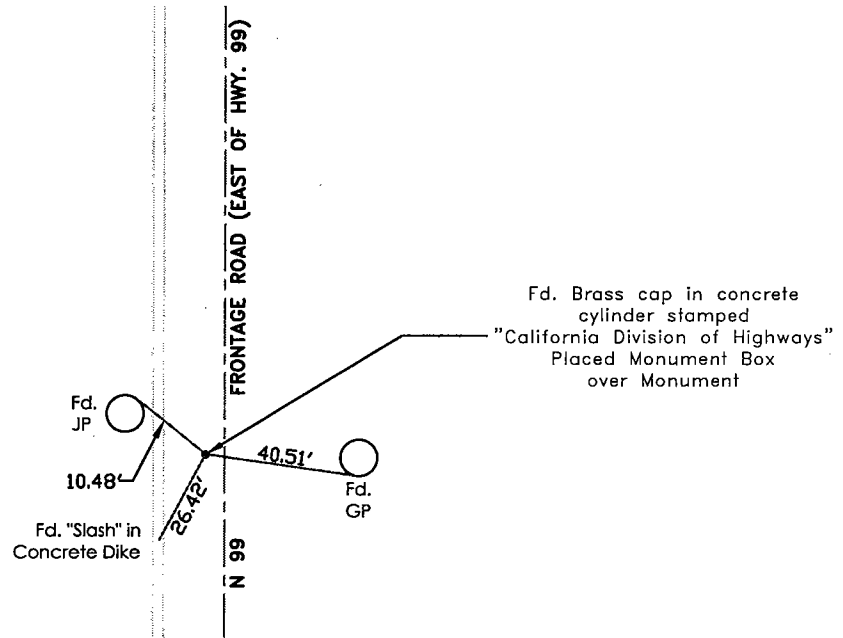
Identification and type of corner found: Evidence used to identify or procedure used to establish or reestablish the corner:
FOUND BRASS CAP IN CONCRETE CYLINDER STAMPED "CALIFORNIA DIVISION OF HIGHWAYS". CONFIRMED LOCATION PER SWING TIES ON CR-01-128. SEE SKETCH ON BACKSIDE.

A description of the physical condition of the monument as found and as set or reset:
FOUND MONUMENT IN GOOD CONDITION. SEE SKETCH ON BACKSIDE.
