CORNER RECORD

Document Number 02-35

County of San Joaquin, California

Brief Legal Description Northeast Corner Section 2, Township 2 South, Range 7 East, M.D.B.&M.

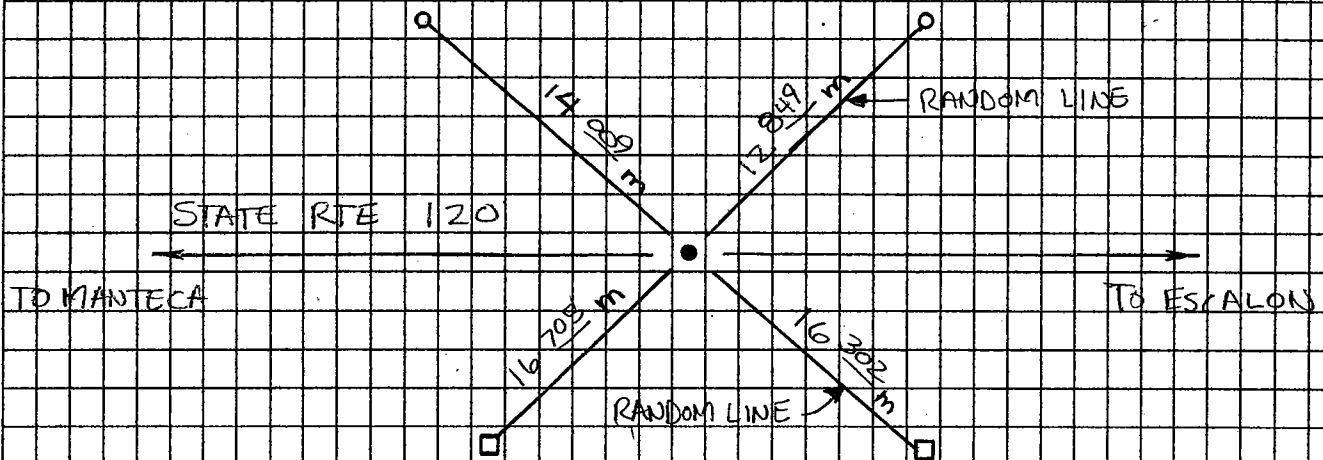
Found Railroad spike per RS 9-30, down 0.245 meters in survey monument well, near the centerline of State Highway 120, approximately 1/2 mile east of Hart's Lane.

The monument is in good condition. The reference points were set in case the monument was accidentally disturbed during construction.

- FOUND RAILROAD SPIKE PER R.S. 9-30
- SET SPIKE & CALTRANS TAG
- SET 2" X 2" HUB & TACK W/ CALTRANS TAG

NOTE: DISTANCES ARE GROUND METERS
