CORNER RECORD

City of Lodi

Document Number 02-55
County of San Joaquin, California

Brief Legal Description Lower Sacramento Road at Yosemite Drive

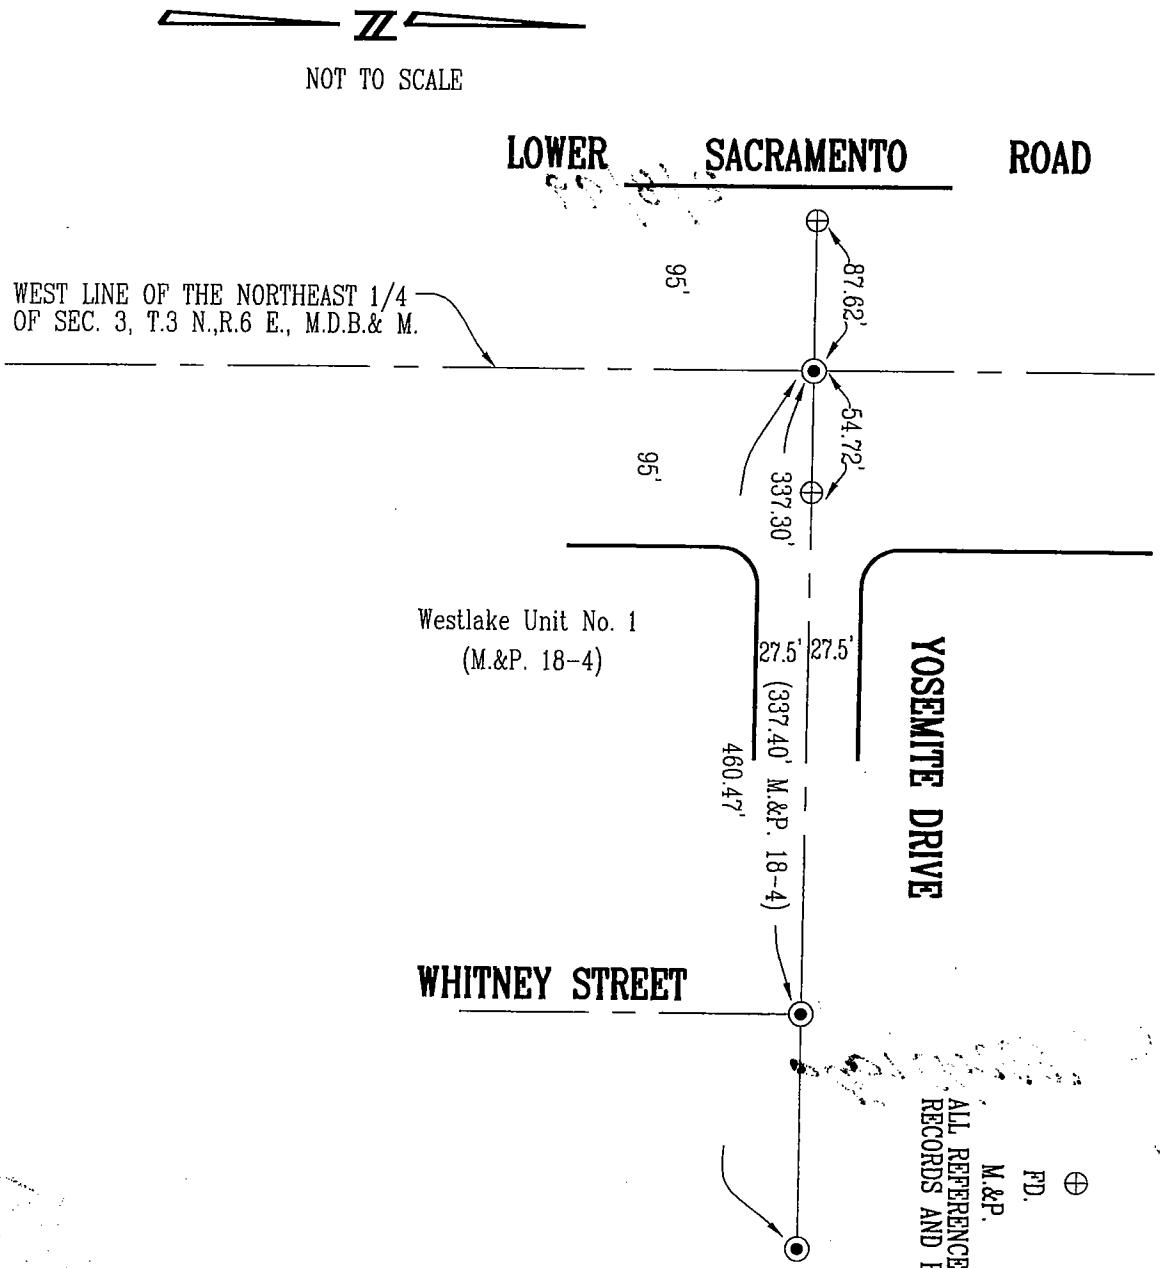
Identification and type of corner found: Evidence used to identify or procedure used to establish or reestablish the corner:
Found 3/4 inch iron rod, tagged R.C.E. 12685, in monument box per Maps and Plats 18-4 at Lower Sacramento Road and Yosemite Drive

A description of the physical condition of the monument as found and as set or reset: The monument is in good condition. Reference points were set in case monument is disturbed.

- ⊙ FD. 3/4" IRON ROD TAGGED
R.C.E. 12685 IN MONUMENT
BOX PER M.&P. 18-4
 - ⊕ SET CHISELED CROSS IN CURB
FOUND
 - M.&P. BOOK OF MAPS AND PLATS
- ALL REFERENCES ARE TO SAN JOAQUIN COUNTY RECORDS AND BOOK OR VOLUME PRECEDES PAGE.
