CORNER RECORD

Document Number CR-95-003

City of MANTEDA County of SAN JOAQUIN, California

Brief Legal Description SECT. COR. 4,5,8,9 T25R7E MDM

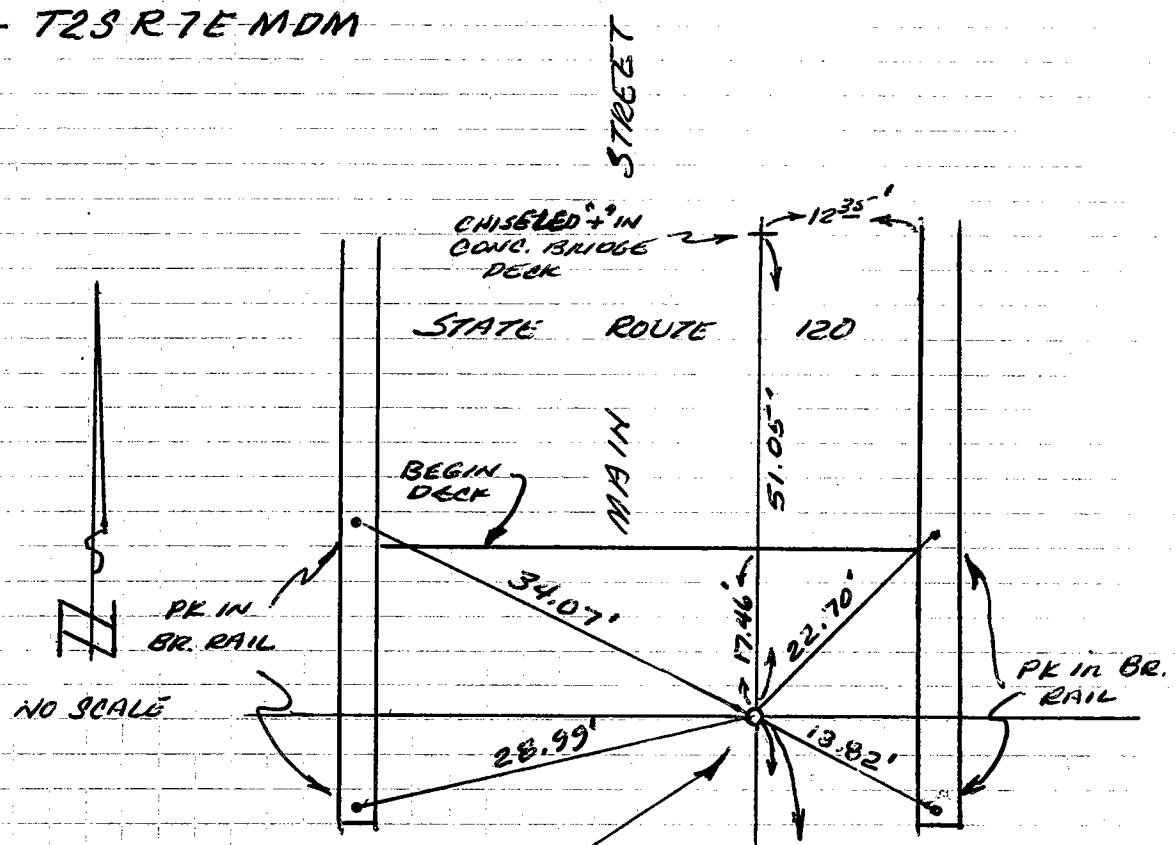
5/4 T2S R7E MDM
8/9

BRASS CAP, CALIFORNIA DIVISION OF HIGHWAYS, STAMPED
MDB+M ^{5/4} _{8/9} T25R7E

IN GOOD CONDITION - IN MONUMENT WELL, DOWN 0.15'
AND MAY BE DISTURBED BY CURRENT CONSTRUCTION.

BRASS CAP IN MON. WELL

QUINTAL Fd COUNTY BOLT & WASHER SOUTH MANTECA ROAD

WOODWARD ROAD

Fd BOLT ~~Cap~~ IN MON. WELL
