Document Number CR-97-45

County of San Joaquin, California

Brief Legal Description State highway reference monument in Sec. 36, T.5N, R.8E, M.D.M.

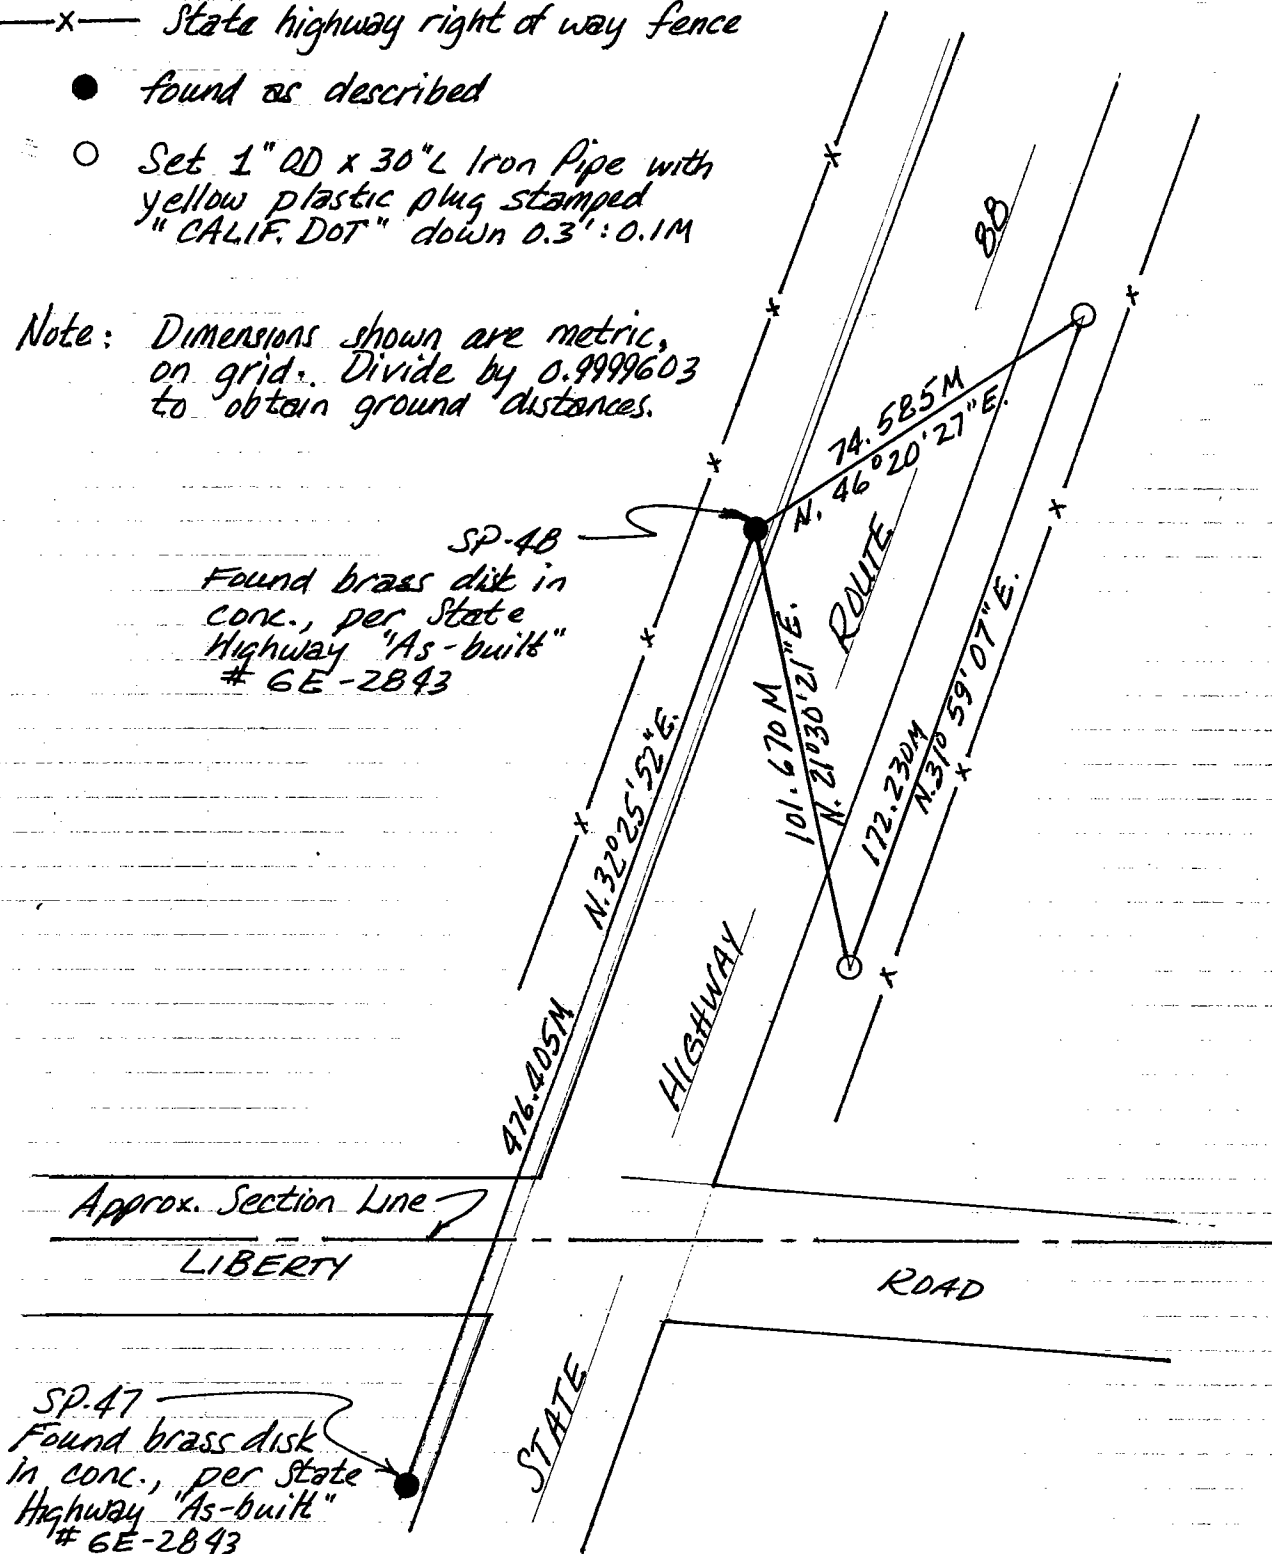
Section 36, T.5N., R.8E., M.D.M.,

Found "DIVISION OF HIGHWAYS" Brass disk in concrete, flush, in the
shoulder of State Highway Route 88, according to the "As-built"
construction plan on file at the District 10 office of Caltrans
in Stockton. "As-built" #GE-2843

A description of the physical condition of the monument as found and as set or reset: Found in good
condition as described. Monument is in jeopardy of demolition,
when the intersection of Highway 88 with Liberty Road is
rebuilt.
