CORNER RECORD

Document Number CR-98-16

Brief Legal Description N.W. Corner Section 25, T.2S., R.7E., M.D.B. & M.

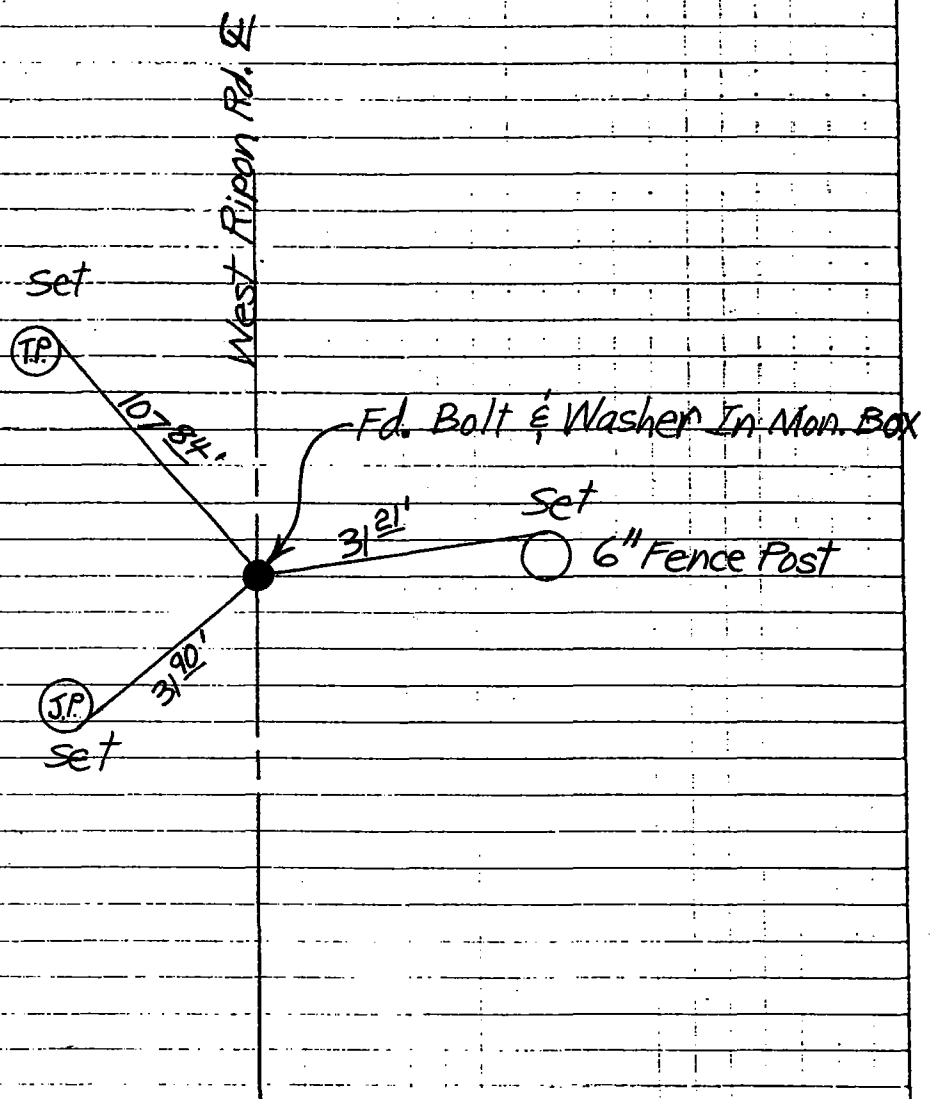
Identification and type of corner found: Evidence used to identify or procedure used to establish or reestablish the corner: Fd. Bolt & Washer In Mon. Box. F.B. 480, P. 74 Describes The Section Corner To Be A R.R. Spike Set Over A Bolt & Washer 18" Below The Surface. ^{Without Mon. Box.} No Attempt Was Made To Verify That The Fd. Monument Is The Section Corner.

A description of the physical condition of the monument as found and as set or reset: The Monument Was In Good Condition & Was Left As Found. Set 3 reference points

Note: Set Monuments Are concrete Nails & Washers Stamped "S.J.Co."
