CORNER RECORD

Document Number CR-99-27
County of San Joaquin, California

Brief Legal Description 245' ± southeasterly of intersection of Jack Tone Road and State Hwy 88

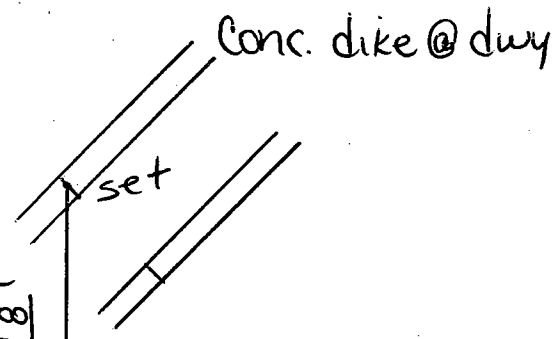
A description of the physical condition of the monument as found and as set or reset: Monument was in good condition & left as found (Monument box was placed over monument during 1999 Jack Tone Rd Resurfacing Project)

FD S.J. CO. PIN/WASHER
IN MON BOX

197'09"

60'18"

Fire hydrant
set in
NE bolt

Note: "Set" ties on PP's &
Conc. dike are nail & washer
stamped "S.J. Co."
"Set" tie on fire hydrant
is a punched dot.
