CORNER RECORD

Document Number 00-07
County of San Joaquin, California

Brief Legal Description S.E. Corner of S.W. 1/4 of Section 20, T.1S., R.8E
per PM-20-178

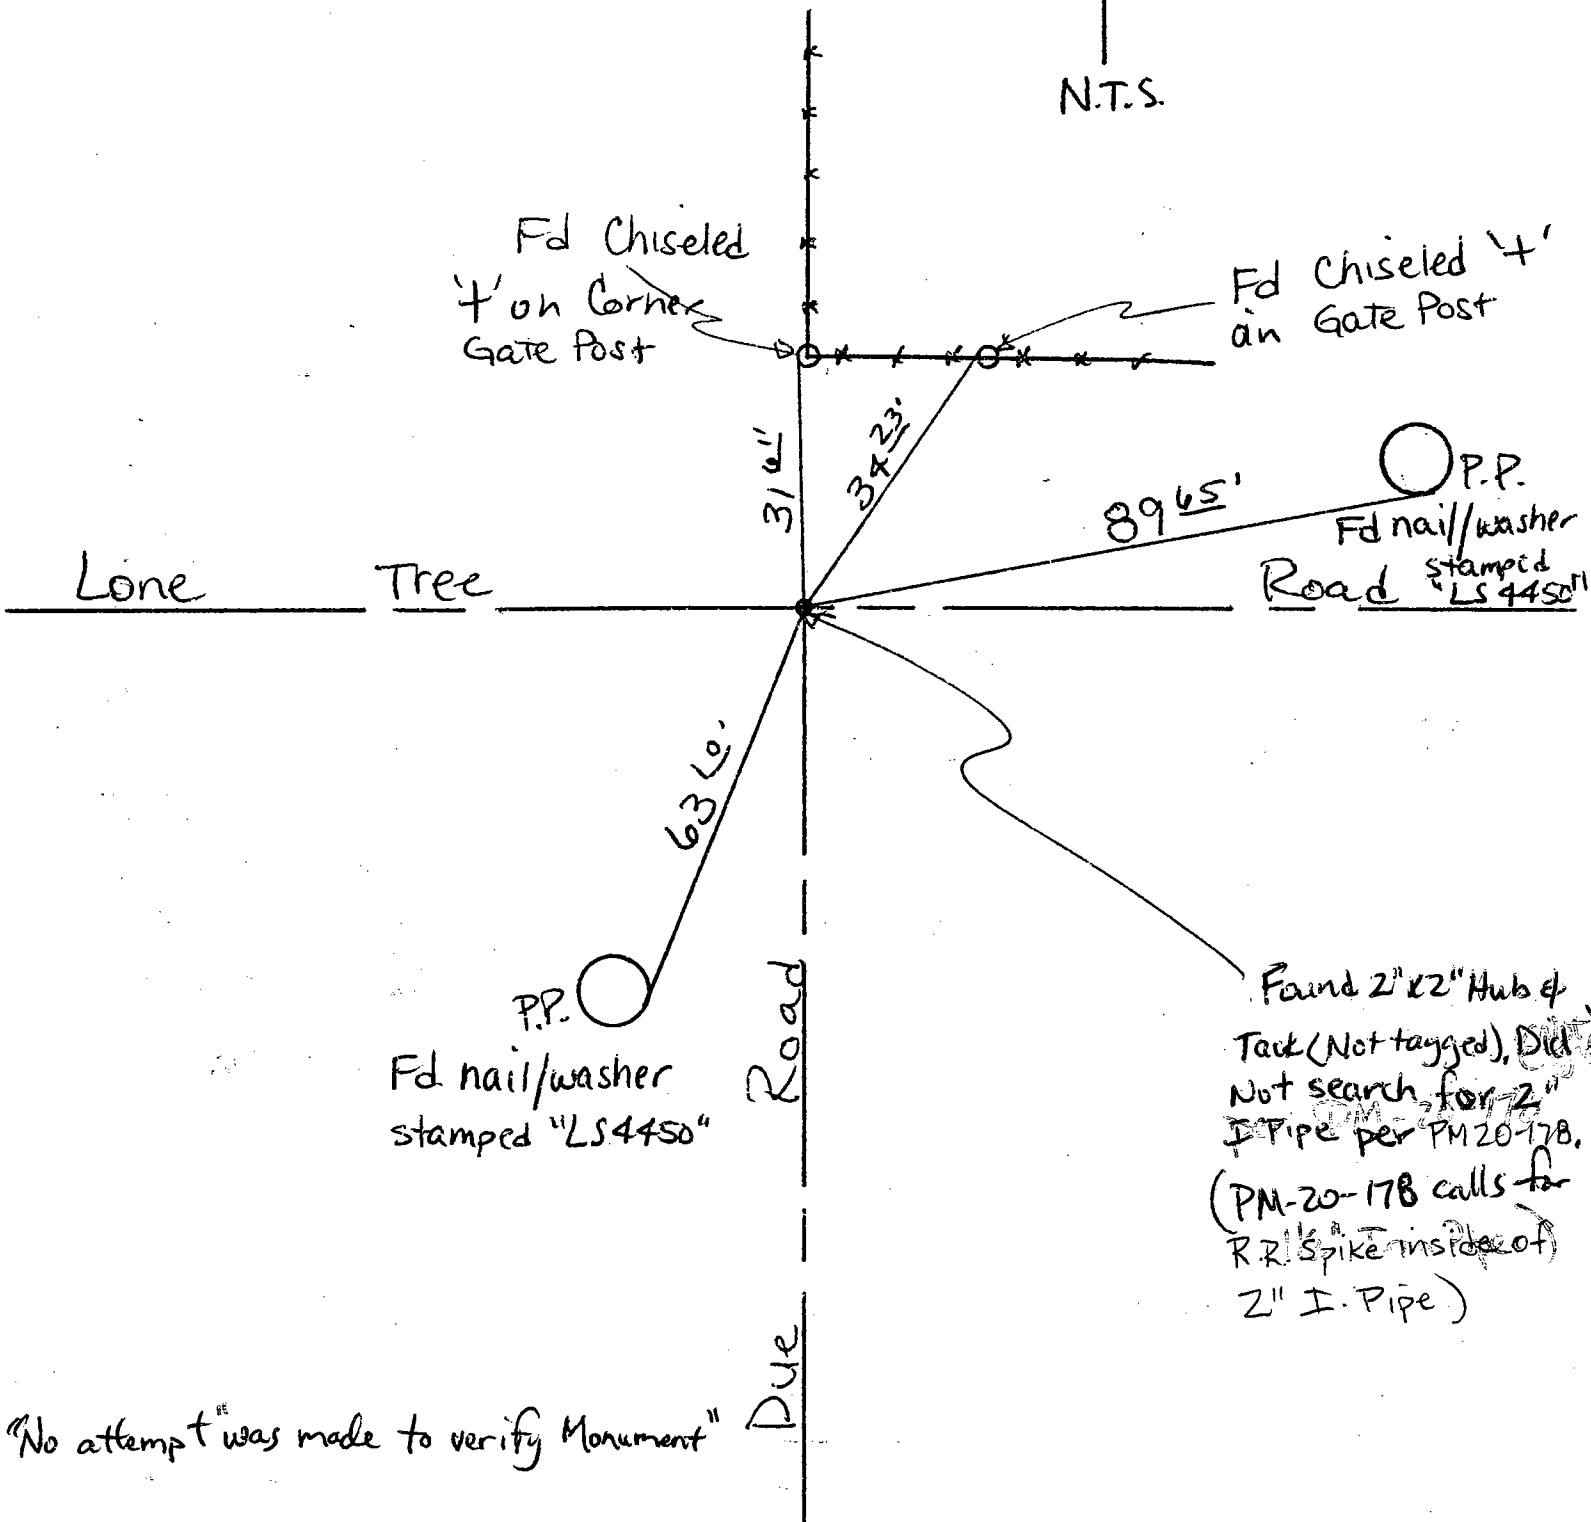
(D.D. Sheet No. 45)

Found Monument in good condition
See Sketch on Backside

Fd Chiseled
+ on Corner
Gate Post

Fd Chiseled +
on Gate Post

Fd nail/washer
stamped
LS4450

Fd nail/washer
stamped "LS4450"

Found 2" x 2" Hub &
Tack (Not tagged), Did
Not search for 2"
I.P. Pipe per PM-20-178,
(PM-20-178 calls for
R.R. Spike inside of
2" I. Pipe)

"No attempt was made to verify Monument"
