CORNER RECORD

Document Number 00-70
County of San Joaquin, California

Brief Legal Description AT THE INTERSECTION OF HARNEY LANE AND
CURRY AVE. NORTH PER. P.M. 18-73

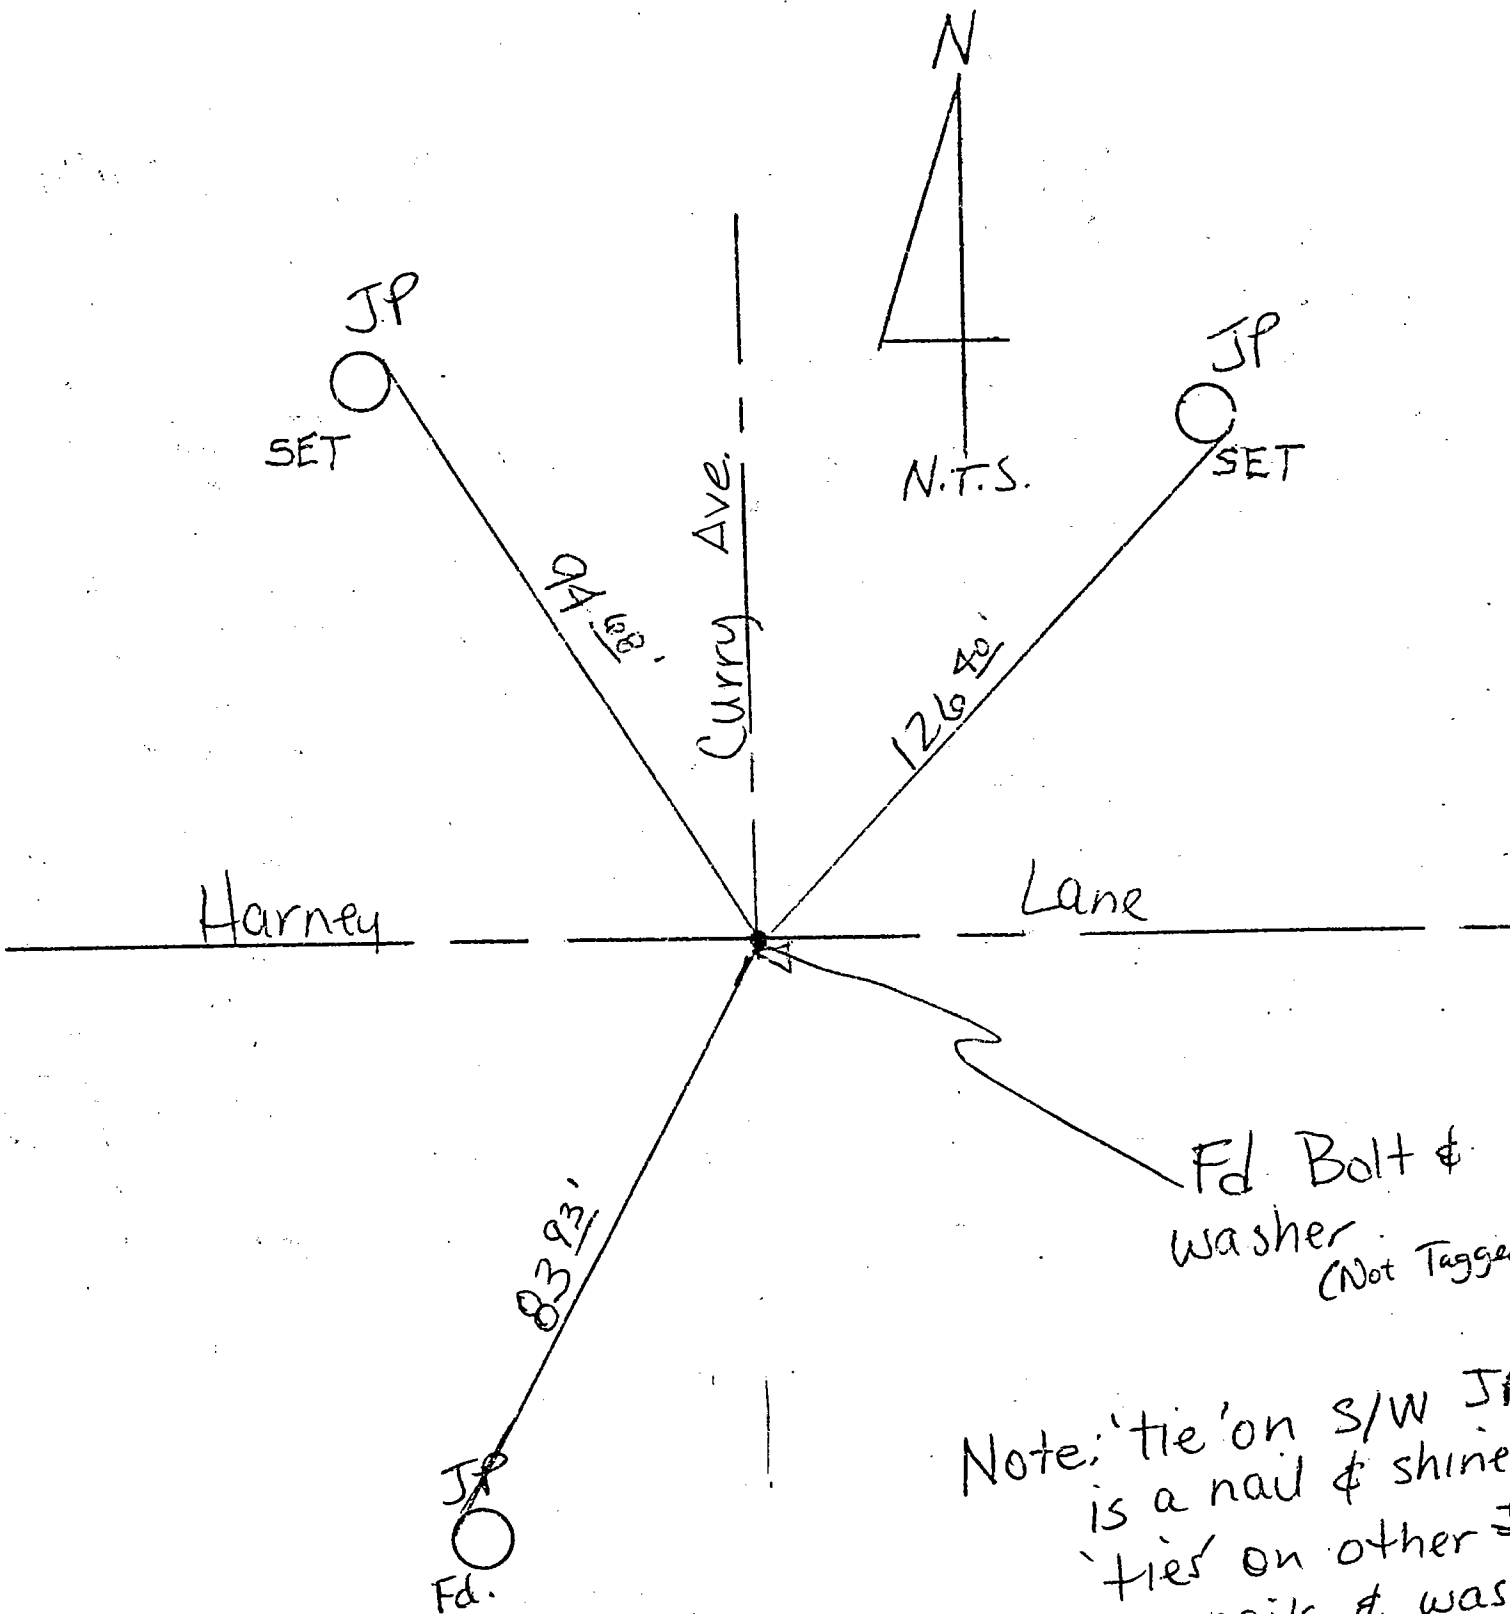
FOUND MONUMENT IN GOOD CONDITION
SEE SKETCH ON BACKSIDE

Fd Bolt & washer
(Not Tagged)

Note: 'tie' on S/W JP is a nail & shiner 'ties' on other J are nails & wash stamped "S.J. Co." "Set"
