CORNER RECORD

Document Number 00-78
County of San Joaquin, California

Brief Legal Description N/W CORNER OF SECTION 21, T.3N., R.7E.

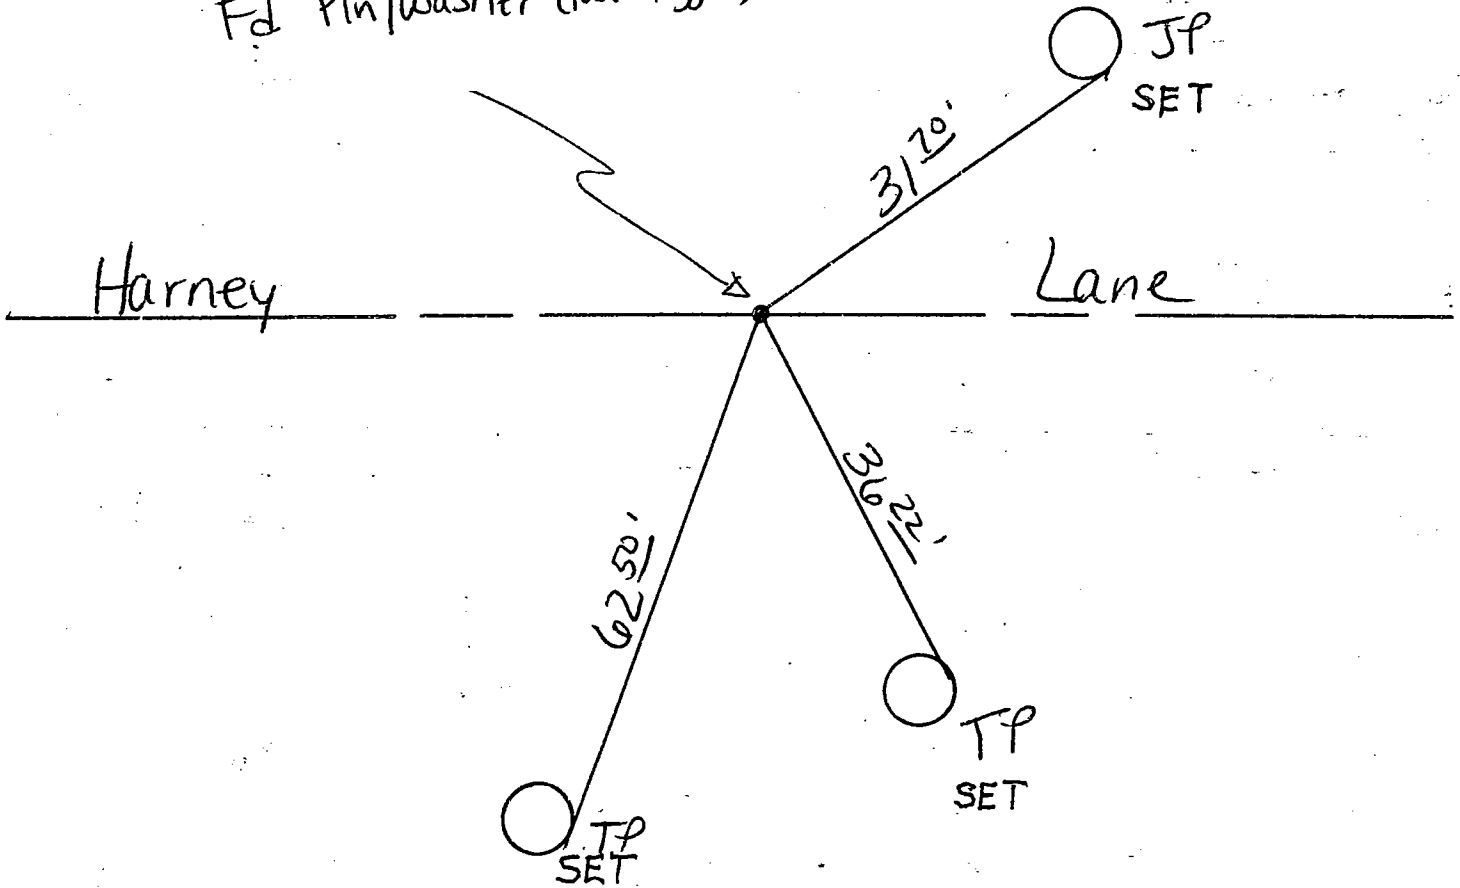
MONUMENT WAS FOUND IN GOOD CONDITION
SEE SKETCH ON BACKSIDE

Fd Pin/washer (Not Tagged)

"No Attempt Was Made To Verify Monument(s)"
