CORNER RECORD

Document Number 00-96
County of San Joaquin, California

Brief Legal Description Intersection of Santa Fe Road and Harold Avenue per
PM-8-72

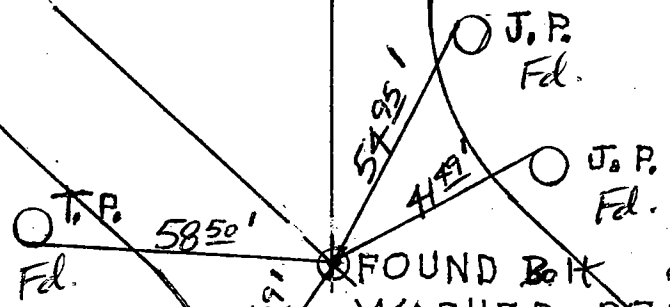
Identification and type of corner found: Evidence used to identify or procedure used to establish or reestablish the corner:
Reestablished location of Fd. Bolt & Washer (Not Tagged) per PM-8-72
per swingtles on C.R.-00-95.
See Sketch on Backside

A description of the physical condition of the monument as found and as set or reset: Fd. Bolt & Washer
(Not Tagged) in good condition per PM-8-72 and placed Mon. Box over
Monument. See Sketch on Backside

(Placed
Mon. Box
over Mon)
