CORNER RECORD

Document Number 00-98
County of San Joaquin, California

Brief Legal Description Santa Fe Road 2103'± Southeasterly of Orange Avenue
per F.B. 658, pg 34.

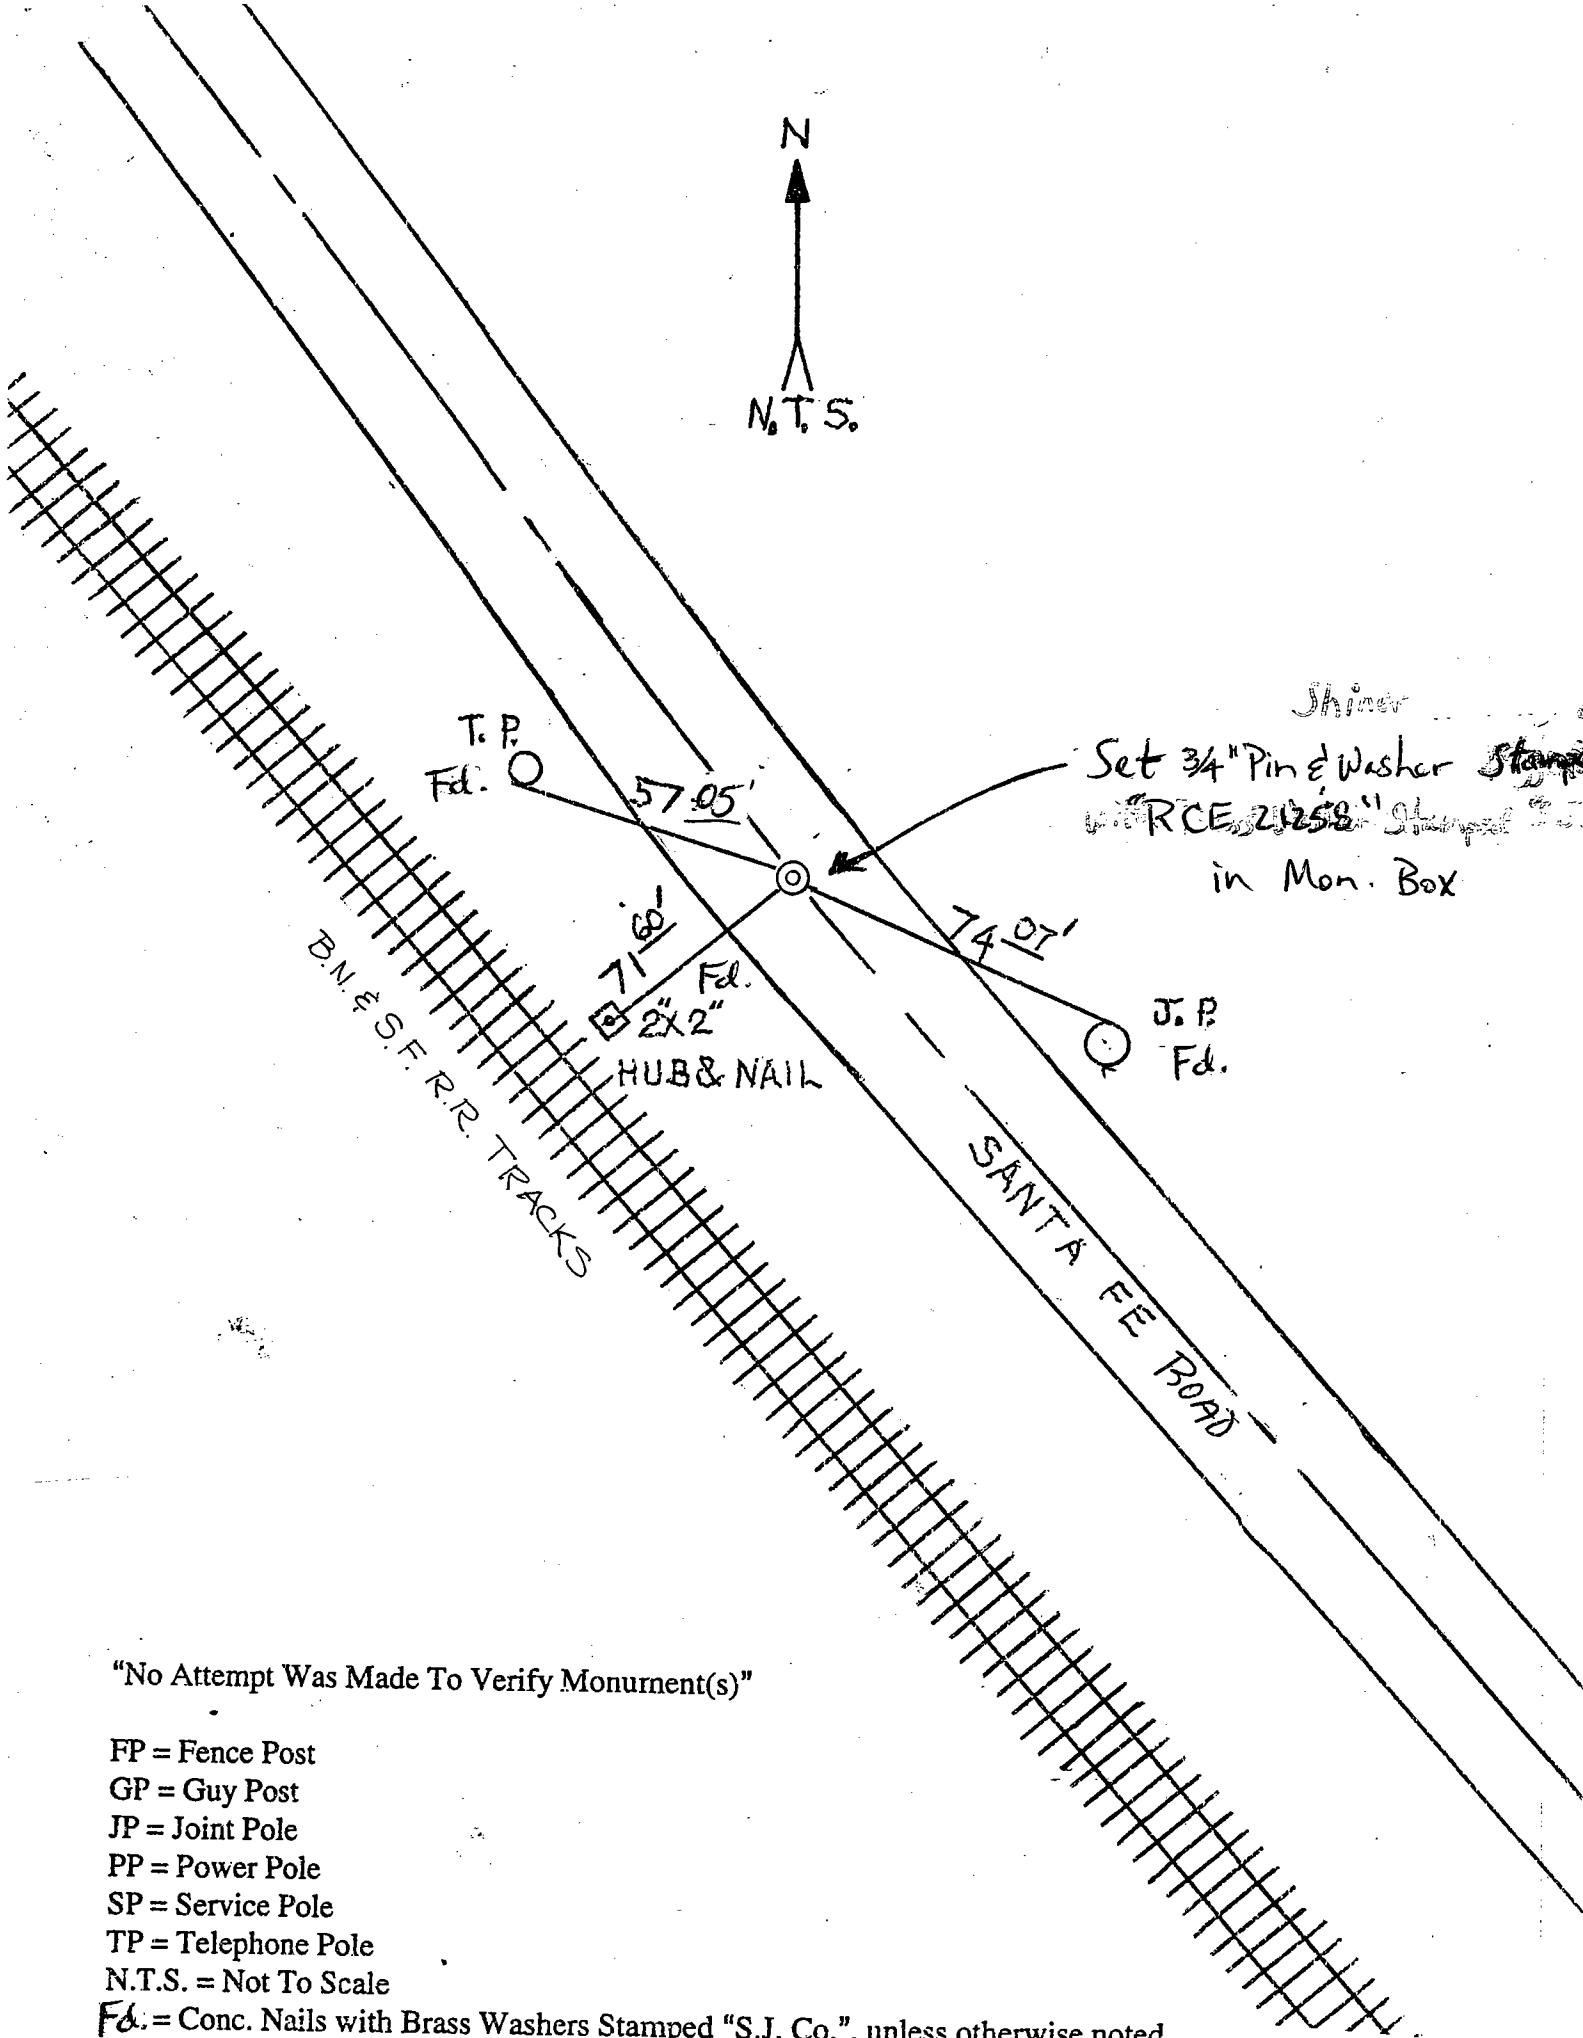
(D.D. Sheet No. 63)

Identification and type of corner found: Evidence used to identify or procedure used to establish or reestablish the corner:
Reestablished location of Found Nail & Shiner (Not Tagged) per F.B. 658, pg 34
per swings on C.R. - 00 - 97.
See Sketch on Backside

A description of the physical condition of the monument as found and as set or reset: Set 3/4" Pin & Washer
Stamped "RCE 21258" per Swings on C.R. - 00 - 97 and placed Mon.
Box over Monument. See Sketch on Backside
