CORNER RECORD

Document Number 00-108
County of San Joaquin, California

Brief Legal Description THE INTERSECTION OF HARNEY LANE AND GARNERO ROAD

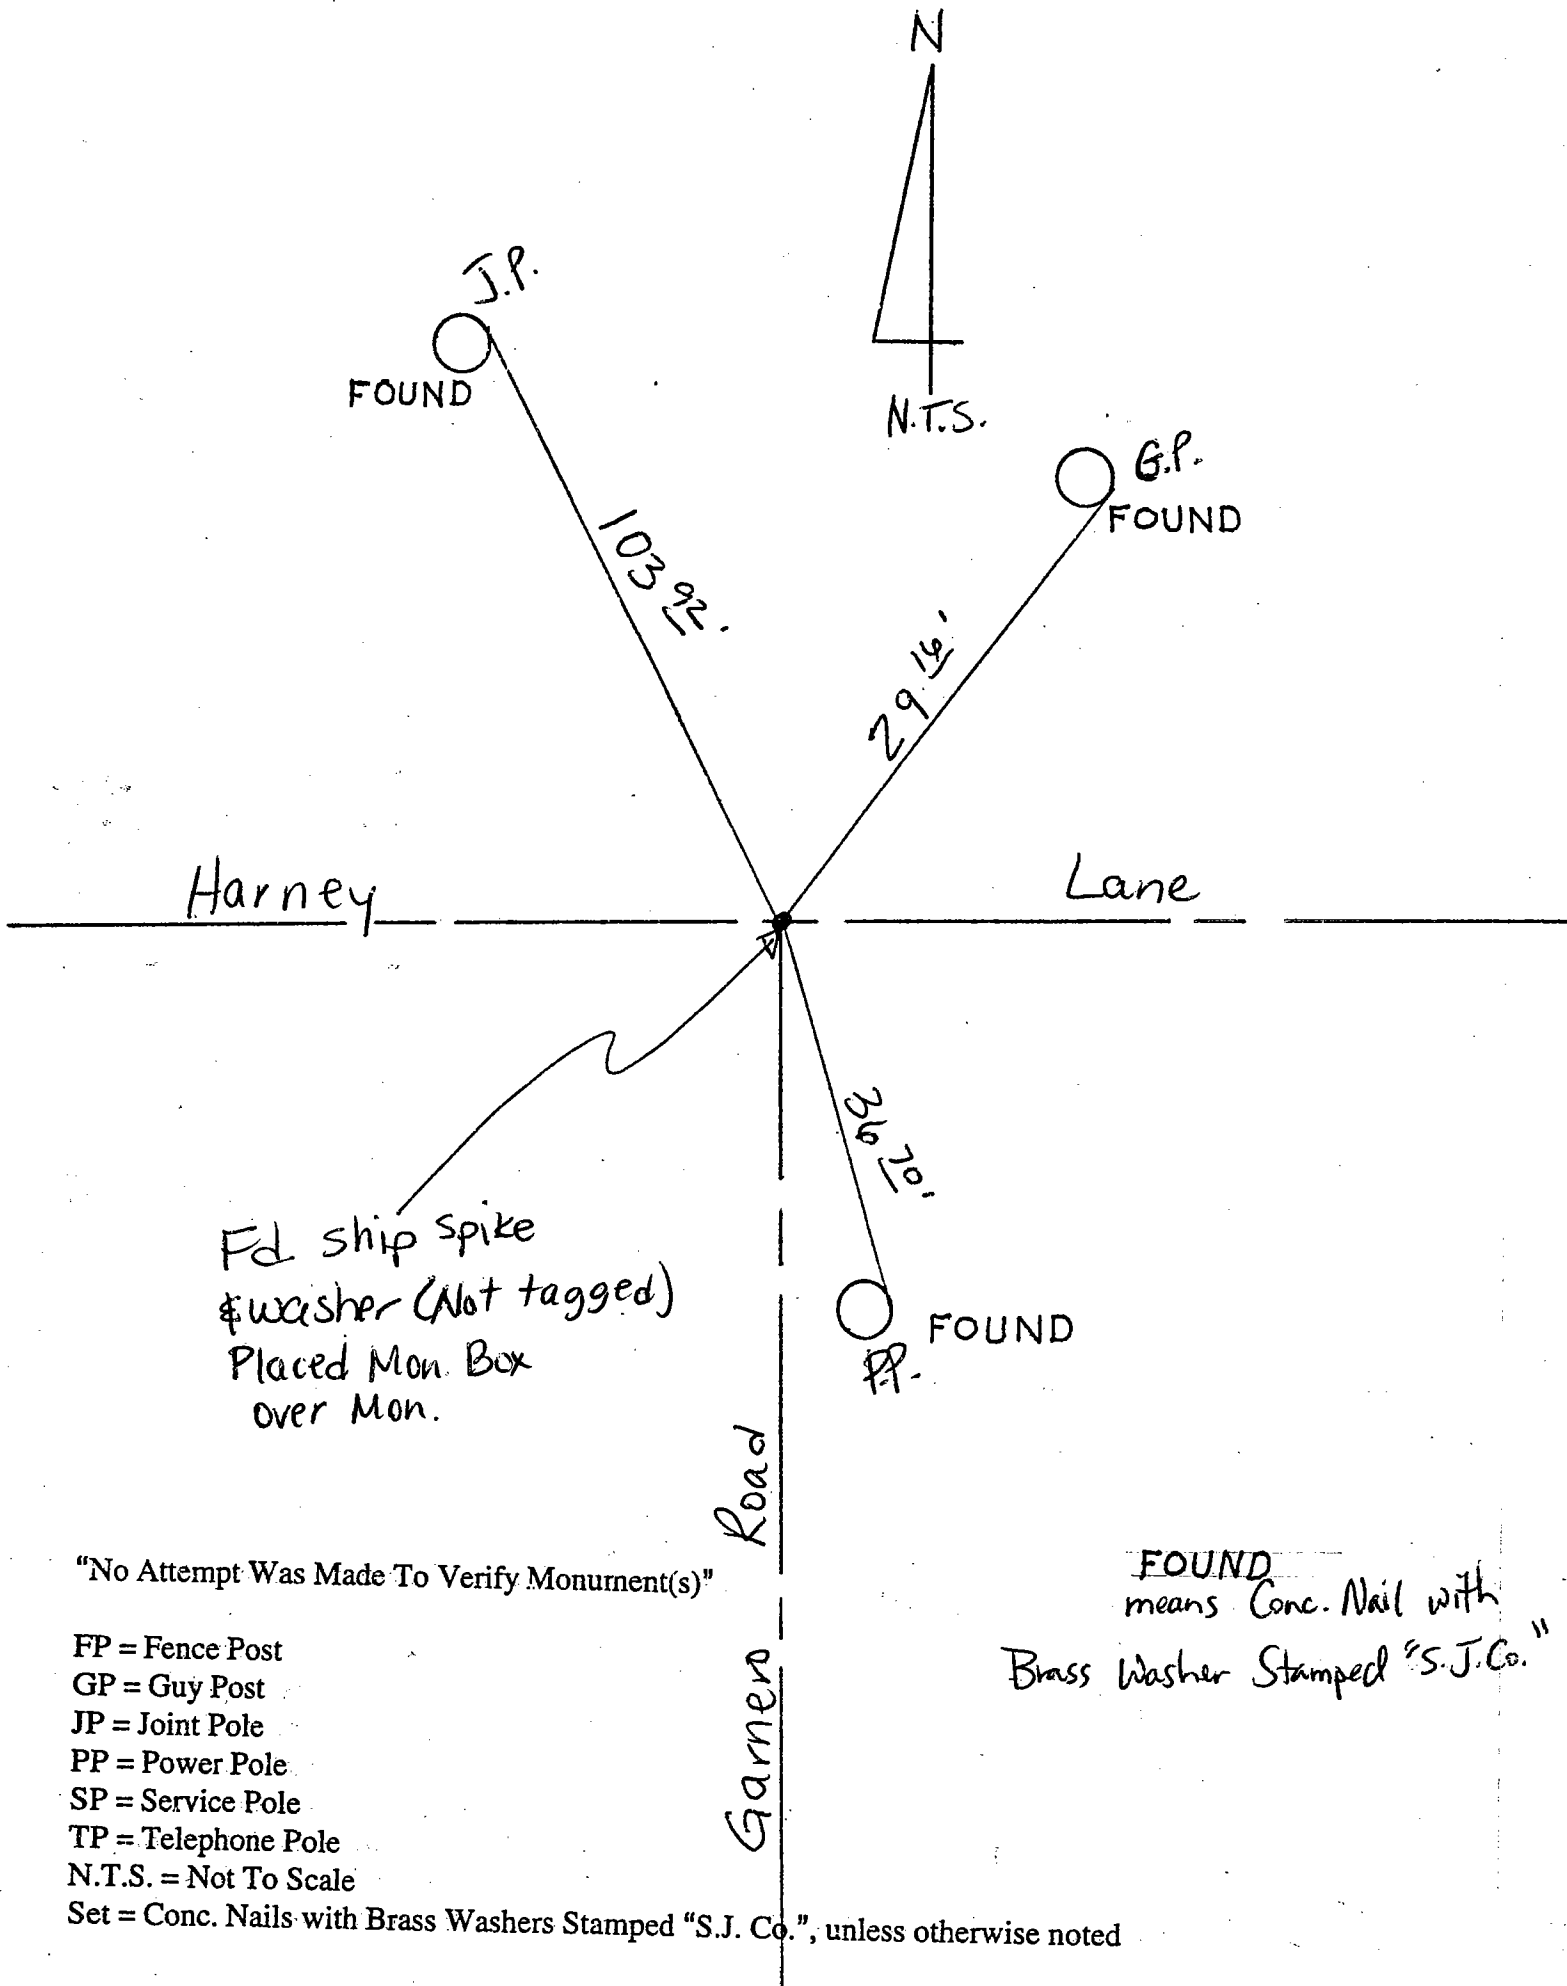
FOUND SHIP SPIKE & WASHER
PER R.S. 26-6 PER SWING TIES ON C.R. 00-7/SEE SKETCH ON
BACKSIDE

A description of the physical condition of the monument as found and as set or reset: FOUND SHIP SPIKE
& WASHER PER R.S. 26-6 IN GOOD CONDITION AND
PLACED MONUMENT WELL OVER MONUMENT
