CORNER RECORD

City of _____ Document Number 00-115
County of San Joaquin, California

Brief Legal Description MONUMENT IS AT THE INTERSECTION OF HARNEY LANE & WELLS LANE (1/4 1/4 CORNER)

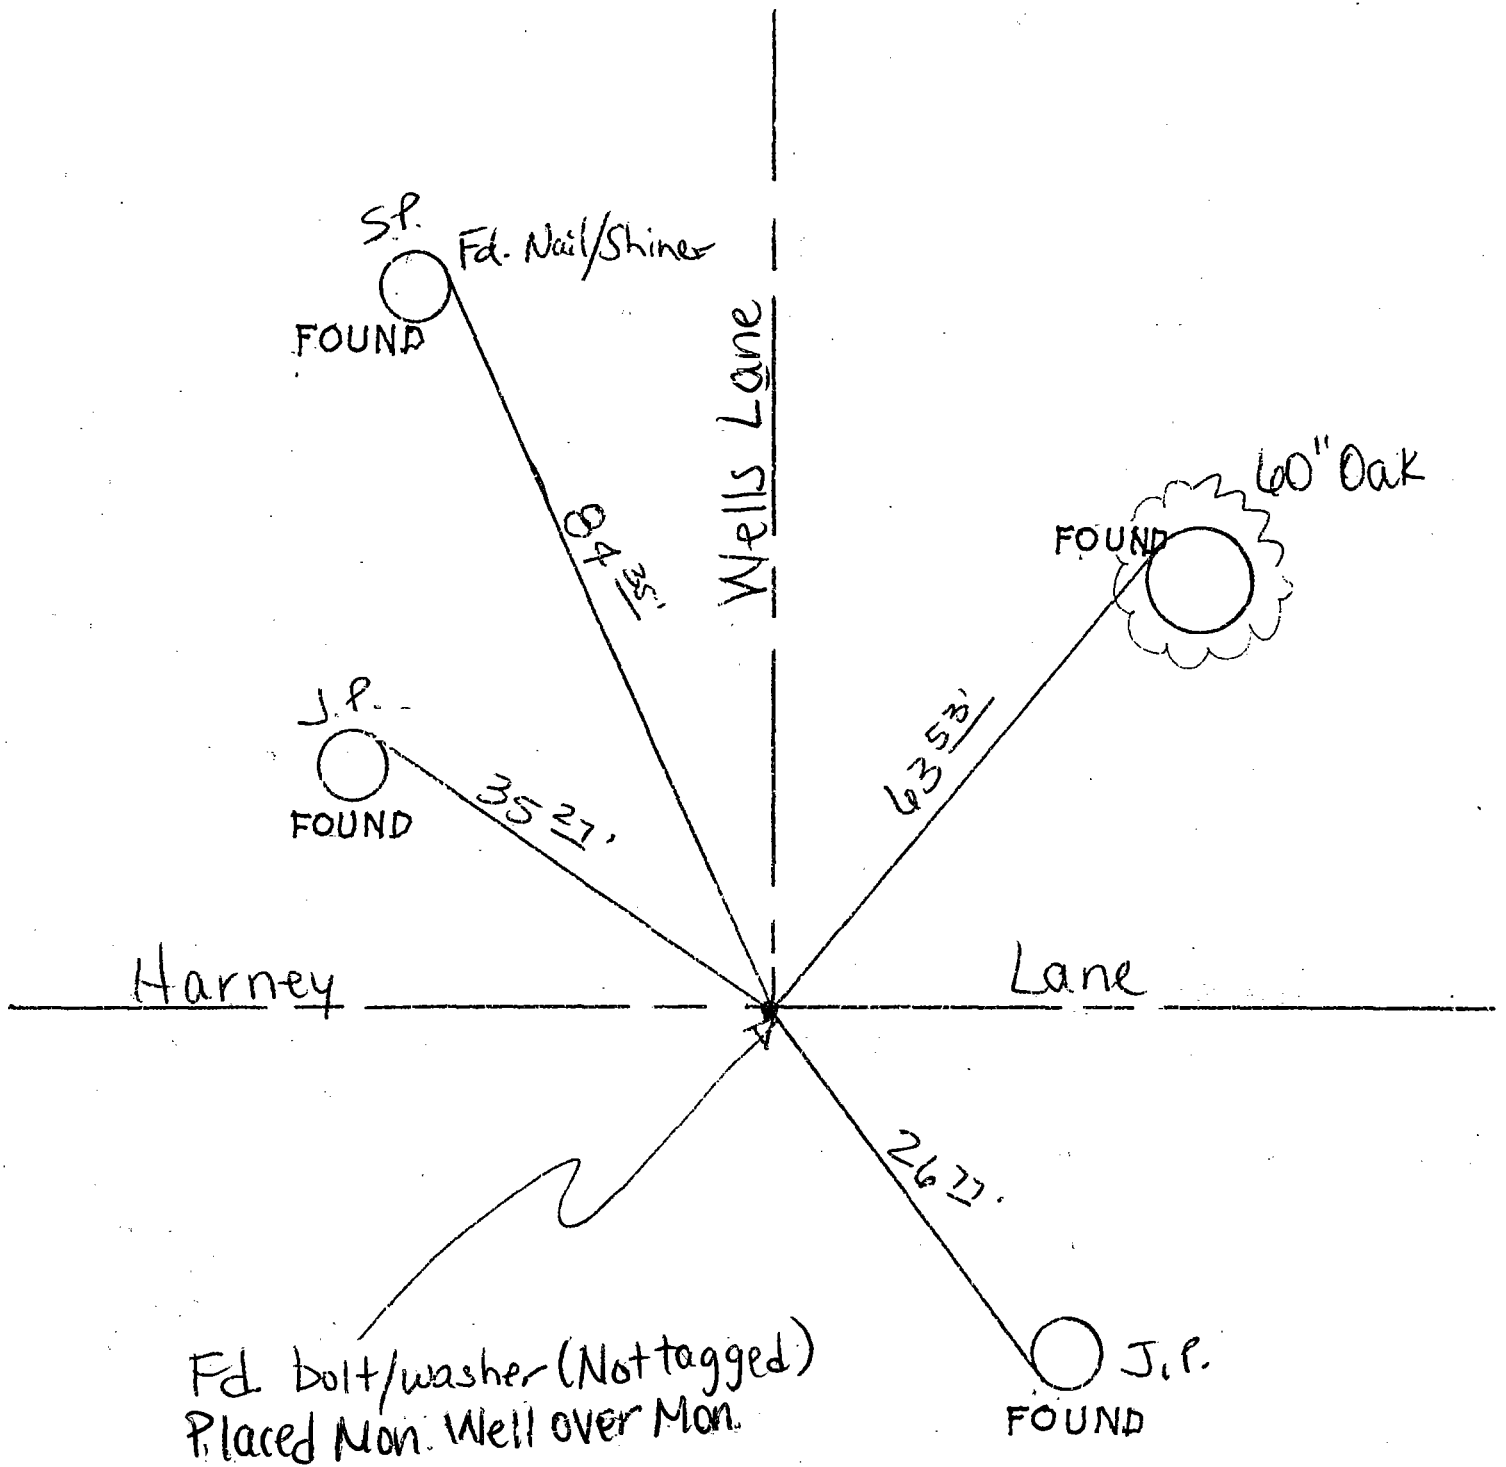
FOUND BOLT & WASHER PER R.S. 21-3 PER SWING TIES ON C.R. 00-74. SEE SKETCH ON BACKSIDE.

A description of the physical condition of the monument as found and as set or reset: FOUND BOLT & WASHER PER R.S. 21-3 IN GOOD CONDITION AND PLACED MONUMENT WELL OVER MONUMENT. SEE SKETCH ON BACKSIDE

Fd. bolt/washer (Not tagged)
Placed Mon. Well over Mon.

"FOUND"
Note: All ties are nails & washers stamped "S.J. Co."
