CORNER RECORD

Document Number 00-121  
County of San Joaquin, California

Brief Legal Description THE NORTHWEST CORNER OF SECTION 23,  
T.3 N., R.7 E.

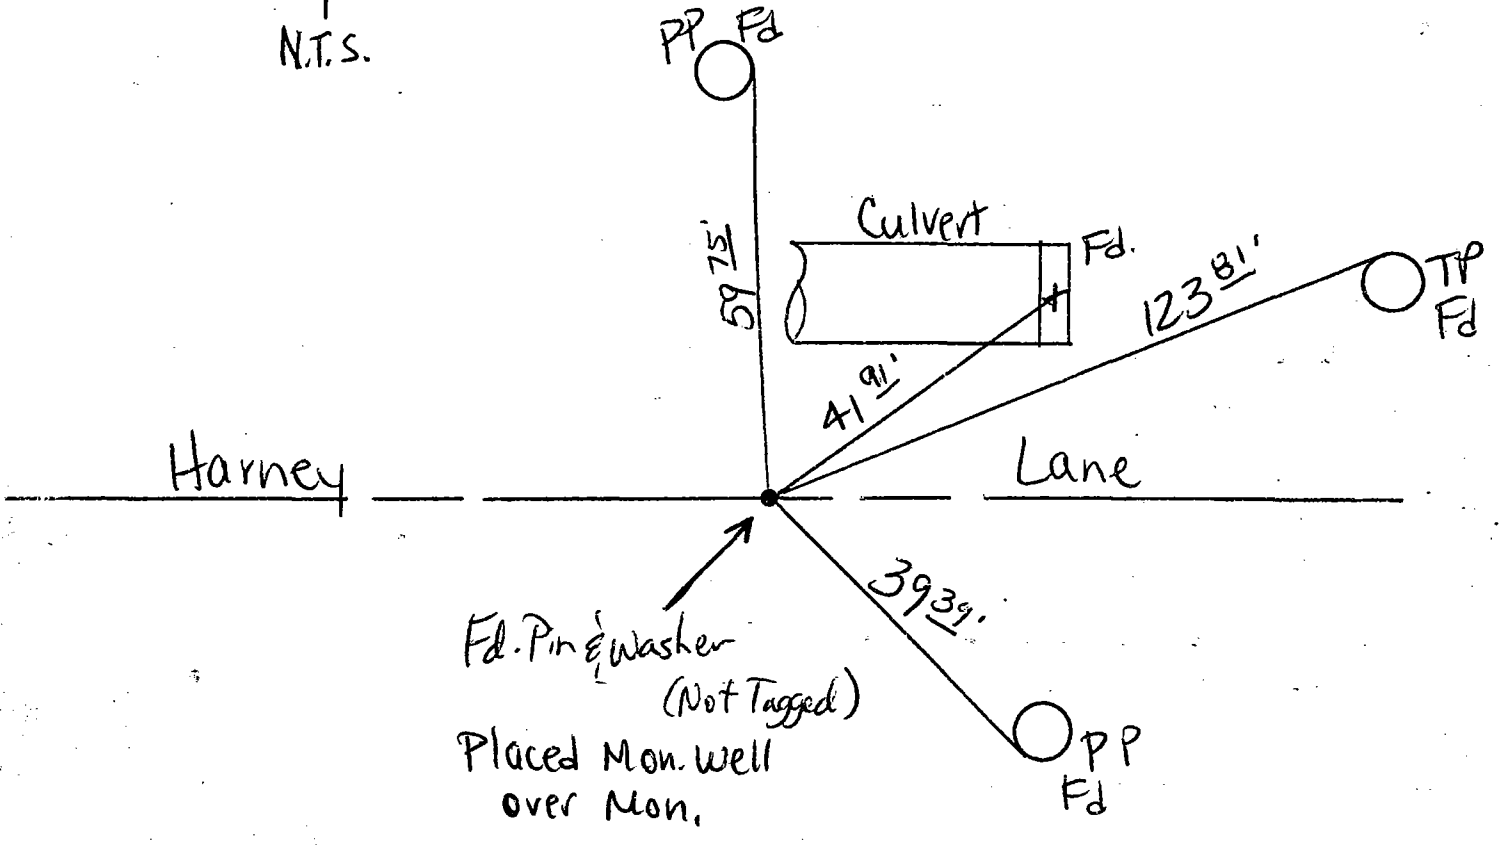
FOUND PIN & WASHER  
(R.S. 22-115 CALLS FOR BOLT), PER SWING TIES ON C.R. 00-120.  
SEE SKETCH ON BACKSIDE.

A description of the physical condition of the monument as found and as set or reset: FOUND PIN &  
WASHER IN GOOD CONDITION AND  
PLACED MONUMENT WELL OVER MONUMENT.

Note: Tie on culvert is a chiseled 't'  
 'Fd.' Ties on poles are nails & washers stamped "S.J. Co."
