CORNER RECORD

City of Stockton

Document Number 00-151
County of San Joaquin, California

Brief Legal Description A portion of Block 10 East of Center Street, as shown on Record of Survey, Book 34, page 40, San Joaquin County Records, City of Stockton N.

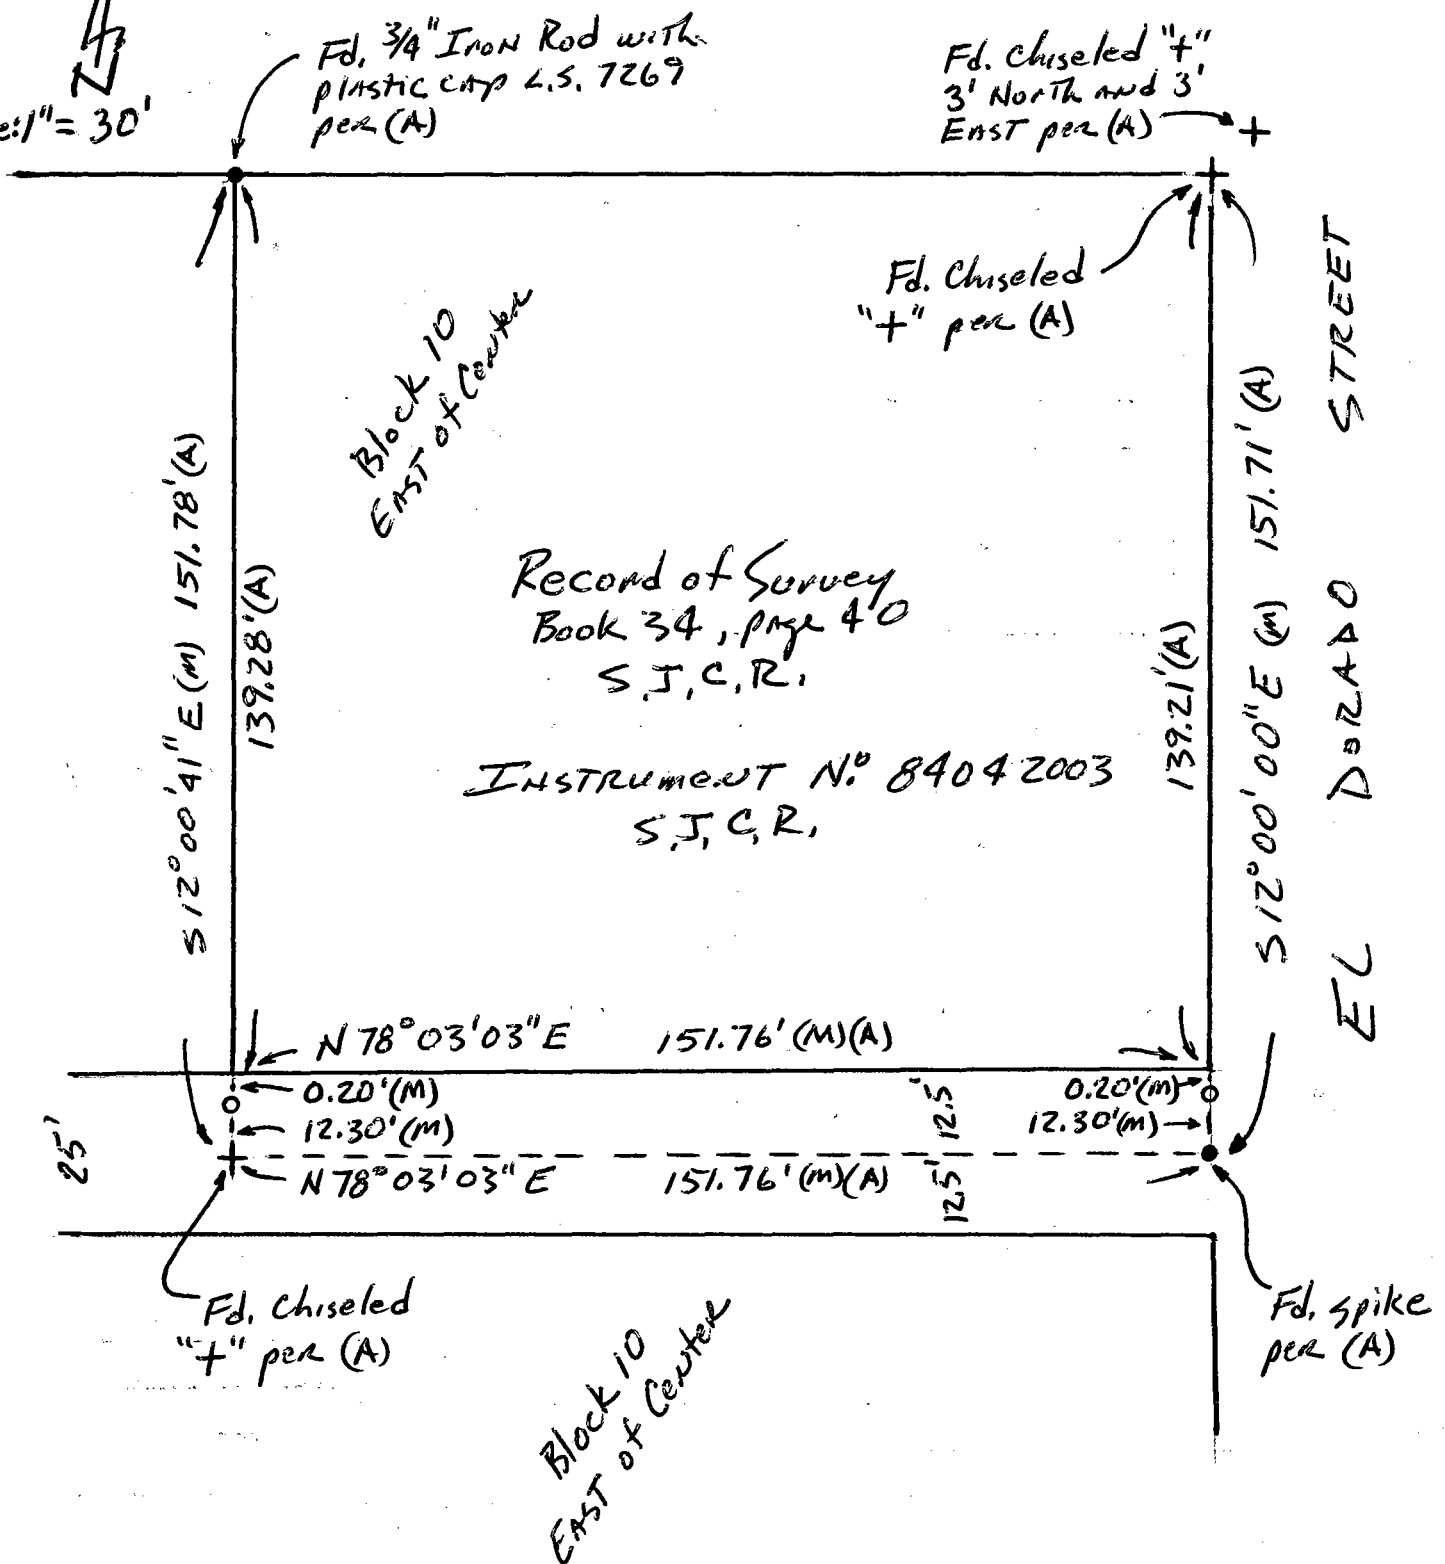
Found monuments as noted on sketch on reverse side

A description of the physical condition of the monument as found and as set or reset: Record of Survey Book 34, Page 40, San Joaquin County Records, shows that a chiseled "t" witness corner was set for the southwest corner of the property described in Instrument N° 84042003 San Joaquin County Records, and a "spike" witness corner was set for the southeast corner of said property. These witness corners are in jeopardy of being destroyed. New witness corners were set as shown on sketch.
