CORNER RECORD

Document Number 00-207  
County of San Joaquin, California

Brief Legal Description Intersection of Eight Mile Road and Golfview Road

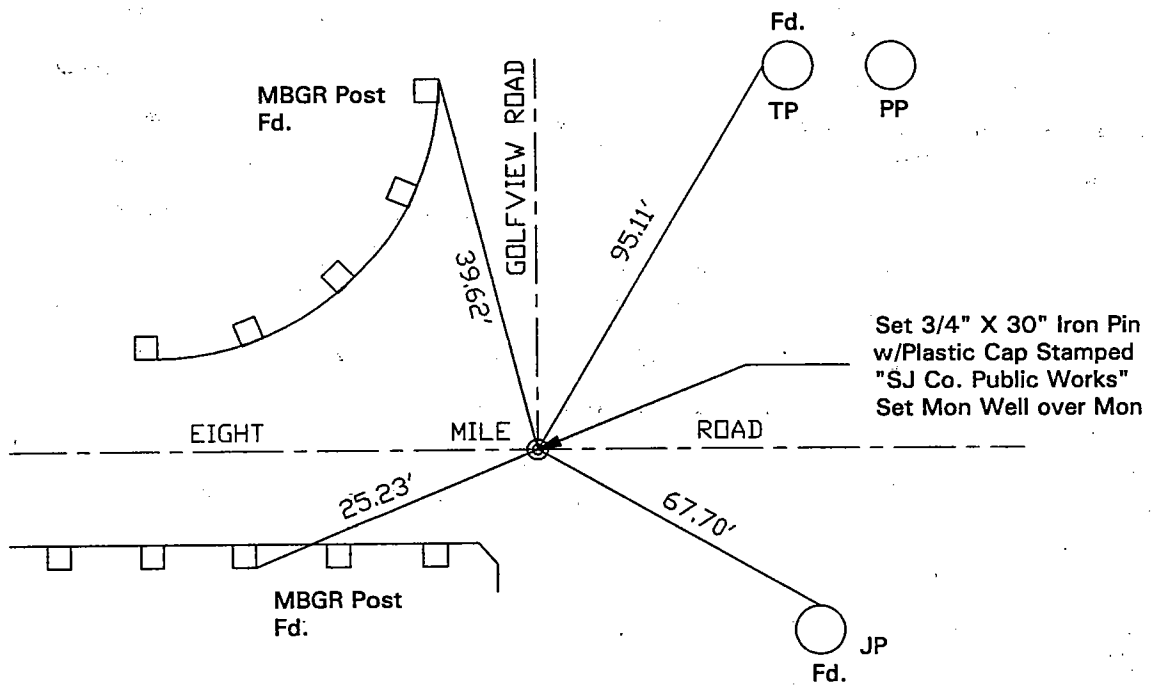
Identification and type of corner found: Evidence used to identify or procedure used to establish or reestablish the corner:  
Reestablished location of Fd Nail per swings on CR-00-194  
See sketch on Backside

A description of the physical condition of the monument as found and as set or reset:  
Set 3/4" X 30" Iron Pin & Placed Mon Well over Mon  
See sketch on Backside
