CORNER RECORD

Document Number 00-287
County of San Joaquin, California

Brief Legal Description CENTER OF SECTION 16, T.2S.,R.8E.

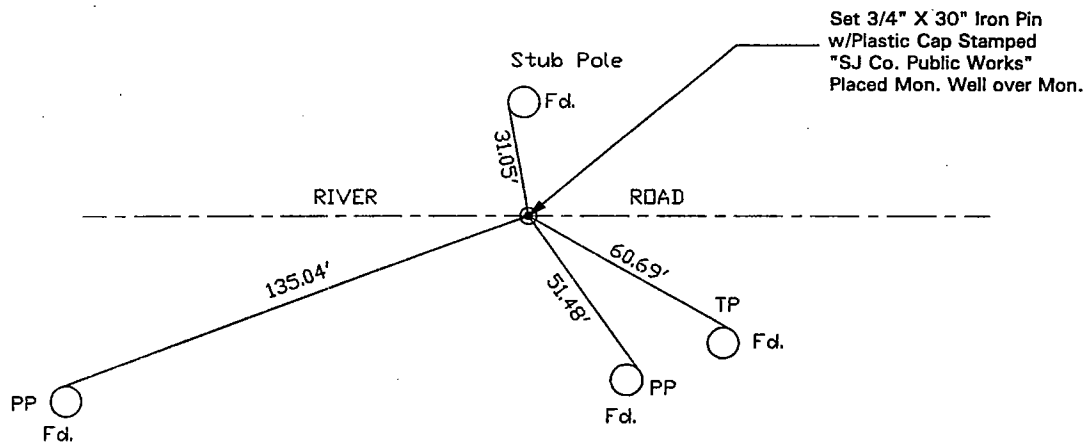
N.T.S.

Identification and type of corner found: Evidence used to identify or procedure used to establish or reestablish the corner
REESTABLISHED LOCATION OF FOUND PK NAIL PER SWINGS ON CR-00-249. SEE SKETCH ON BACKSIDE

A description of the physical condition of the monument as found and as set or reset:
SET 3/4" x 30" IRON PIN AND PLACED MON. WELL OVER MON. SEE SKETCH ON BACKSIDE
