CORNER RECORD

Document Number 01-5
County of San Joaquin, California

Brief Legal Description SE CORNER OF NE QUARTER OF SECTION 19, T.3N.,R.6E

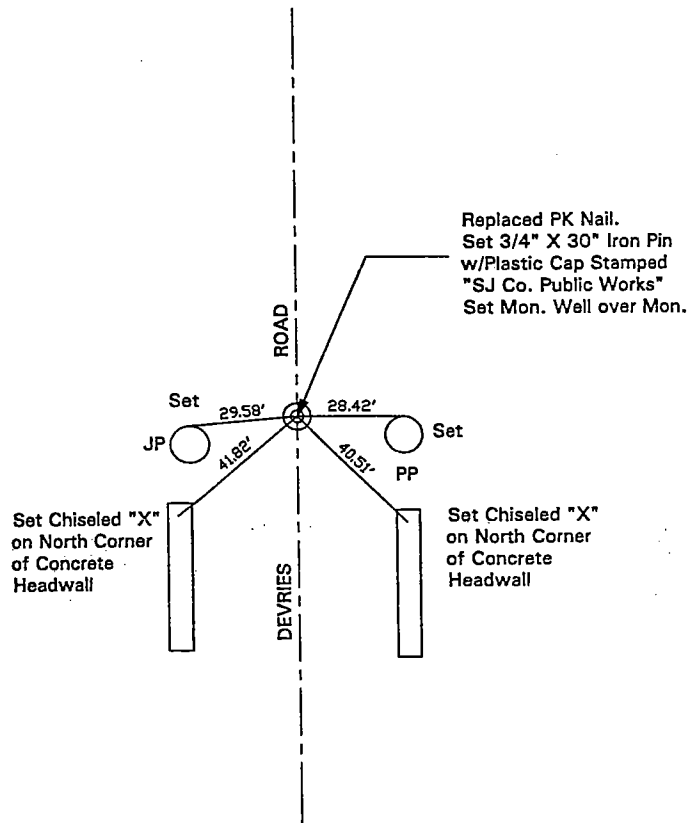
(D.D. Sheet No. 14)

Identification and type of corner found: Evidence used to identify or procedure used to establish or reestablish the corner
FOUND PK NAIL (NOT TAGGED). SEE SKETCH ON BACKSIDE.

A description of the physical condition of the monument as found and as set or reset: _____
SET 3/4" x 30" IRON PIN AND SET NEW TIES. PLACED MONUMENT WELL OVER MONUMENT. SEE SKETCH ON BACKSIDE
