CORNER RECORD

City of Stockton

Brief Legal Description Fontana Avenue, south of Country Club Blvd.

CORNER RECORD
OF 4 MONUMENTS
TO BE DESTROYED BY
ROAD RECONSTRUCTION

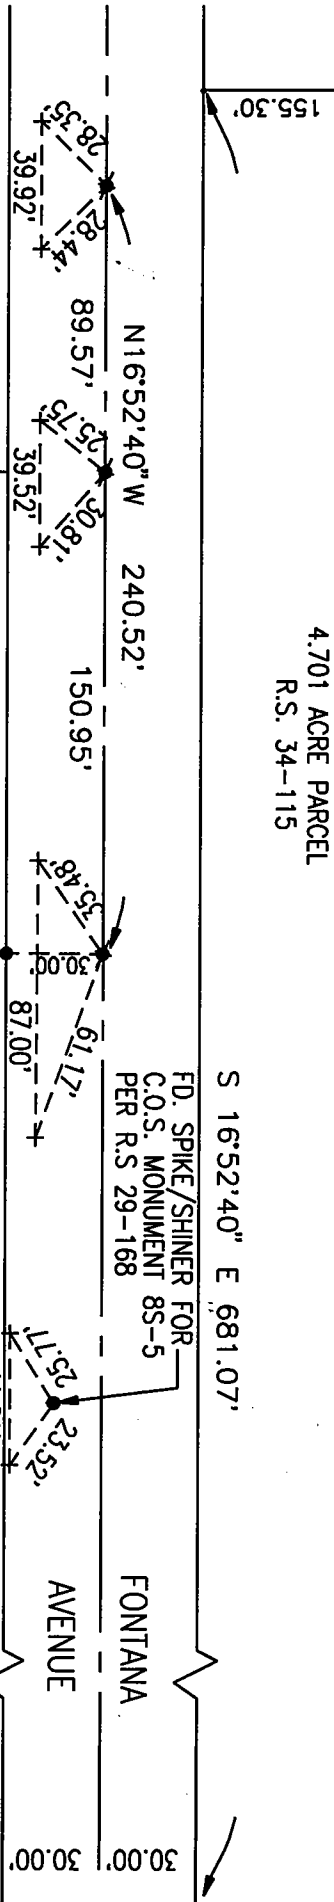
S 16°52'40" E 681.07'

FD. SPIKE/SHINER FOR
C.O.S. MONUMENT
PER R.S. 29-168

- FD. CONG. NAIL PER P.M. 14-114 AND R.S. 34-115
- + DENOTES CHISELED CROSS SET ON TOP OF CURB AS SWING THE POINT

Note: Fontana Ave. is scheduled for reconstruction. The 4 monuments tied out on back will be destroyed.
