CORNER RECORD

City of Lodi

Document Number 01-79  
County of San Joaquin, California

Brief Legal Description NE corner section 14, T3N, R6E, MDB&M

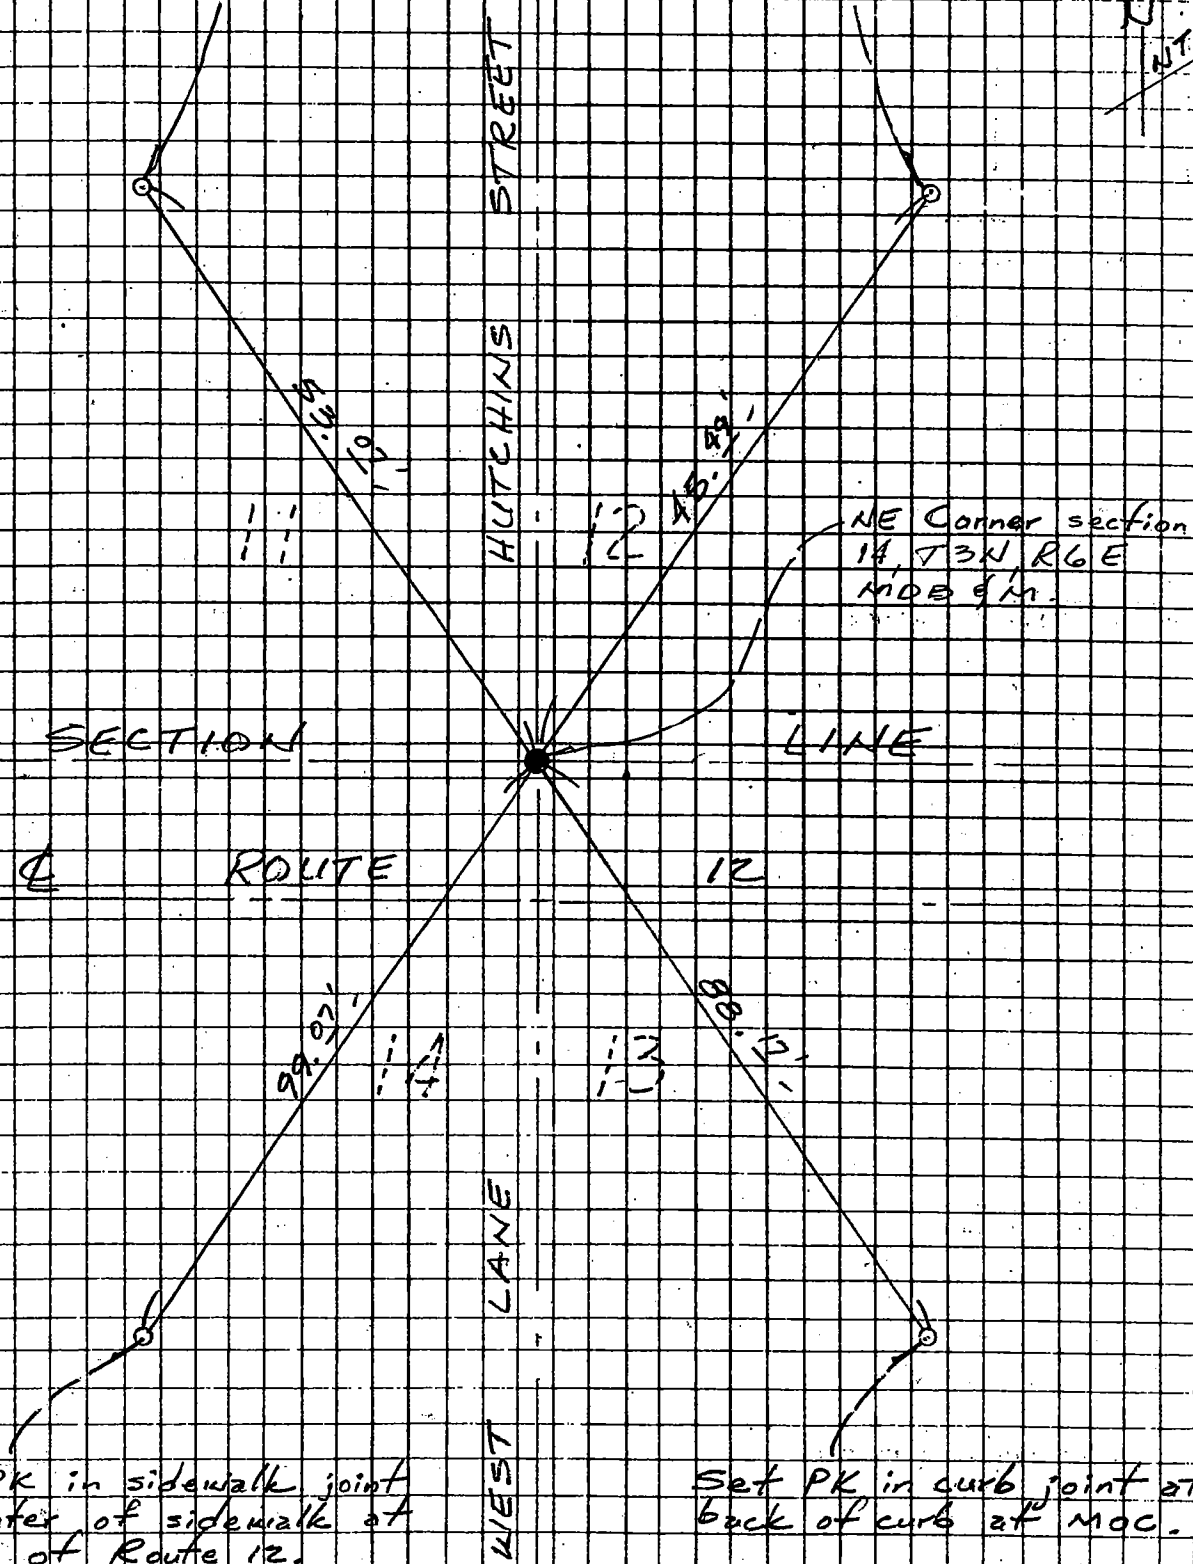
(D.D. Sheet No. 15)

Found Caltrans brass disk in survey well.

Monument found in good condition.

NOTE:  
 All PK swing  
 ties are with  
 "Calltrans" brass  
 tag.

Set PK in curb joint at  
 back of curb at MOC.

Set PK in sidewalk joint  
 at center of sidewalk at  
 BCR of Route 12.
