CORNER RECORD

Document Number 01-113

City of MANTECA County of SAN JOAQUIN, California

Brief Legal Description BOOK 35 OF MAPS AND PLATS, PAGE 4, SAN JOAQUIN COUNTY RECORDS.

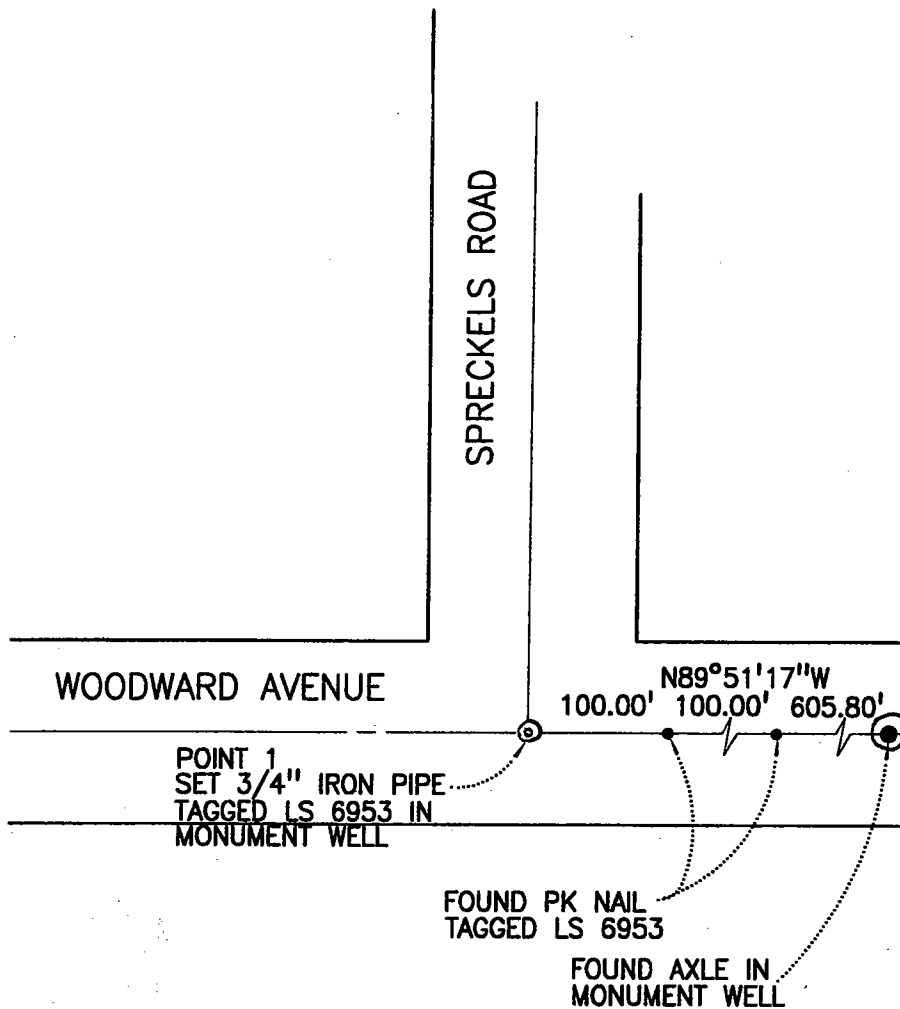
NOT TO SCALE

Identification and type of corner found: Evidence used to identify or procedure used to establish or reestablished the corner:
POINT 1: NAIL AT THE INTERSECTION OF WOODWARD AVE. AND SPRECKELS ROAD WAS DESTROYED
DUE TO PAVEMENT RECONSTRUCTION AND WAS REESTABLISHED USING THE SWING TIES SET PRIOR TO
THE MONUMENT BEING DESTROYED AS SHOWN ON PREVIOUS CORNER RECORD 01-29.

A description of the physical condition of the monument as found and as set or reset:
SET 3/4" IRON PIPE TAGGED LS 6953 IN MONUMENT WELL.

NOTE: FOUND MONUMENTS ARE NOT VERIFIED AS BEING THE CENTERLINE OF THE STREET RIGHTS-OF-WAYS.
