CORNER RECORD

Document Number 01-114

Brief Legal Description CENTER OF SECTION 9, T.2S., R.7E., M.D.B.&M.

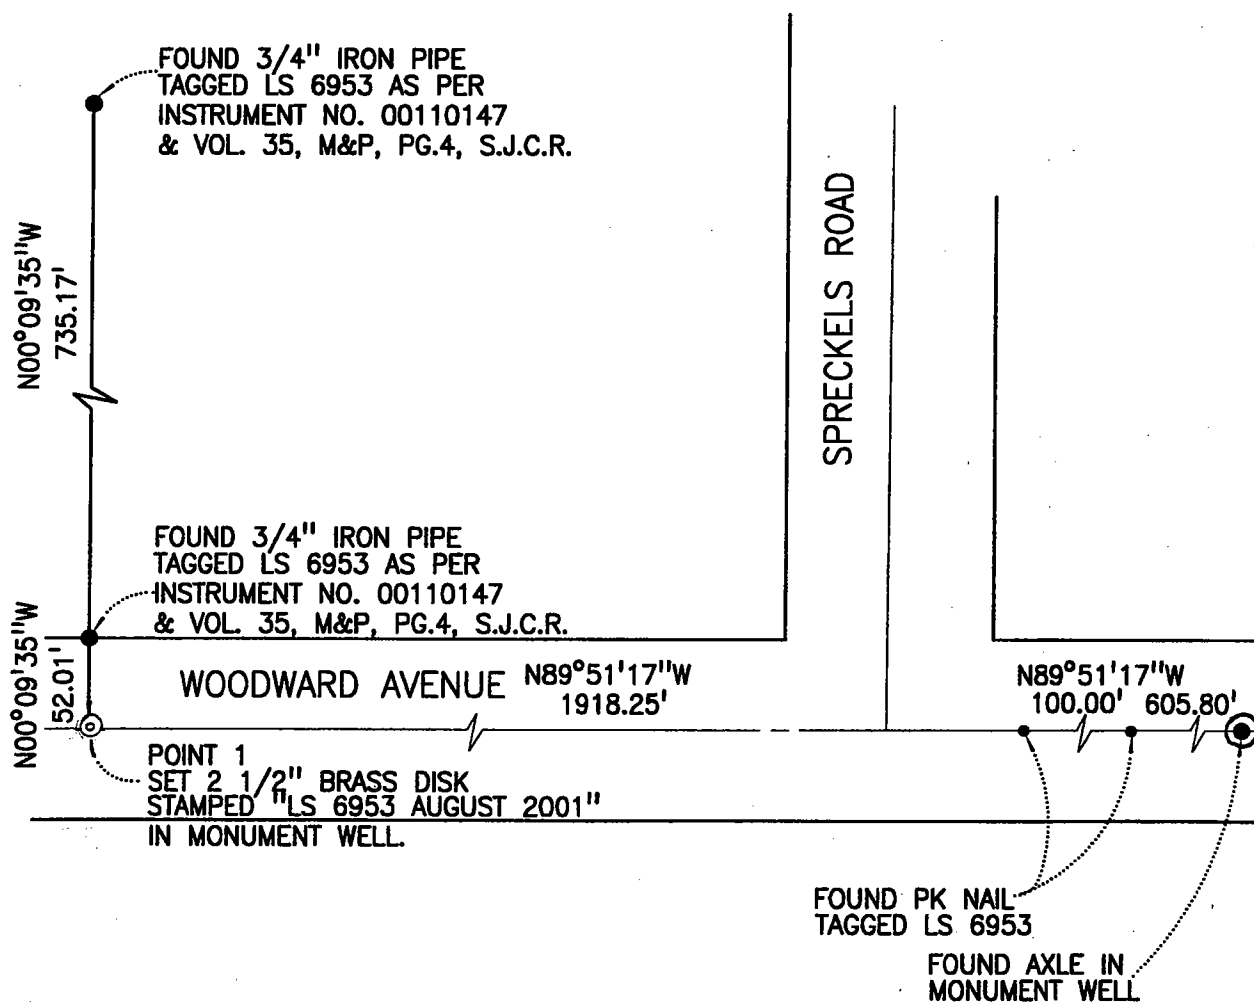
Identification and type of corner found: Evidence used to identify or procedure used to establish or reestablished the corner:
POINT 1: BRASS DISK STAMPED R.E. 9338 IN MONUMENT BOX MARKING THE CENTER OF SECTION 9 AT
THE CENTERLINE OF WOODWARD AVENUE AS SHOWN FOR RECORD IN BOOK 35 OF MAPS AND PLATS AT
PAGE 4, SAN JOAQUIN COUNTY RECORDS WAS DESTROYED DUE TO PAVEMENT RECONSTRUCTION AND
REESTABLISHED USING THE SWING TIES SET PRIOR TO THE MONUMENT BEING DESTROYED AS SHOWN
ON PREVIOUS CORNER RECORD 01-29.

A description of the physical condition of the monument as found and as set or reset: _____
SET 2 1/2" BRASS DISK STAMPED "LS 6953 AUGUST 2001" IN MONUMENT WELL.

NOTE: FOUND MONUMENTS ARE NOT
VERIFIED AS BEING THE CENTERLINE
OF THE STREET RIGHTS-OF-WAYS.
