CORNER RECORD

Document Number CR-01-132  
County of San Joaquin, California

Brief Legal Description EAST MAIN STREET AT THE INTERSECTION OF GILLIS RD.

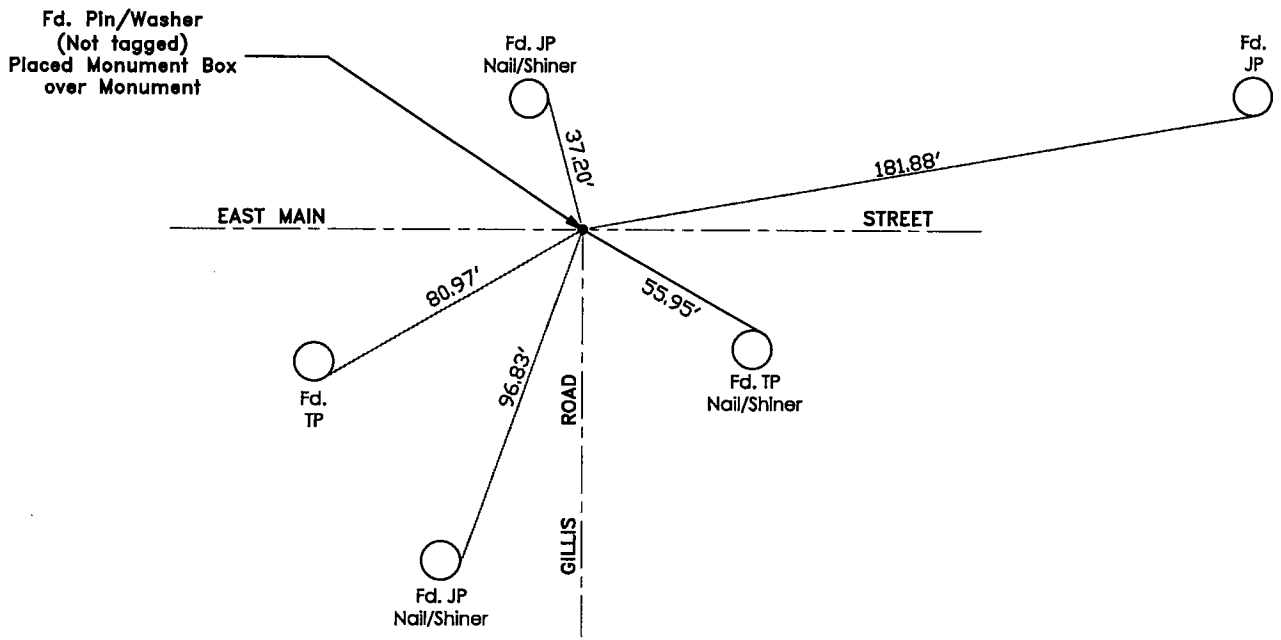
Identification and type of corner found: Evidence used to identify or procedure used to establish or reestablish the corner:  
FOUND PIN/WASHER (NOT TAGGED). CONFIRMED LOCATION PER SWING TIES ON CR-01-93. SEE SKETCH ON BACKSIDE.

A description of the physical condition of the monument as found and as set or reset:  
FOUND MONUMENT IN GOOD CONDITION. SEE SKETCH ON BACKSIDE.
