CORNER RECORD

Document Number CR-01-134

County of San Joaquin, California

Brief Legal Description BIRD ROAD 40' ± N/O KENNER RD. AND

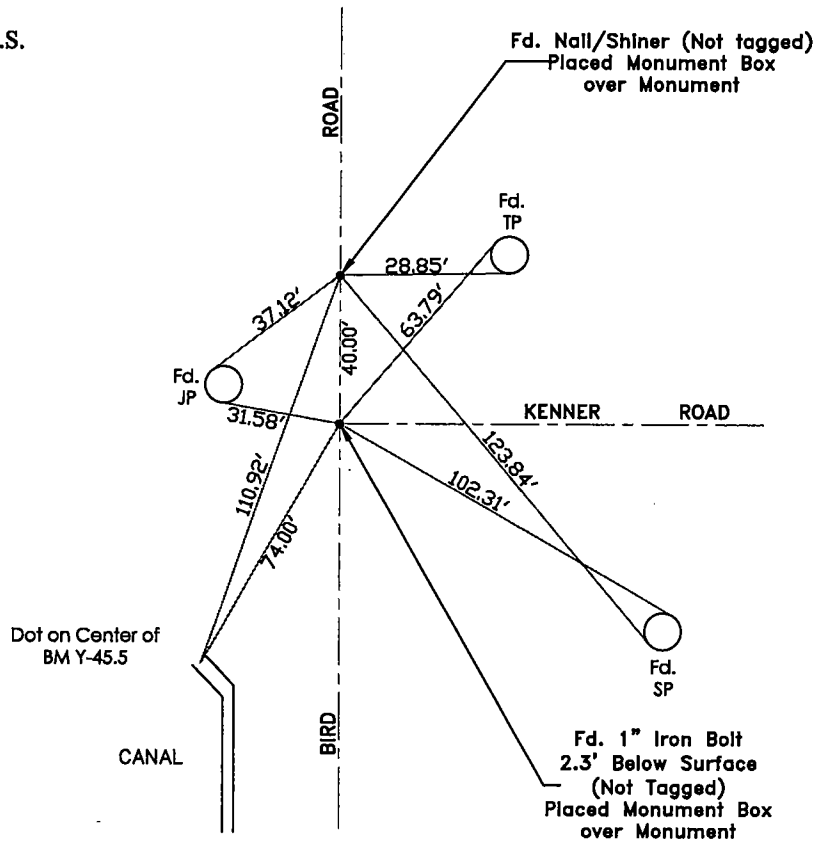
Identification and type of corner found: Evidence used to identify or procedure used to establish or reestablish the corner:  
FOUND NAIL/SHINER AND FOUND 1" IRON BOLT 2.3' BELOW SURFACE. CONFIRMED LOCATION PER SWING TIES ON  
CR-00-227. SEE SKETCH ON BACKSIDE.

A description of the physical condition of the monument as found and as set or reset:  
FOUND MONUMENTS IN GOOD CONDITION. SEE SKETCH ON BACKSIDE.
