CORNER RECORD

Document Number 02-12
County of San Joaquin, California

Brief Legal Description MICHIGAN AVENUE AT THE INTERSECTION OF WISCONSIN AVE.

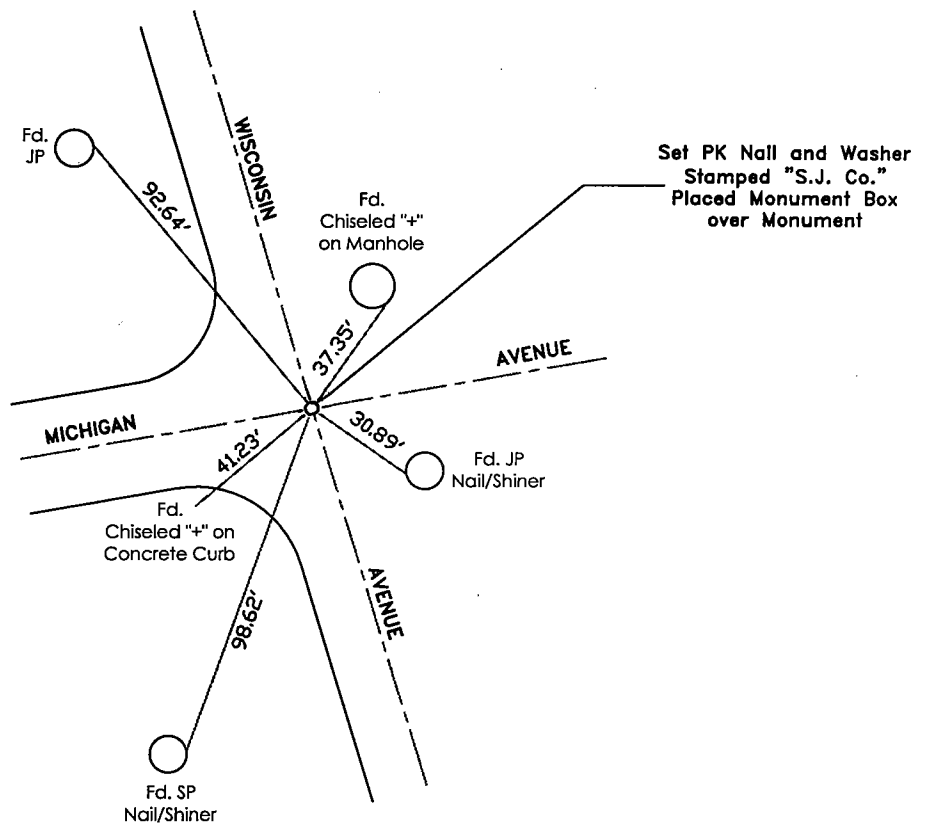
N.T.S.

Identification and type of corner found: Evidence used to identify or procedure used to establish or reestablish the corner:
SET PK NAIL AND WASHER STAMPED "S.J. CO.". REESTABLISHED LOCATION PER SWING TIES ON CR-00-191. SEE SKETCH ON BACKSIDE.

A description of the physical condition of the monument as found and as set or reset:
SET MONUMENT. SEE SKETCH ON BACKSIDE.
